**PROJECT COMPLETION REPORT**  
**MAI JAMAN**  
**MOSQUE**  
**December | 2024**

**Endowment Fund Trust**  
**for Preservation of the Heritage of Sindh**

## COMPLETION REPORT: MAI JAMAN MOSQUE

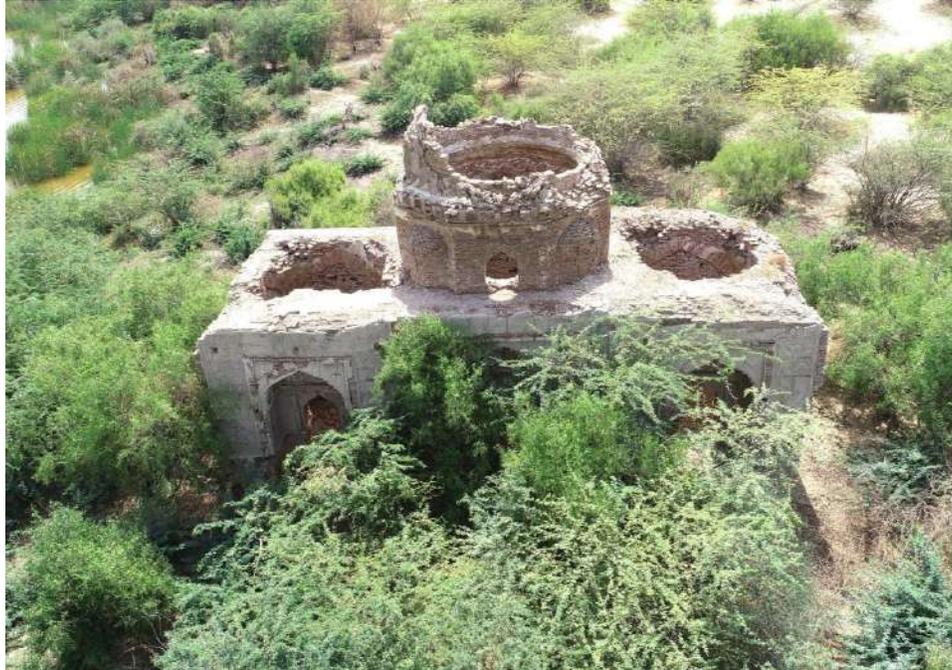
Alas, through neglect and passing of time, the great domes of the mosque, alongside the plastering, collapsed completely leaving behind a shell of the structure.

**The photo of the Mosque was taken during preliminary survey-2021**

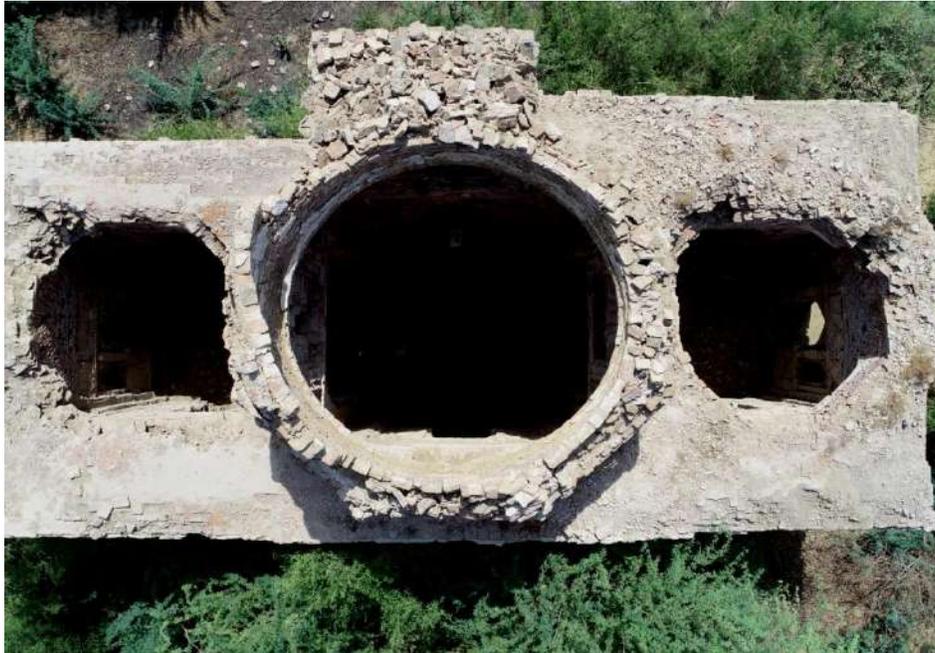
All three domes have collapsed

When restoring the mosque, the squinches were initially reinforced by incorporating steel bars. A lintel was subsequently installed on the octagonal drum of the central dome. After the drum was rebuilt, the center dome was redesigned utilizing computer assistance. Thus, the two smaller domes were designed. Thus the structure was reconstructed to the original form of the three collapsed domes, brick by brick.

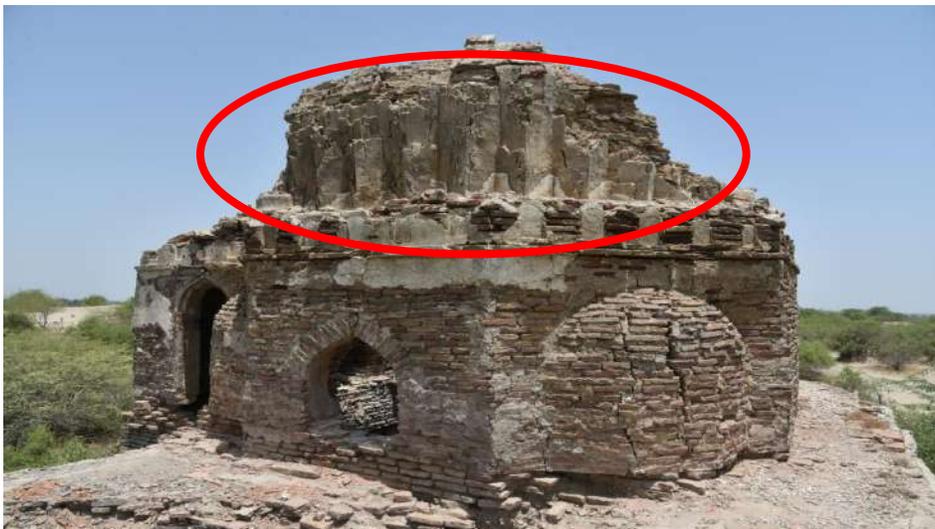
View of the badly weathered octagonal drum with remains  
of the plaster dome ribs

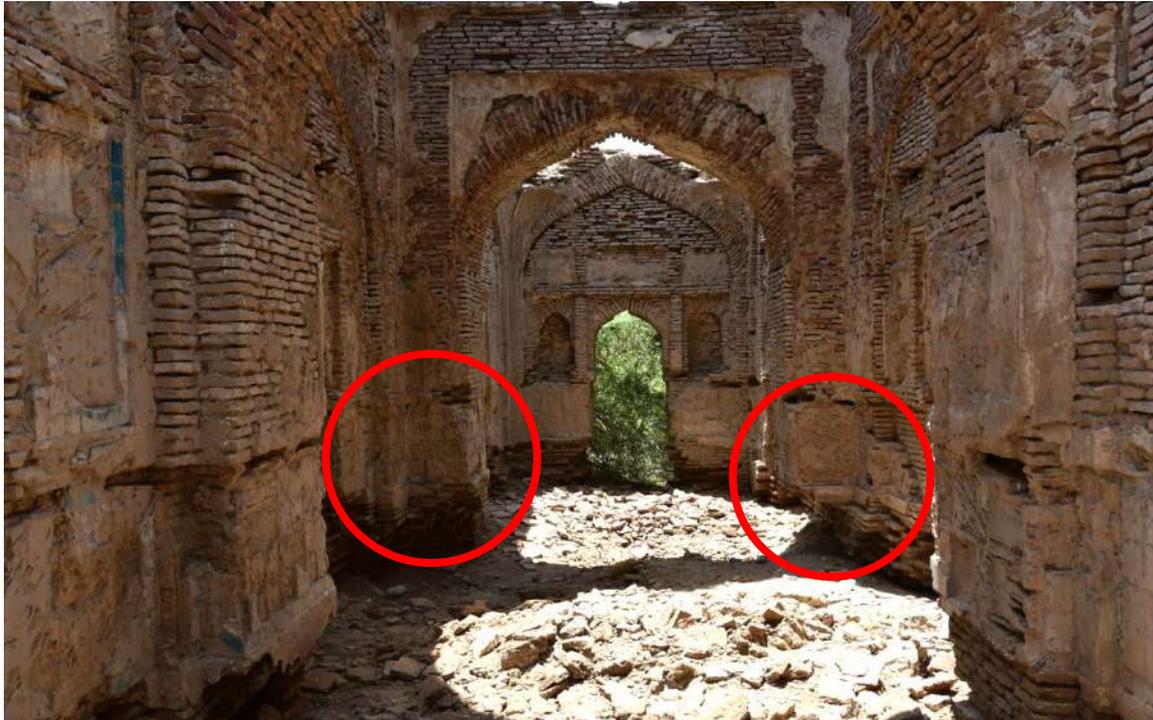
**View showing the absence of base bricks. (Arch abutments hanging)**

First, debris was removed from the site. The work began with underpinning and wall pinning, as the width of the walls varied at the entrances and columns. Bricks were missing up to a height of 4 feet in some areas. These missing sections were restored using new bricks of the same size.

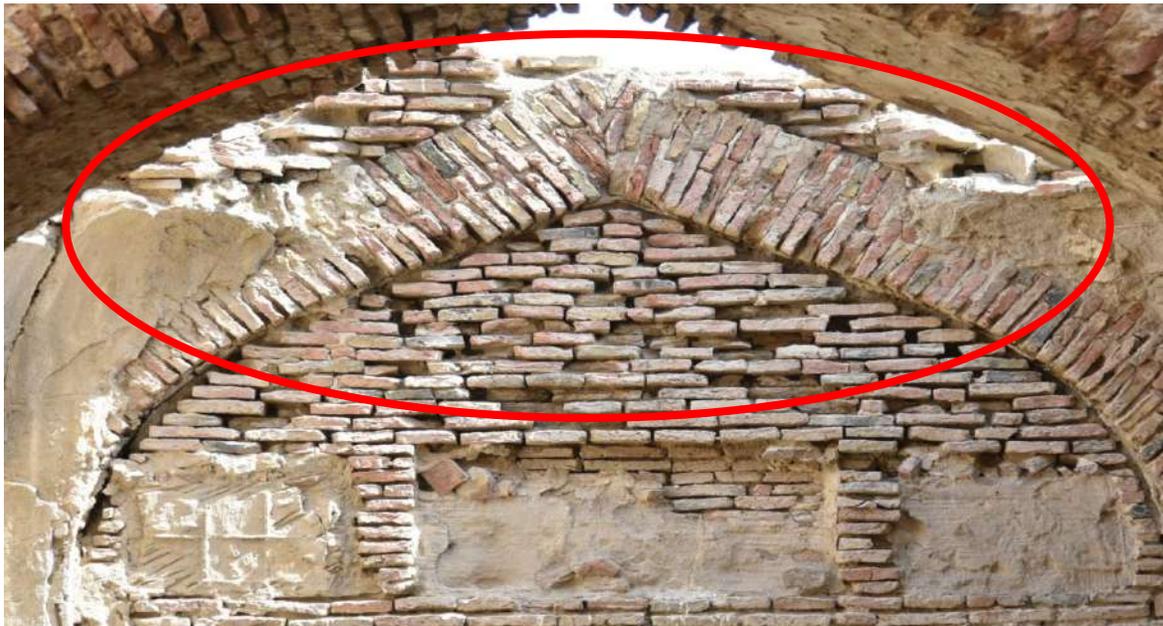
**Picture showing the badly spalled and bulging interior masonry work**

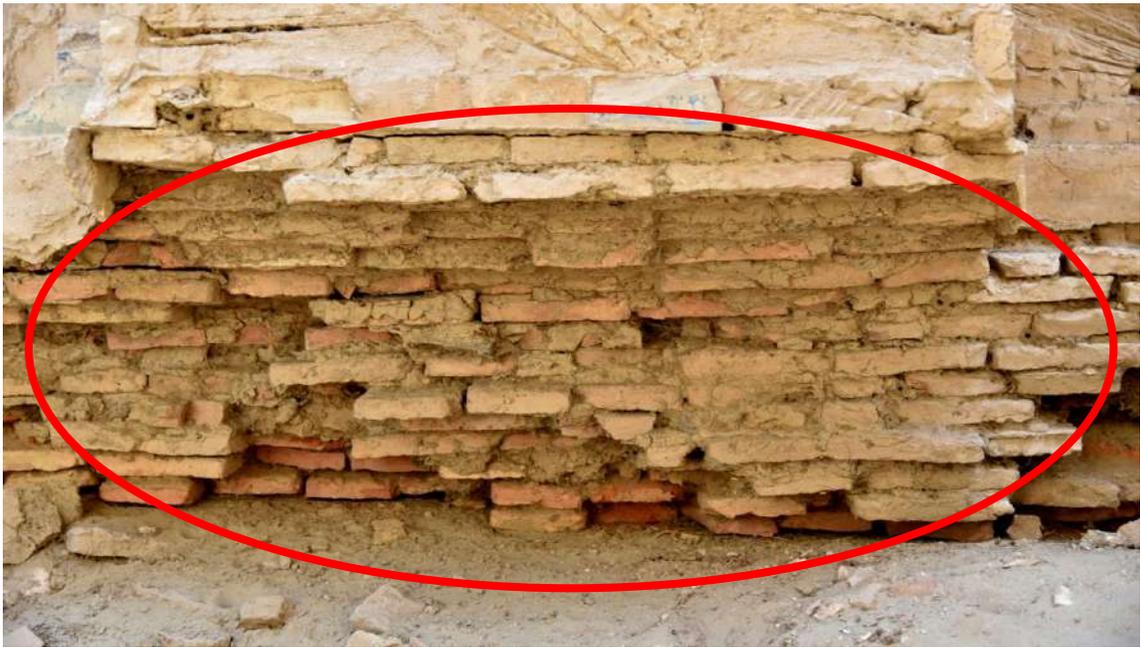
**Eroded (or extracted) base bricks**

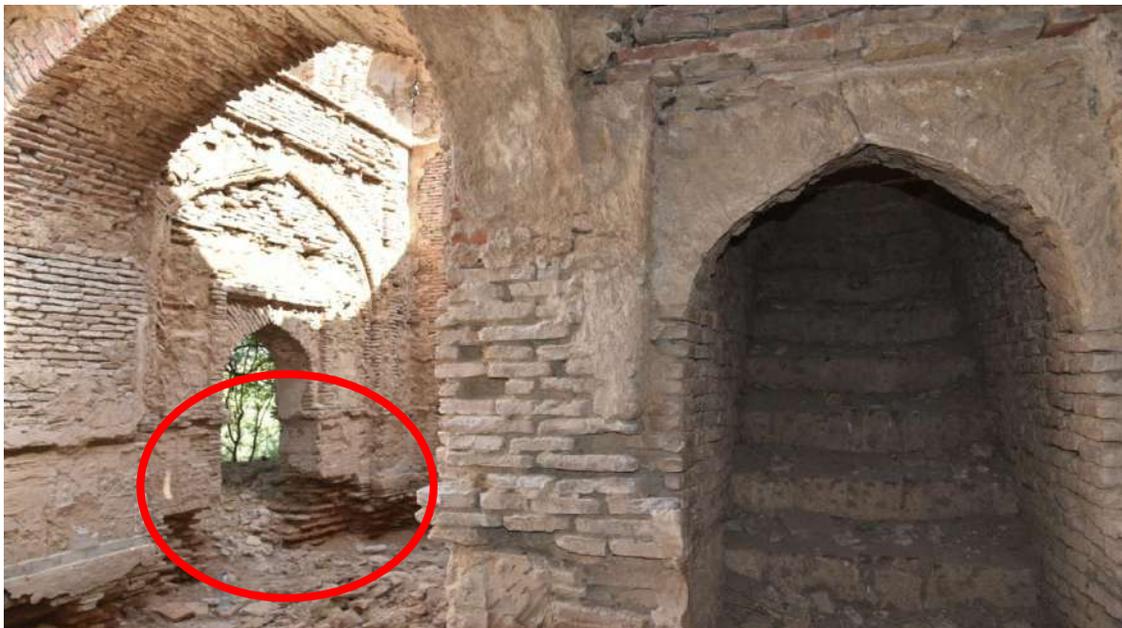
**View of the staircase and the eroded ground level bricks**

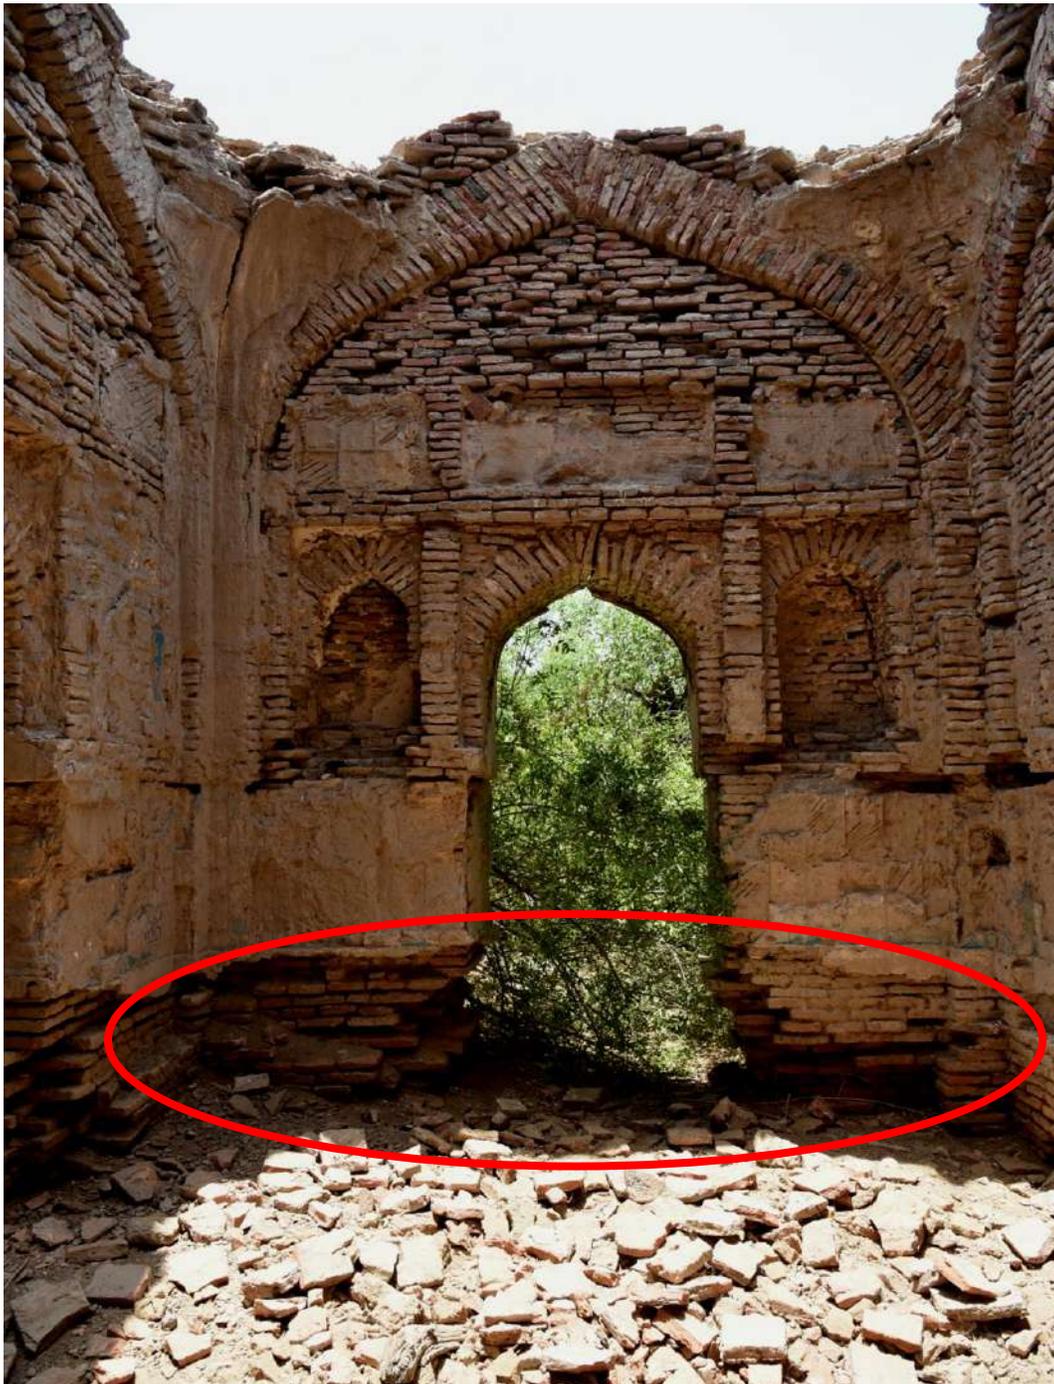
View of the interior arch shows the way blocked by overgrowth and erosion of base bricks.

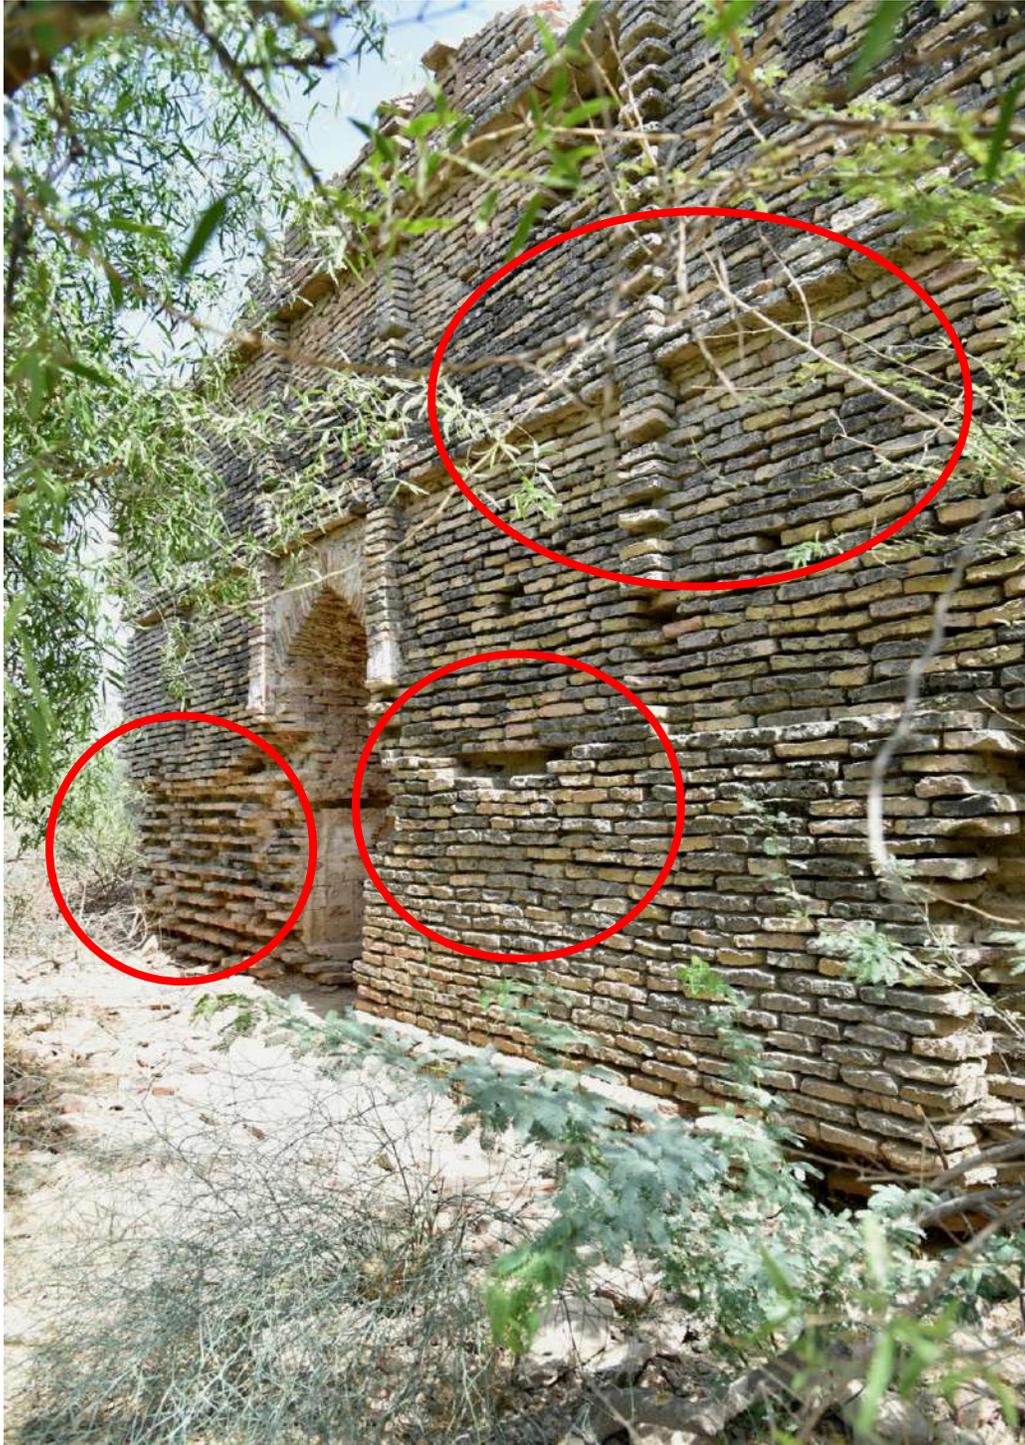
View of exterior shows a variety of masonry defects like spalling, displacement and staining.

The EFT technical team restored various issues, including spalling, bulging, displacement of masonry, black staining, and plaster deterioration of exterior walls. The restoration process of walls involved applying a first coat of Chirolly, followed by two coats of lime covered with lime cream mixed with soapstone.

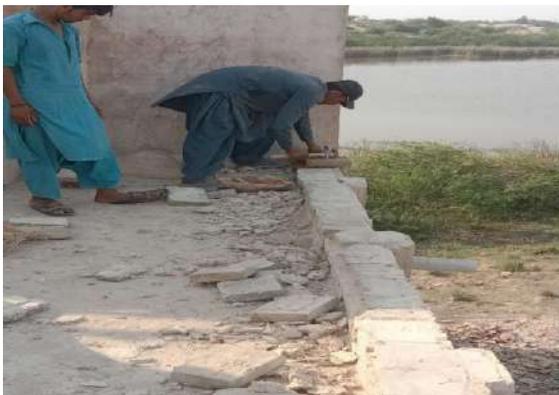
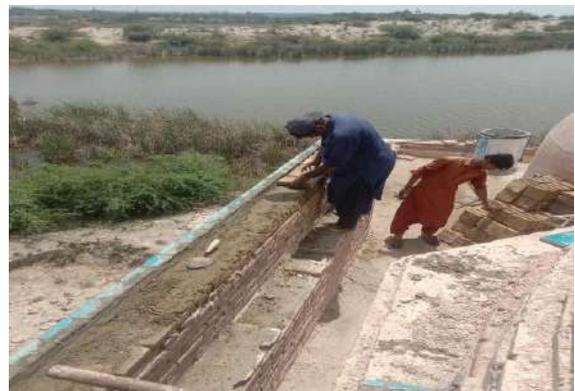
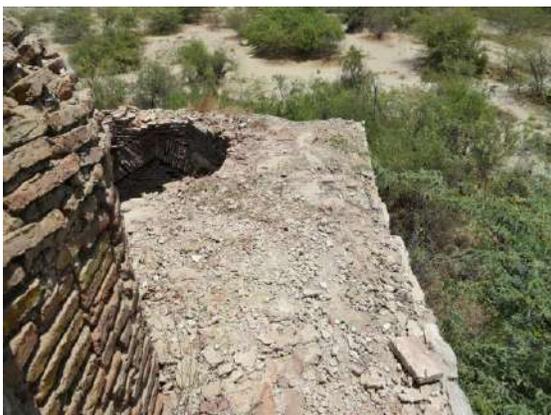
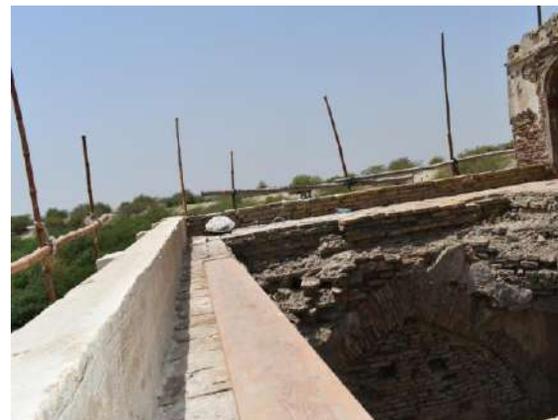
Since the construction of this mosque, it was left without an owner to look after and maintain the structure. For centuries, it remained abandoned, allowing the weather and people to damage it significantly, especially its decorative elements and bricks, which were often taken to be used in homes. As a result, the parapet wall had either collapsed or was removed entirely.

EFT redesigned the parapet wall using the original bricks, keeping its height at 1.5 feet. It was then covered with chiroly and lime. To protect it from rain and other weather effects, it was waterproofed with a mixture of lime cream and soapstone.

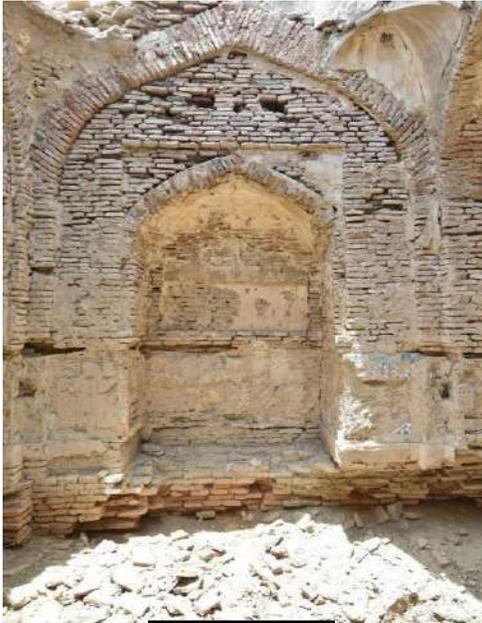
View of interior Arch showing the exposed, weathered and missing bricks. New homogenous bricks were incorporated into the structure to ensure stability.

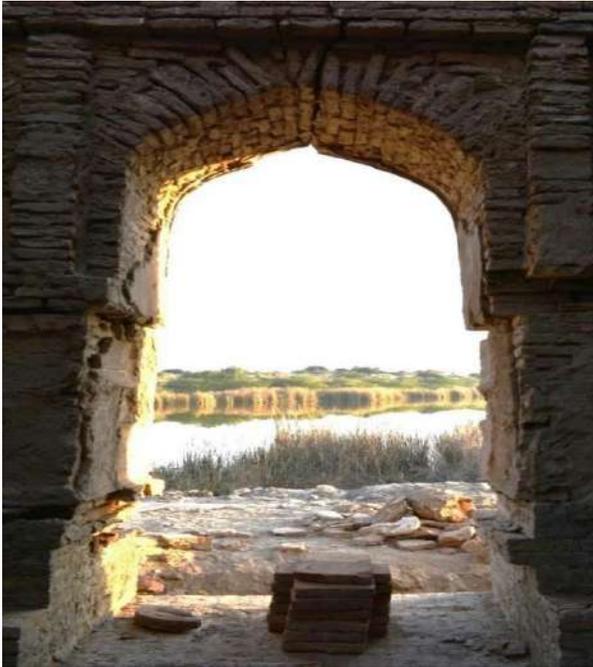
Before

Animals and treasure hunters had dug numerous tranches inside the structure. Additionally local people had taken bricks from the site for their own use.

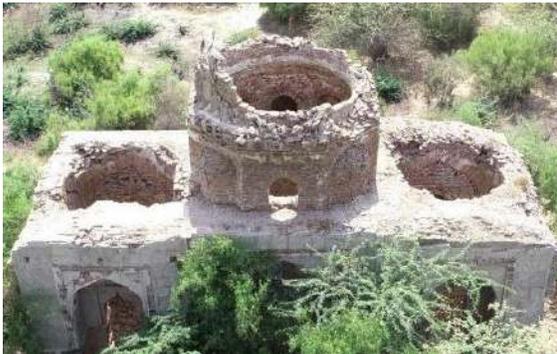
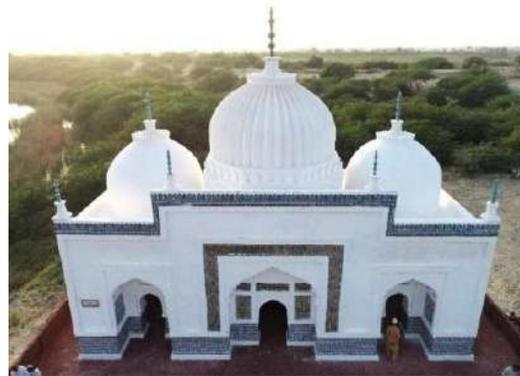
**The three collapsed domes have been restored**

Finally, the domes were plastered with one coat of chiroli and two coats of lime. To protect them from rain and moisture, lime was applied which was followed by soapstone for waterproofing. In the final stage, the lotuses were crafted, and kashi finials were erected atop the three domes.
