COMPLETION REPORT

THE HINDU TEMPLE (SHIVA MARHI) AT MOOSA
KHATIAN

ENDOWMENT FUND TRUST
For Preservation of the Heritage of Sindh

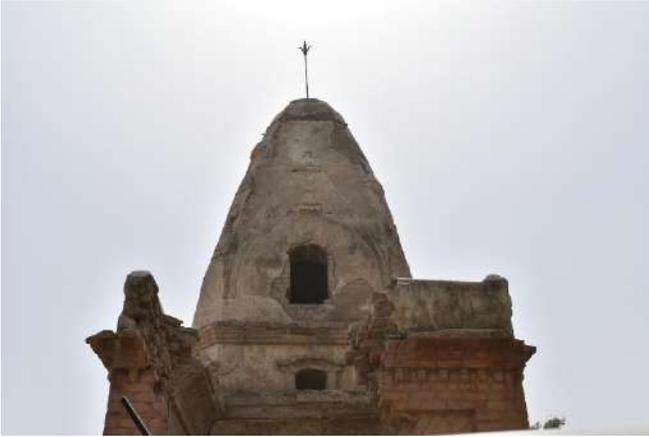
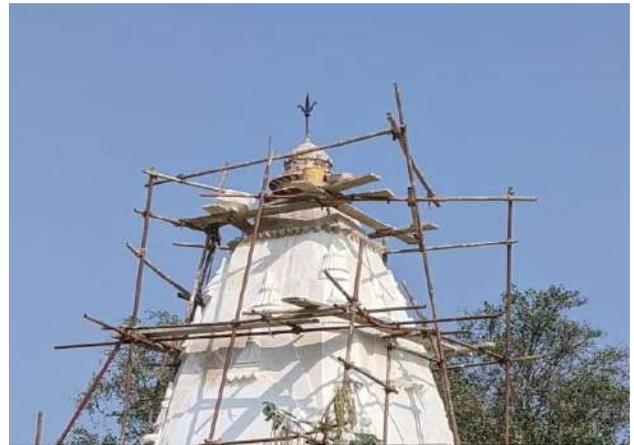
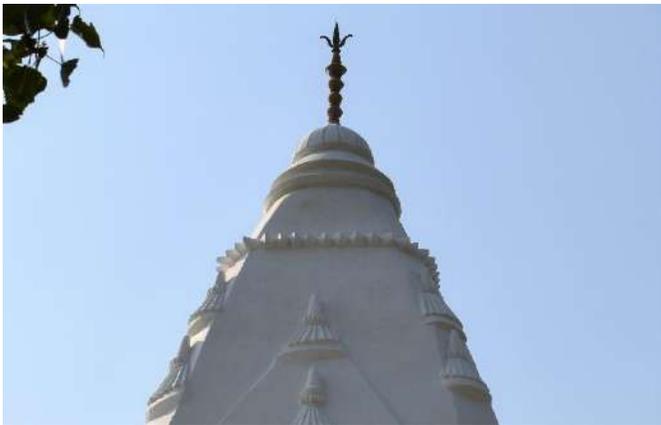
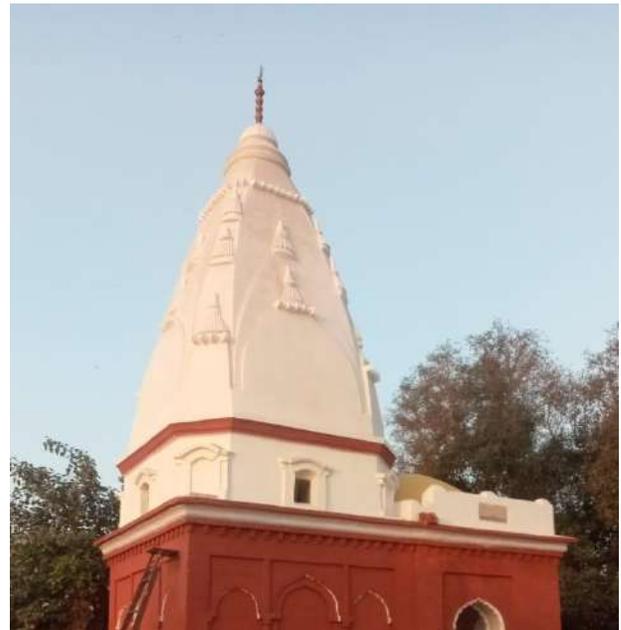
FINIAL PHOTOGRAPHS:

The following photographs show the before and after conservation of the restored finial.

- The finial was finally installed on the spire of the *Shikhara*.
- The lime cream layer was plastered on the *Shikhara*.
- The interior of the *garbhagriya* was plastered.
- The flooring work was started.

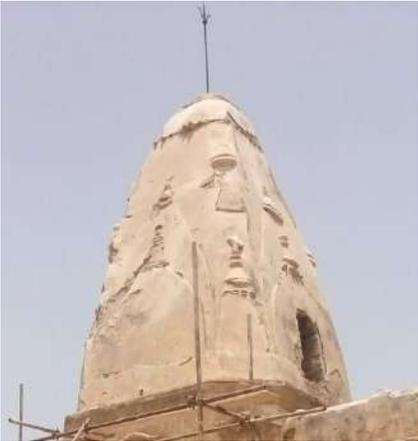
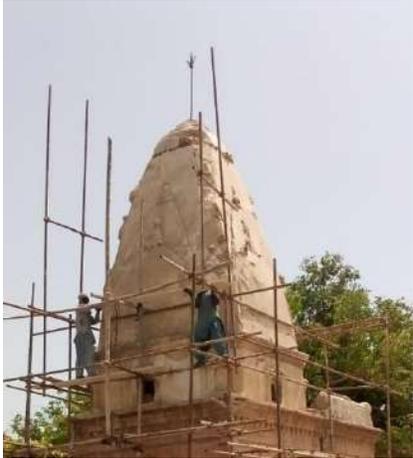
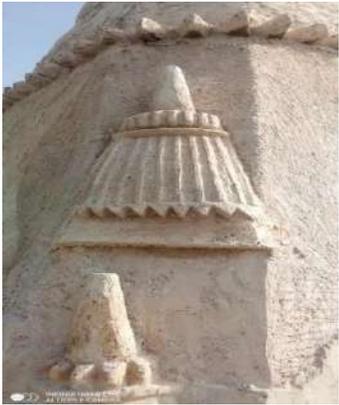
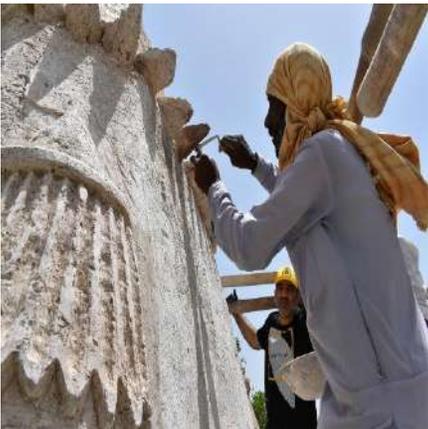
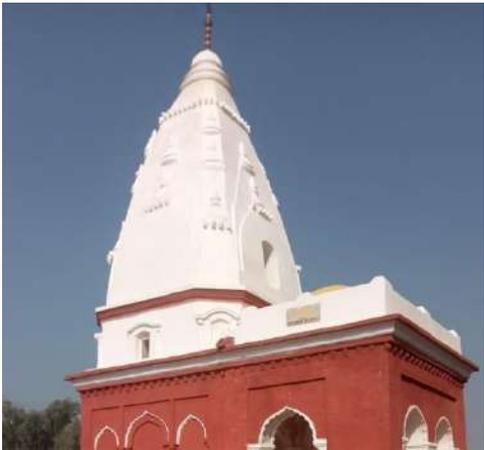
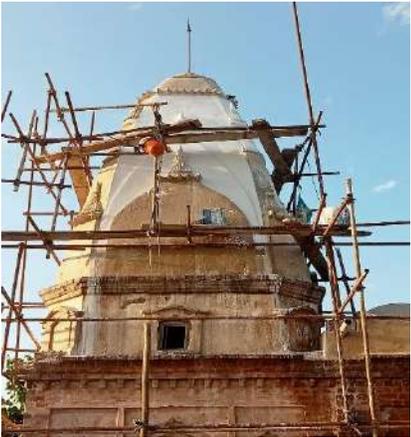
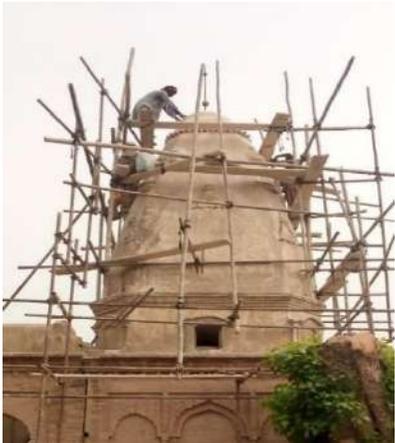
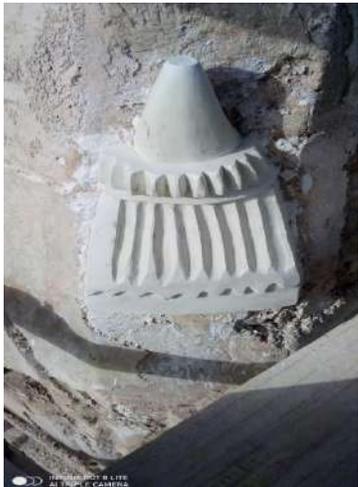
SHIKARA PHOTOGRAPHS:

- The *Shikhara* is entwined with the tree branches.
- Many of the relief plaster decoration have eroded due to the effects of rain.
- Many bricks can be found at the site that are supposedly said to belong to the original structure.

The following photographs show the timeline conservation of the Shikhara of the temple along with cultural detailing.

- The centre column of the arch ensemble was erected.
- A field template was made (reminiscing the conservation of Dooleh Darya Khan Otaaq) and arches were carefully fashioned.
- Further structural reinforcements were made to ensure that risks be eliminated.
- The *Shikhara* conservation was started with faulty plaster being removed and damaged bricks replaced.
- A field template for the vaulted roof of the *Mandap* was made and the base was re-constructed using lime and *chirol*.
- Reconstruction work of the parapets was underway.

- The central column of the structure was given shape mirroring the original design of the original columns.
- Structurally, the arches were reinforced using an interventive conservation procedure where they were reinforced with iron bars at the crown.
- The interior saw extensive plastering work (including the arch foil).
- The *shikhara* saw extensive plastering work.

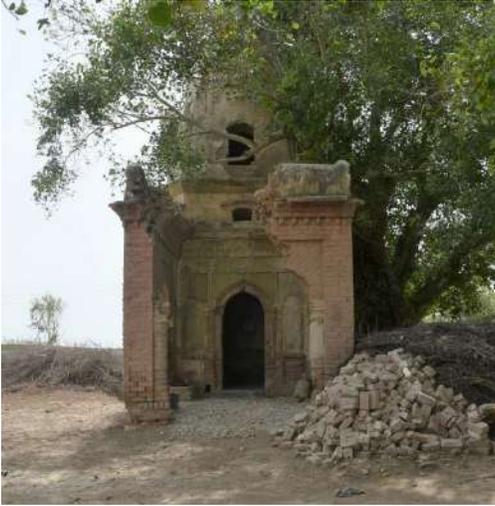
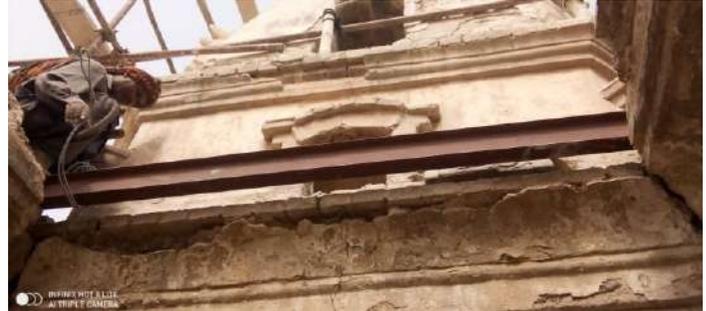
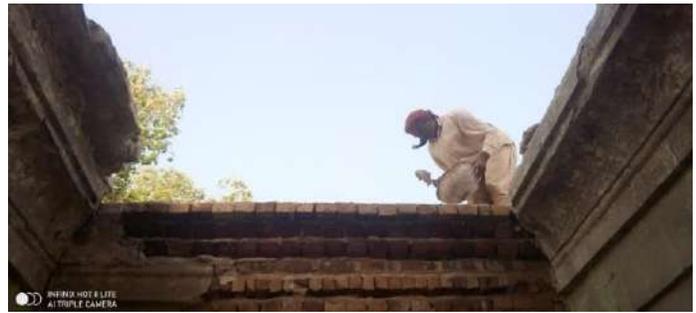
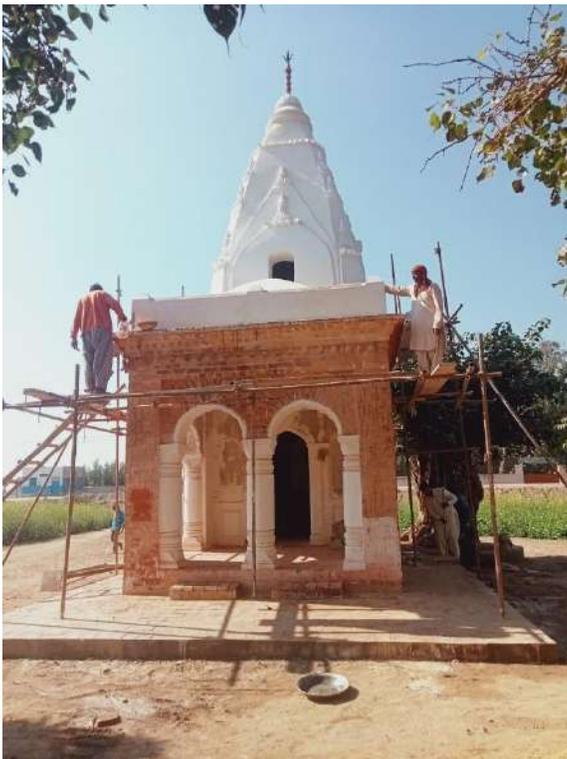
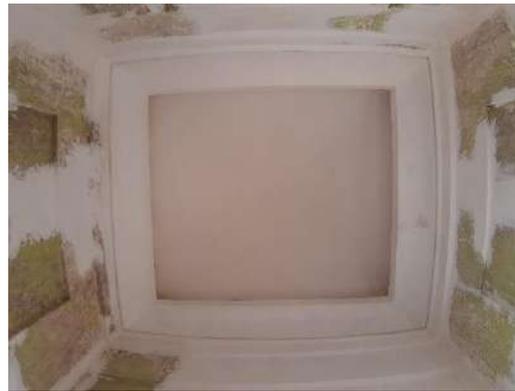
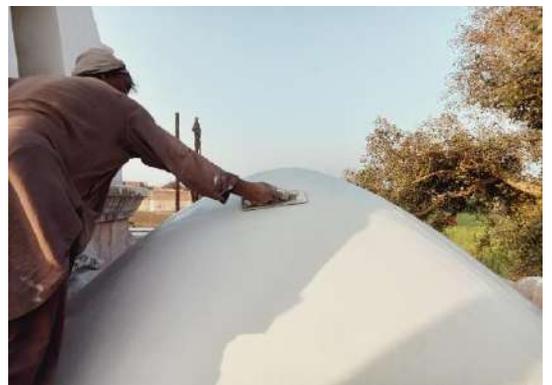
MANDAP MAIN ARCH PHOTOGRAPHS:

- Buffing of the brick masonry to scrape off the extra moisture.
- Pointing work between the bricks to ensure cohesion.
- Plastering work of interior of the *mandap*.
- Grouting of the cracks in the structure caused by inherent design failure. (The *Mandap* was a later addition to the temple and had lost cohesion with the *Garbhagriya* due to improvisation of joints/ interlocking between the two structures).

The mandap was perhaps the most difficult portion of the structure to conserve owing to an innate design failure. On-site strategic responses had to be devised to strengthen the structure.

The conservation work was resumed, first with potentially the riskiest activity of the project: removal of the template propping the *Mandap* roof. The template was eventually removed, and the dome stood firm. Other activities during the month include:

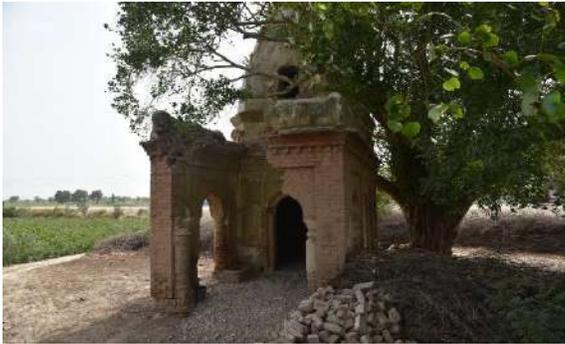
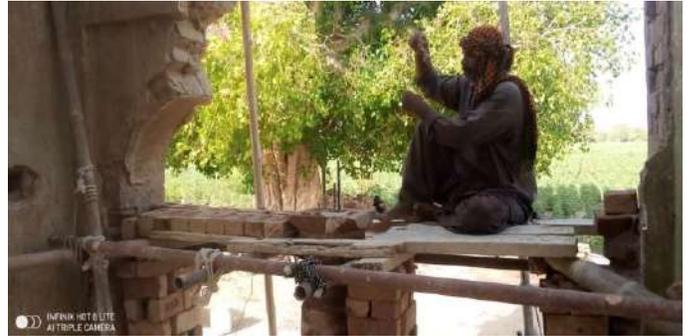
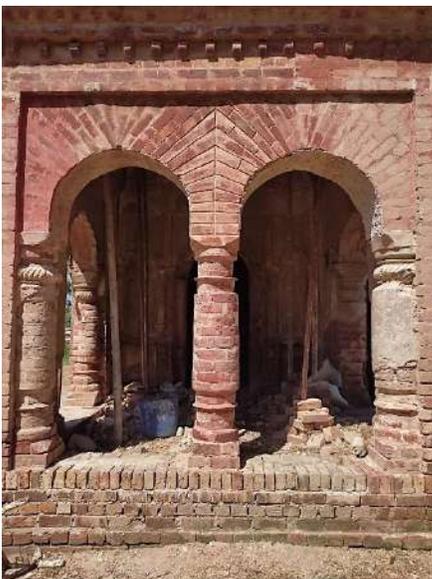
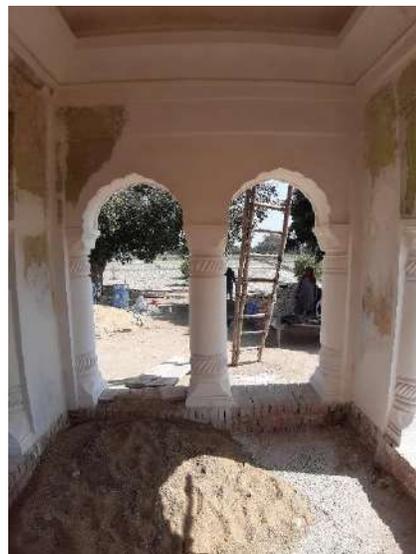
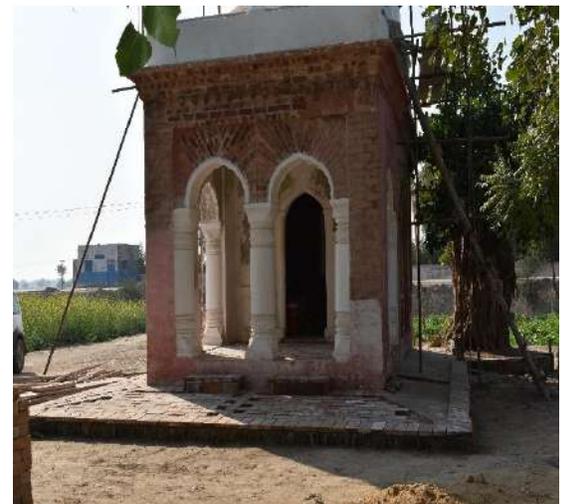
MAIN ARCH PHOTOGRAPHS:

The front arch openings were one of the most complex activities of the project. The engineers and masons on site managed to meticulously execute its reconstruction.

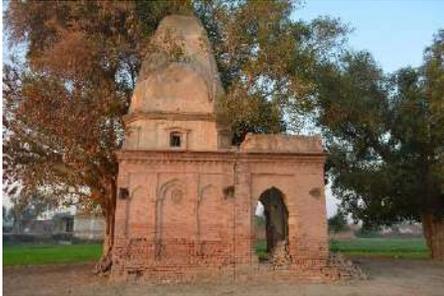
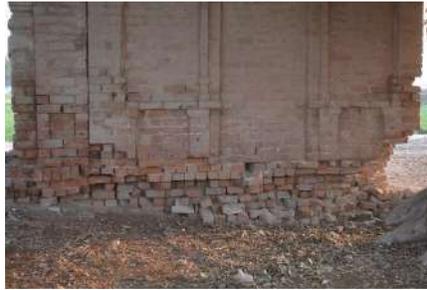
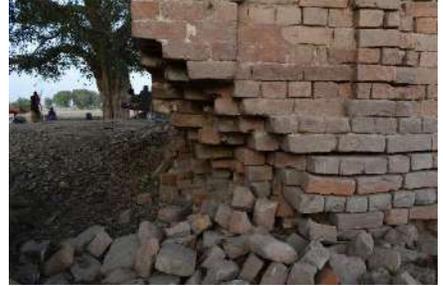
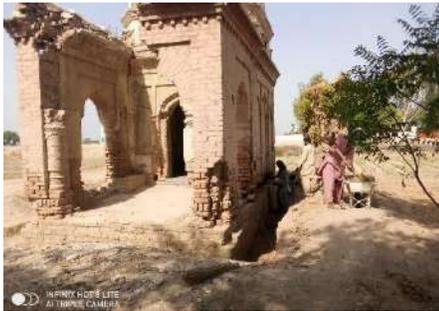
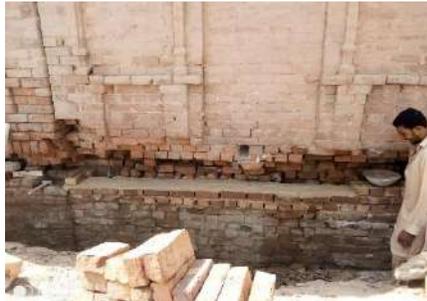
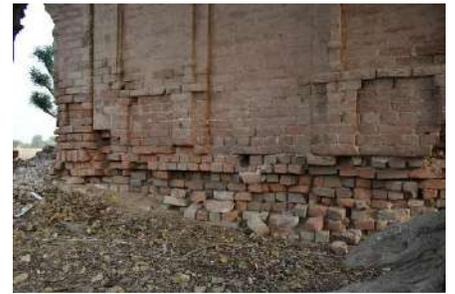
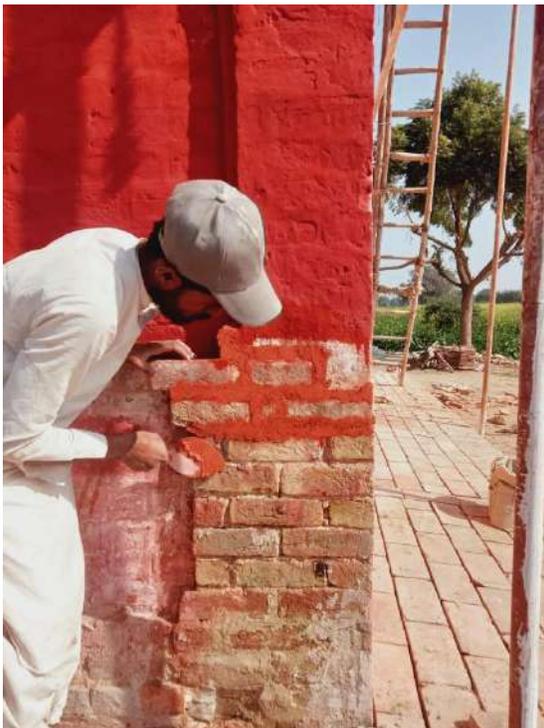
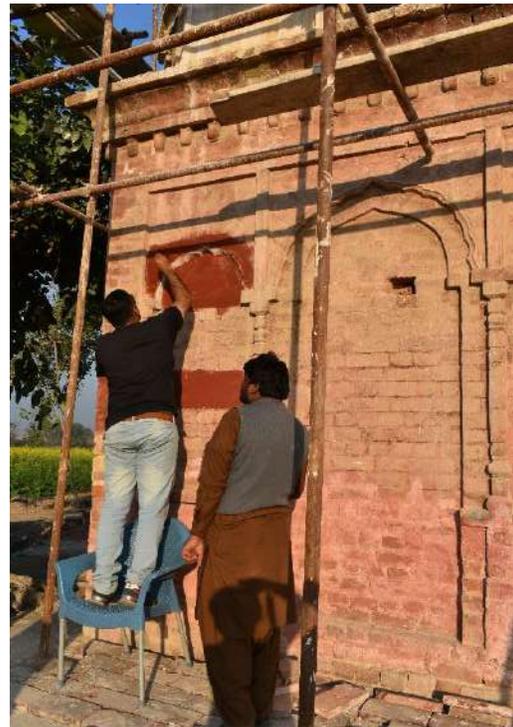
EXTERIOR PHOTOGRAPHS:

- The *Garbhagriya* has seen previous restoration attempts with the floor being remade with cement concrete up to the skill level.
- An outer corner of the *Garbhagriya* that is closest to the tree has been undercut by the tree growth.

The structure was heavily undercut by erosion and interventive measures were deployed to ensure structural stability.

- The outer platform of the structure was constructed to provide additional stability.
- The area around the temple was hardscaped for beautification purposes.
- The finishing touches were given to the structure and the progress.
- The project was handed over to the local community and reviews were taken from the stakeholders.

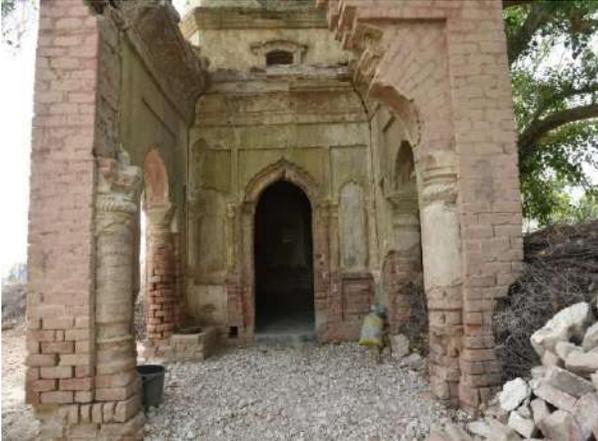
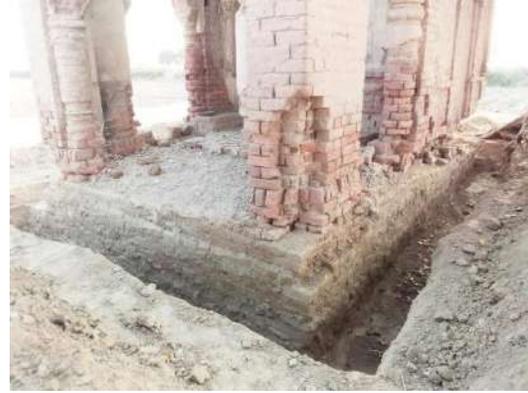
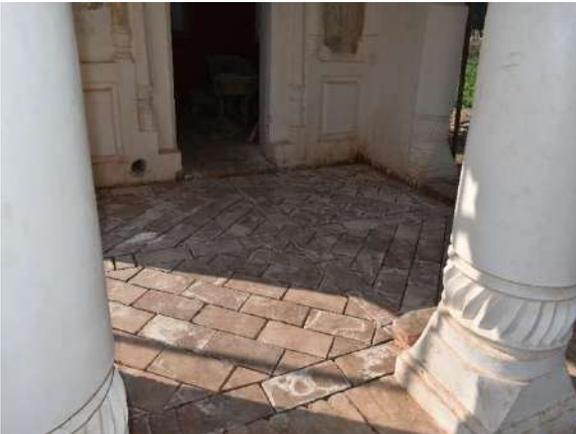
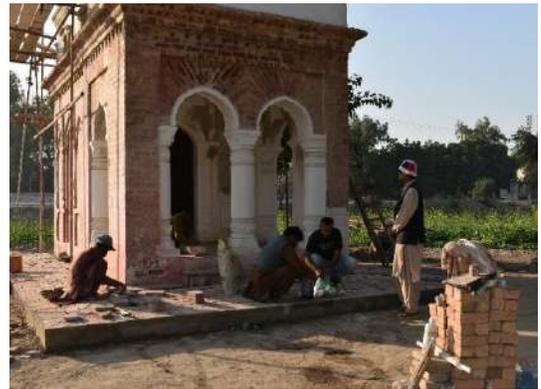
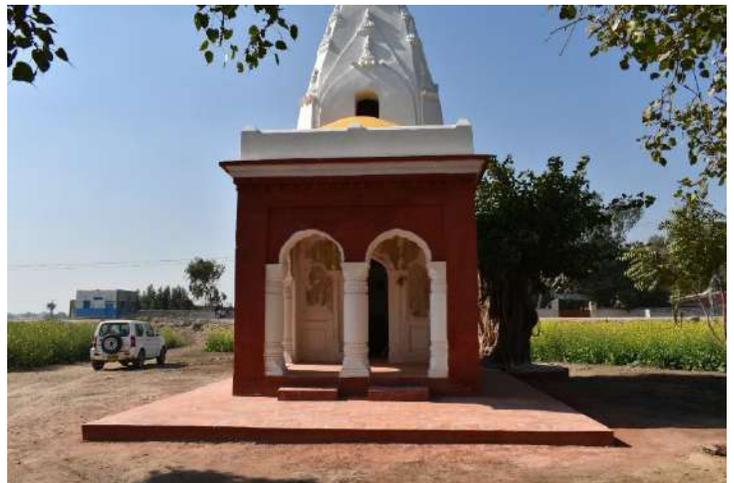
FLOORING PHOTOGRAPHS:

The flooring of the temple was poorly conserved by cement which damaged the structure. A new flooring was given with adequate drainage.

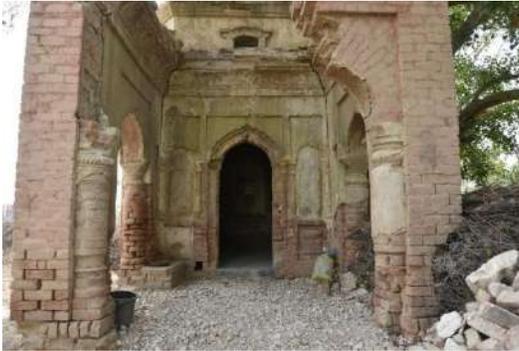
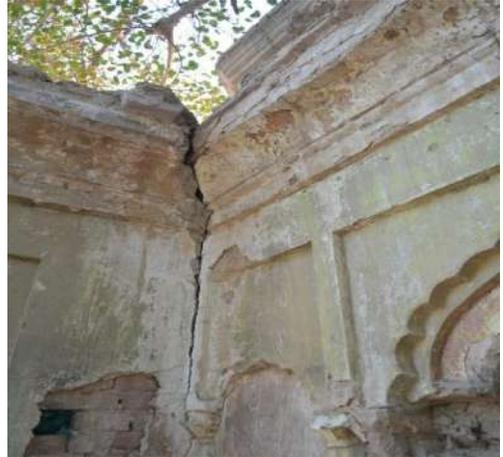
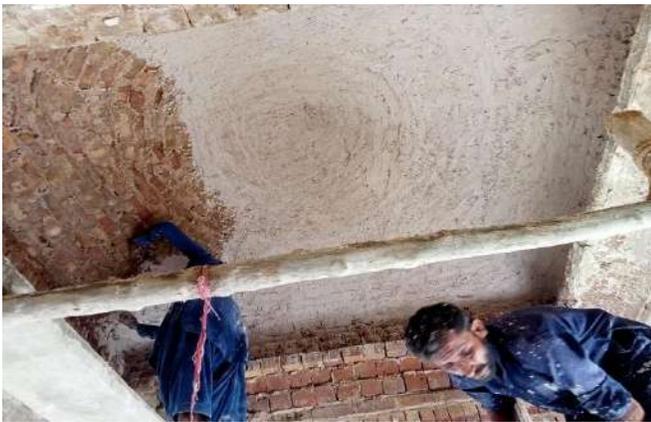
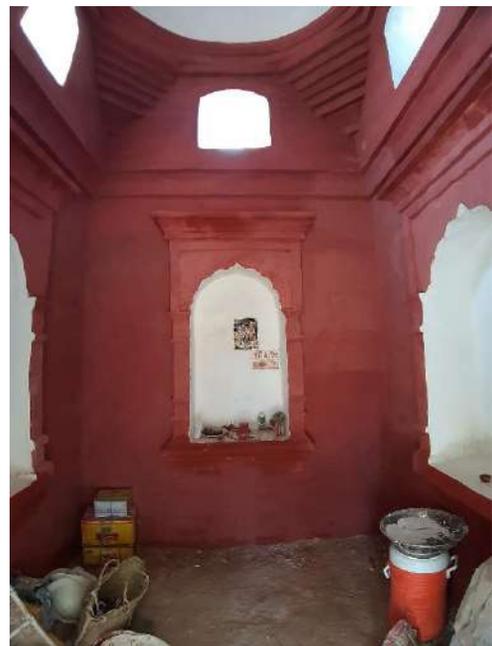
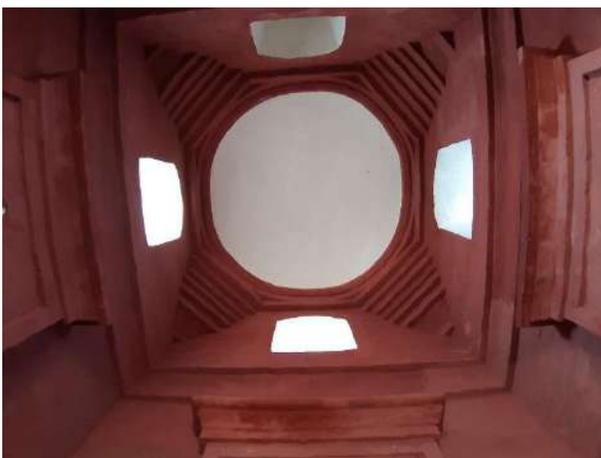
INTERIOR PHOTOGRAPHS:

The interior of the temple was conserved with lime mortar. Special attention was paid to the detailing and plasterwork.
