# GOBINDH RAM DARBAR

## Project Completion Report

**Center for Documentation and Conservation  
of the Heritage of Sindh**

**Endowment Fund Trust for Preservation  
of the Heritage of Sindh**

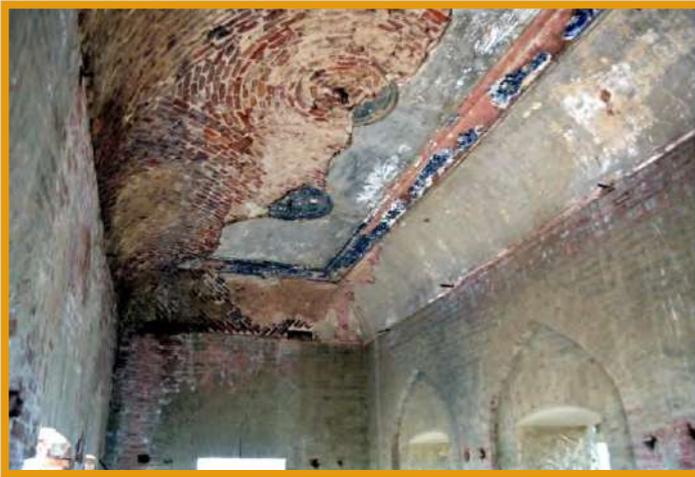
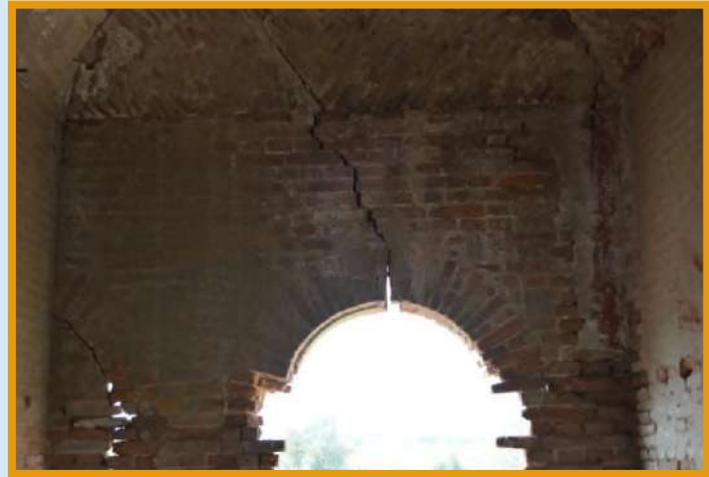
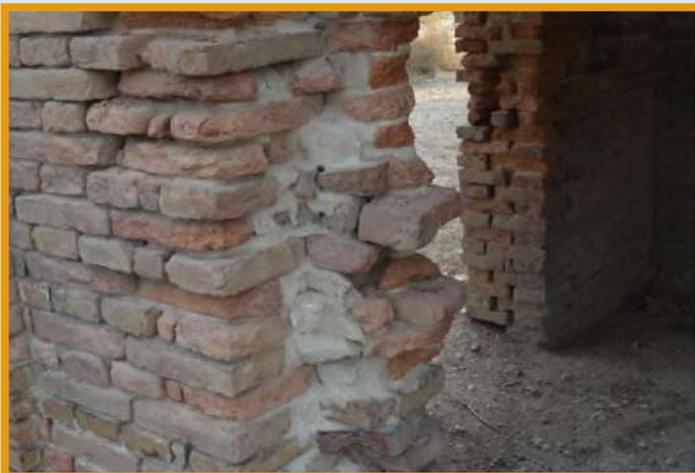
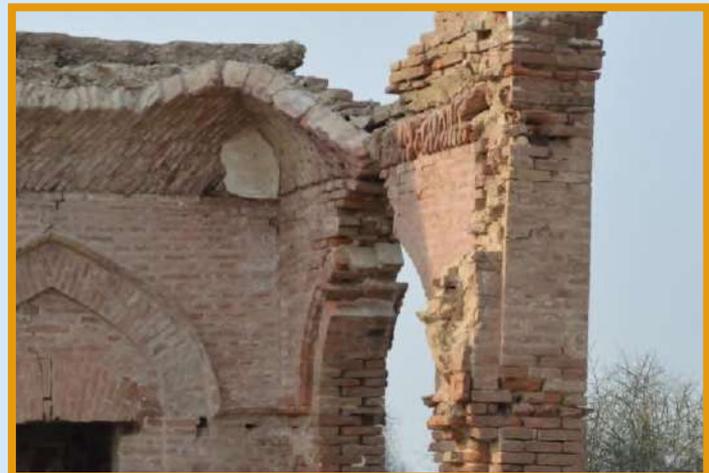
- ◆ There were rooms and verandas connected to central portion but they are completely destroyed except one hall in the north side and a portion of veranda in east having the signs of through roof but were destroyed and have two arches in either side.
- ◆ Due to Flood water and negligence, the building has developed cracks and fissures in the structures.
- ◆ Finial on the dome is completely destroyed.
- ◆ Minor cracks are appearing on the dome and plaster needs repair.
- ◆ Design on octagonal drum & Floral Pattern are completely destroyed.
- ◆ Cracks found in the circular arch of hall at northern side.
- ◆ Small niches with ogee arch constructed with carved bricks are damaged.
- ◆ Interior walls decorated with fresco work needs treatment.
- ◆ Floor tiles completely destroyed.

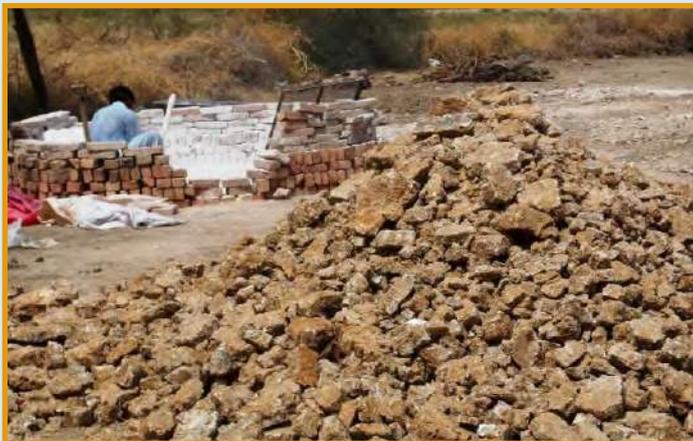
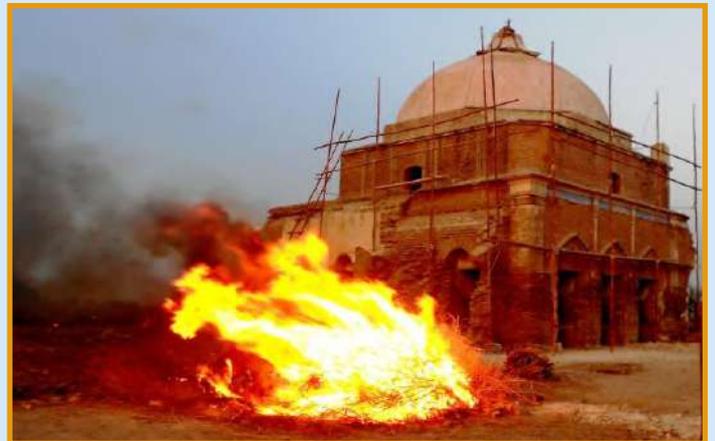
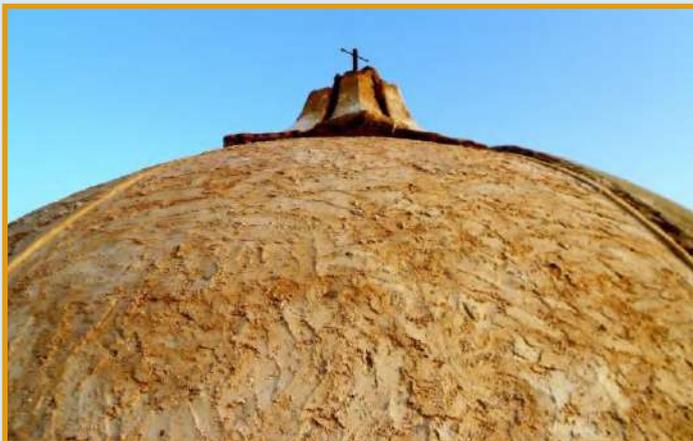
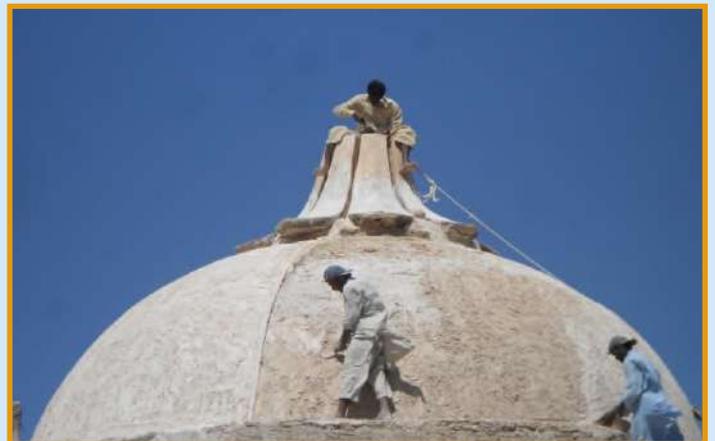
Chirolis Coating

- ◆ Constructed water tank.
- ◆ Constructed lime mixing tank.
- ◆ Scrapping at Dome.
- ◆ 1st coating of Chirolis has been completed.
- ◆ 2nd coating of Chirolis has also been completed.
- ◆ 1st coating of lime has been done.
- ◆ 2nd coating of lime is in progress.
- ◆ Concluding all - we have completed 30% of the work, still 70% is remaining.

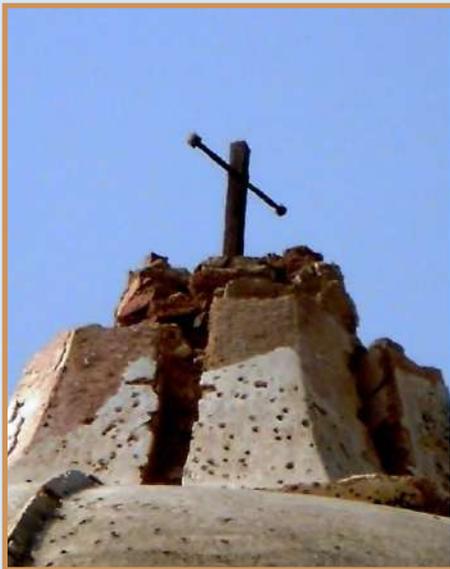
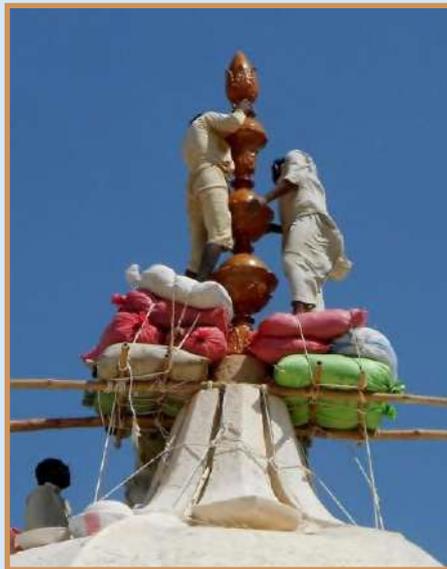
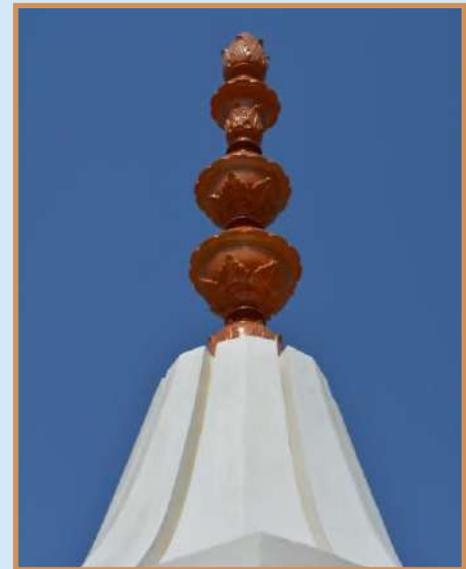
Fixing of Finial

- ◆ Constructed water tank.
- ◆ Constructed lime mixing tank.
- ◆ Scrapping at Dome.
- ◆ 1st coating of Chiroli has been completed at dome.
- ◆ 2nd coating of Chiroli has also been completed at dome.
- ◆ 1st coating of lime has been done at dome.
- ◆ 2nd coating of lime is in progress.
- ◆ New Finial are fixed at Darbar.
- ◆ Under Pinning of Darbar is in progress.
- ◆ Concluding all - we have completed 50% of the work, still 50% is remaining.

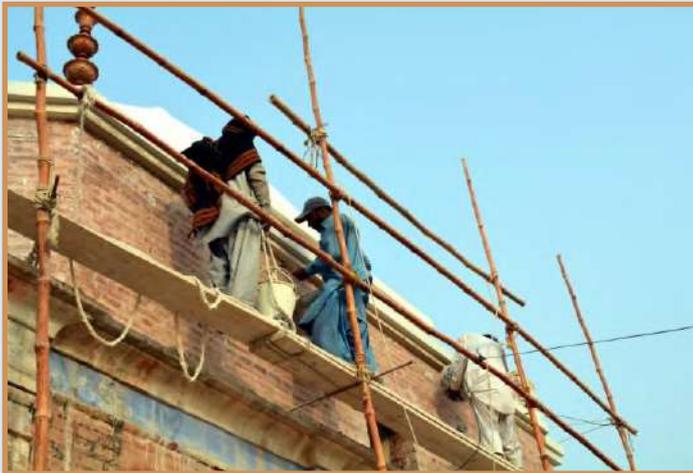
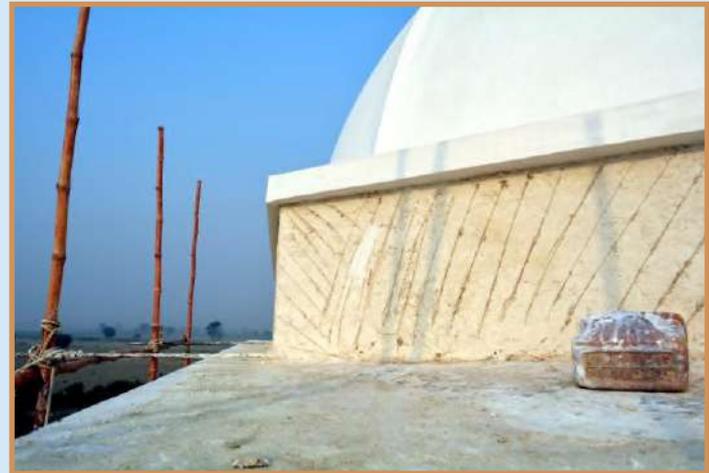
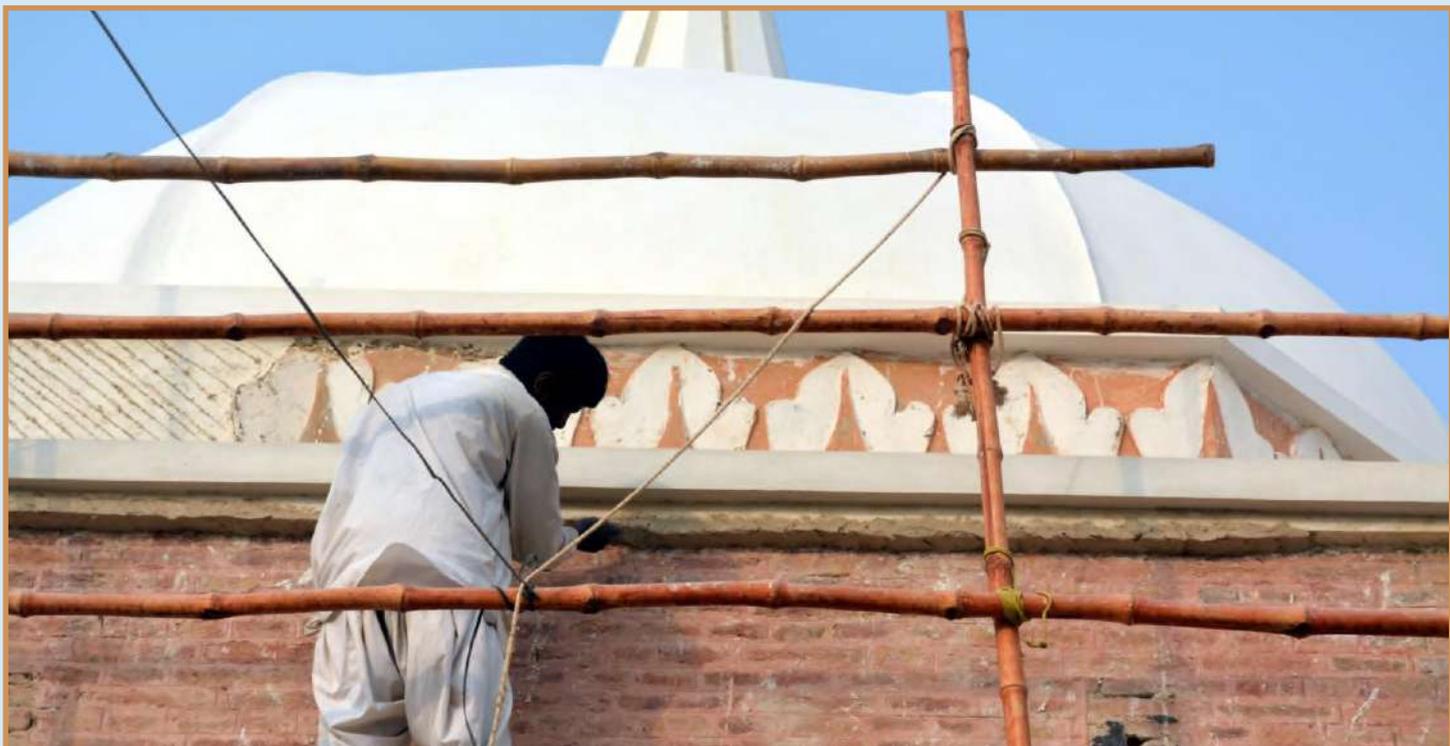
- ◆ Constructed water tank.
- ◆ Constructed lime mixing tank.
- ◆ 1st coating of Chiroli has been completed at dome.
- ◆ 2nd coating of Chiroli has also been completed at dome.
- ◆ 1st coating of lime has been done at dome.
- ◆ 2nd coating of lime is completed.
- ◆ New Finial are fixed at Darbar.
- ◆ Under Pinning of Darbar is in progress.
- ◆ Coating of lime on the octagonal drum of Darbar is in progress.
- ◆ Restoration of Cornice of octagonal drum is in progress.

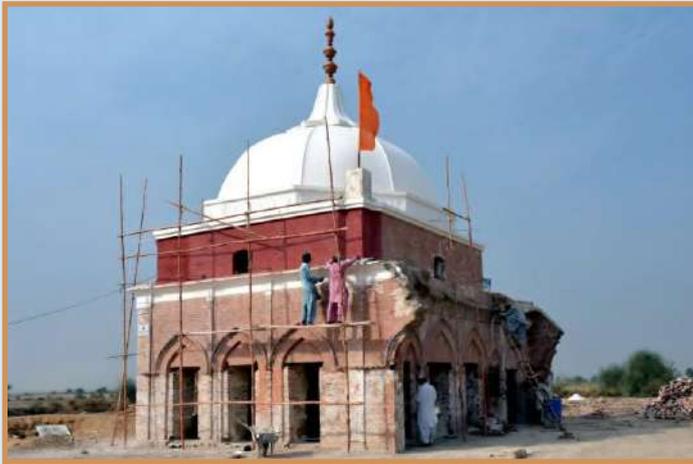
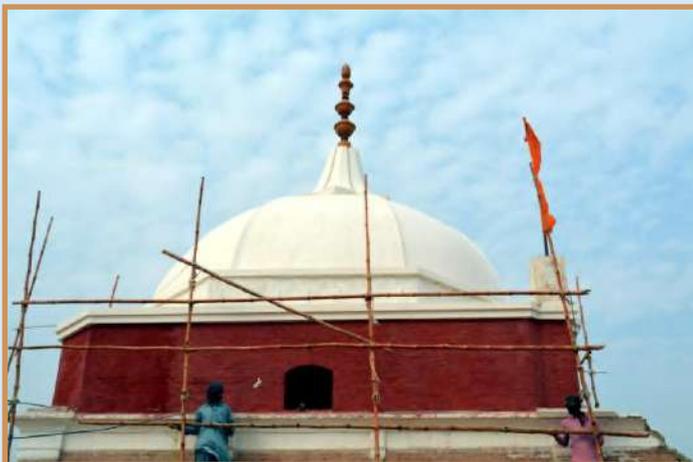
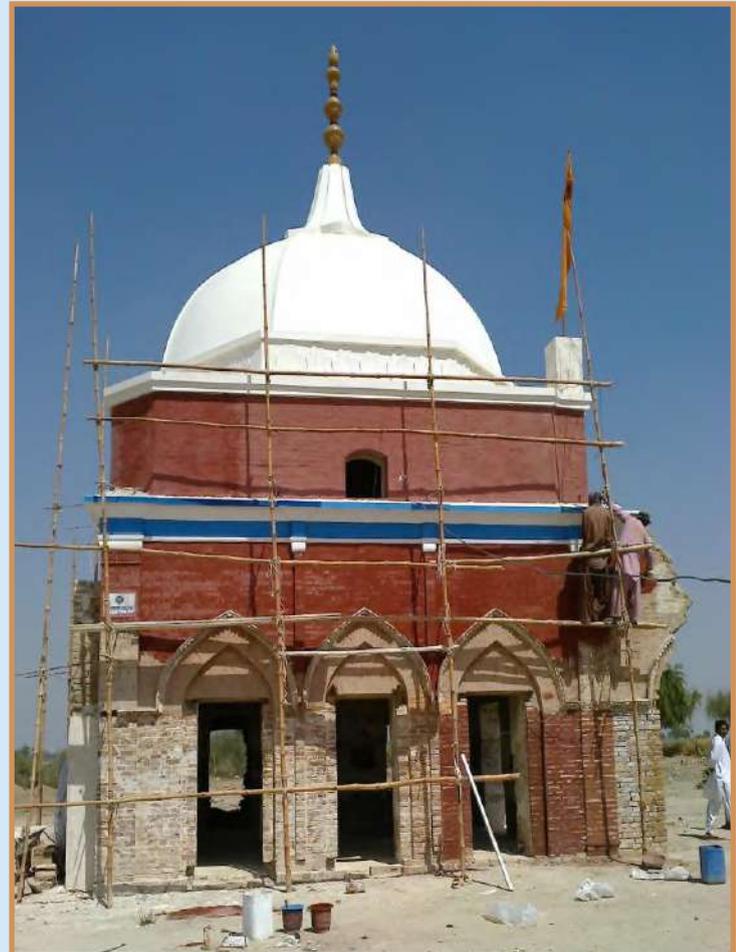
- ◆ Constructed water tank.
- ◆ Constructed lime mixing tank.
- ◆ 1st coating of Chiroli has been completed at dome.
- ◆ 2nd coating of Chiroli has also been completed at dome.
- ◆ 1st coating of lime has been done at dome.
- ◆ 2nd coating of lime is completed.
- ◆ Dome is finalized in all aspects.
- ◆ New Finial are fixed at the top of dome.
- ◆ Under Pinning of Darbar is in progress.
- ◆ Coating of lime on the octagonal drum of Darbar is ended.
- ◆ Restoration of cornice of octagonal drum is completed.
- ◆ Plantation around the structure are in progress.
- ◆ Flowery design around chaffered flitted rectangular drum is finished.
- ◆ Temporary few doors of the Darbar are closed with brunt bricks and mud mortar to support the cracked and weaken upper structure.
