# SAHIB MAHAL

Project Completion Report | 2018

Center for Documentation and Conservation of the Heritage of Sindh  
Endowment Fund Trust for Preservation of the Heritage of Sindh

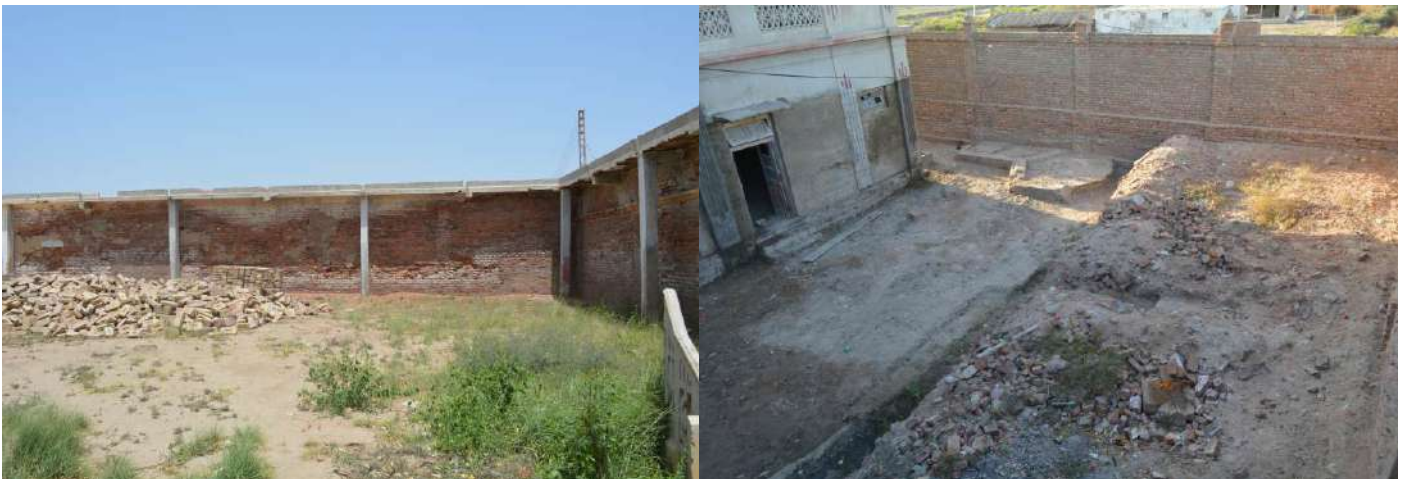
Boundary wall is made with Brunt brick and cement mortar. Boundary wall is in very worst condition, major cracks has been appeared & missing parts of masonry. It needs immediate attention to start restoration work to preserve the Compound Wall by doing underpinning, re-masonry work in missing portion of the wall, throughout pointing & plaster with same material & technique used in previous with minimum intervention. Some portions of Boundary wall are recently constructed with Cement Brick Masonry, (Constructed by Owner/Custodian).

INTERIOR VIEW OF BOUNDARY WALL

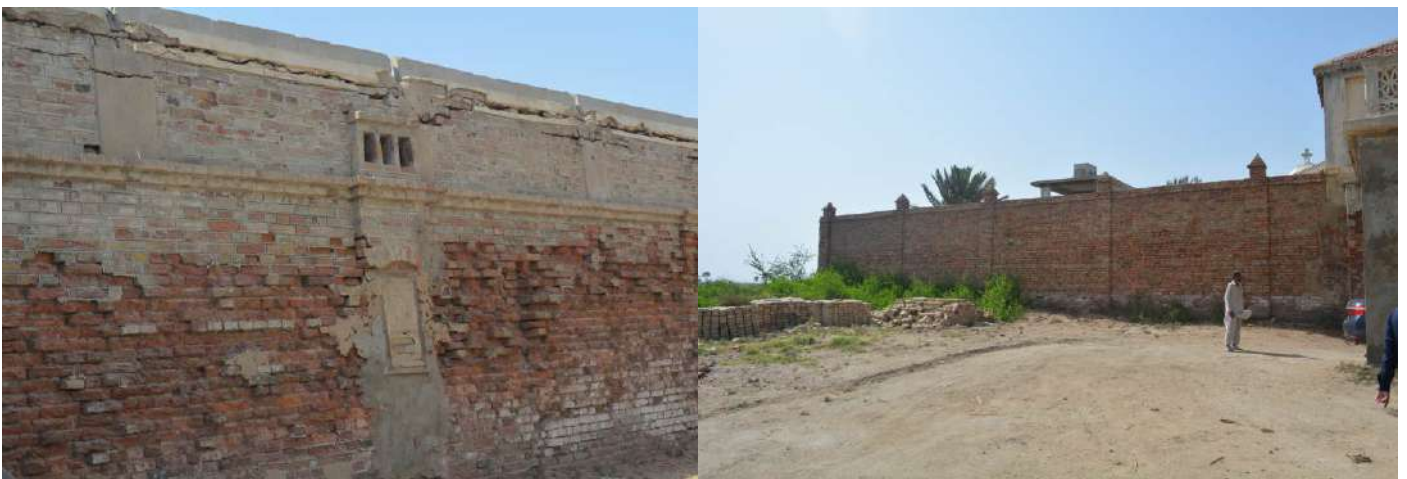
EXTERIOR VIEW OF BOUNDARY WALL

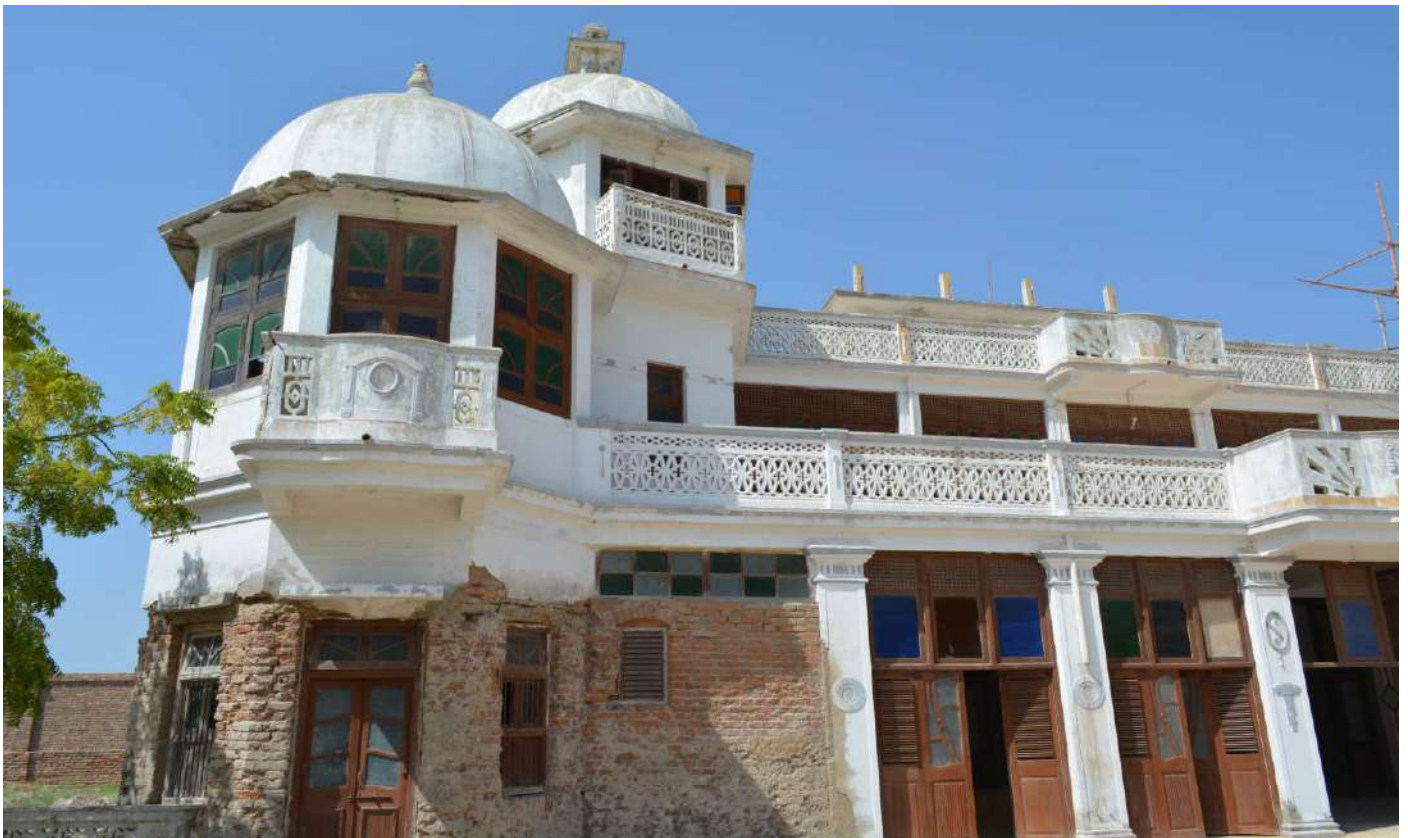
- Architectural work is done on outer sides of Building found in week condition.
- Cemented Colored Tiles (8"x8"x3/4") are used on Floor, tiles are totally deteriorated need replace.

- of lime plaster found and White wash is done on it, plaster is almost removed & cracks are occurred on it, it needs removing of old plaster & required re-plaster .

- Plaster and brick masonry is deteriorated from various parts of structure because of Water logging and salinity problem.
- 100% floor inside the building is made with cemented Tiles which are in worst condition & floor is settled down, needs replacing.

EXTERIOR VIEW OF BUILDING

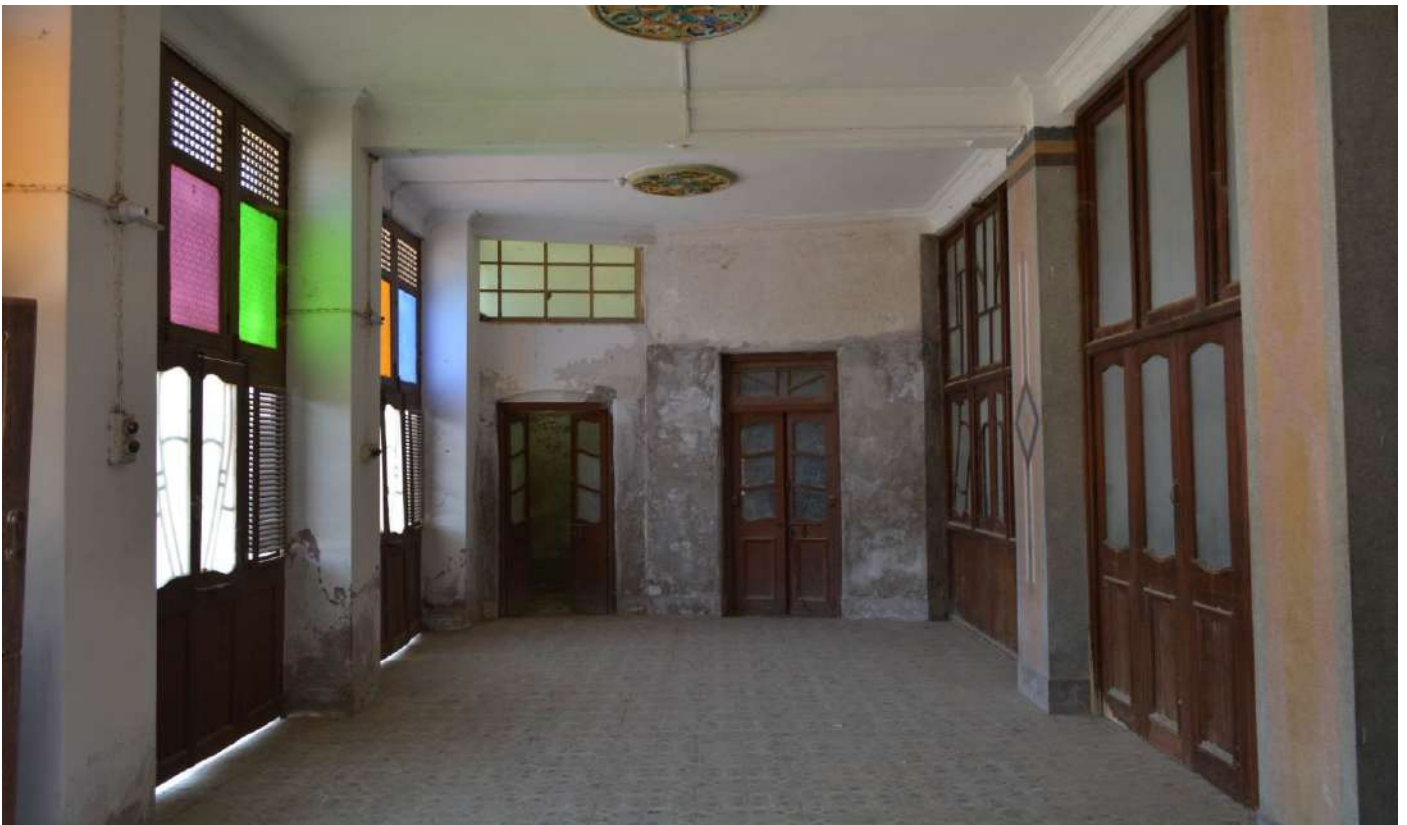
- Area of Main/ Front Verandah side is 624.1728Sq-Ft (51'-4" X 12'-2").
- Height of Verandah (Inside) is 12'-6".
- Walls of Main Verandah`s are Plastered with Cement sand mortar (1") in thickness and found in very week

- Condition needs removing re-plaster.
- Distemper color Paint is used on Walls and 40% paint is scratched.
- Architectural work is done on Walls & roof in way of fall sealing on roof & Taj mahal paint.

- All Doors and Ventilators are made with Wood (Sag wan).
- All Doors and Ventilators & windows need repair and replacing of glasses & /polish.

INTERIOR VIEW FRONT FIRST VERANDAH

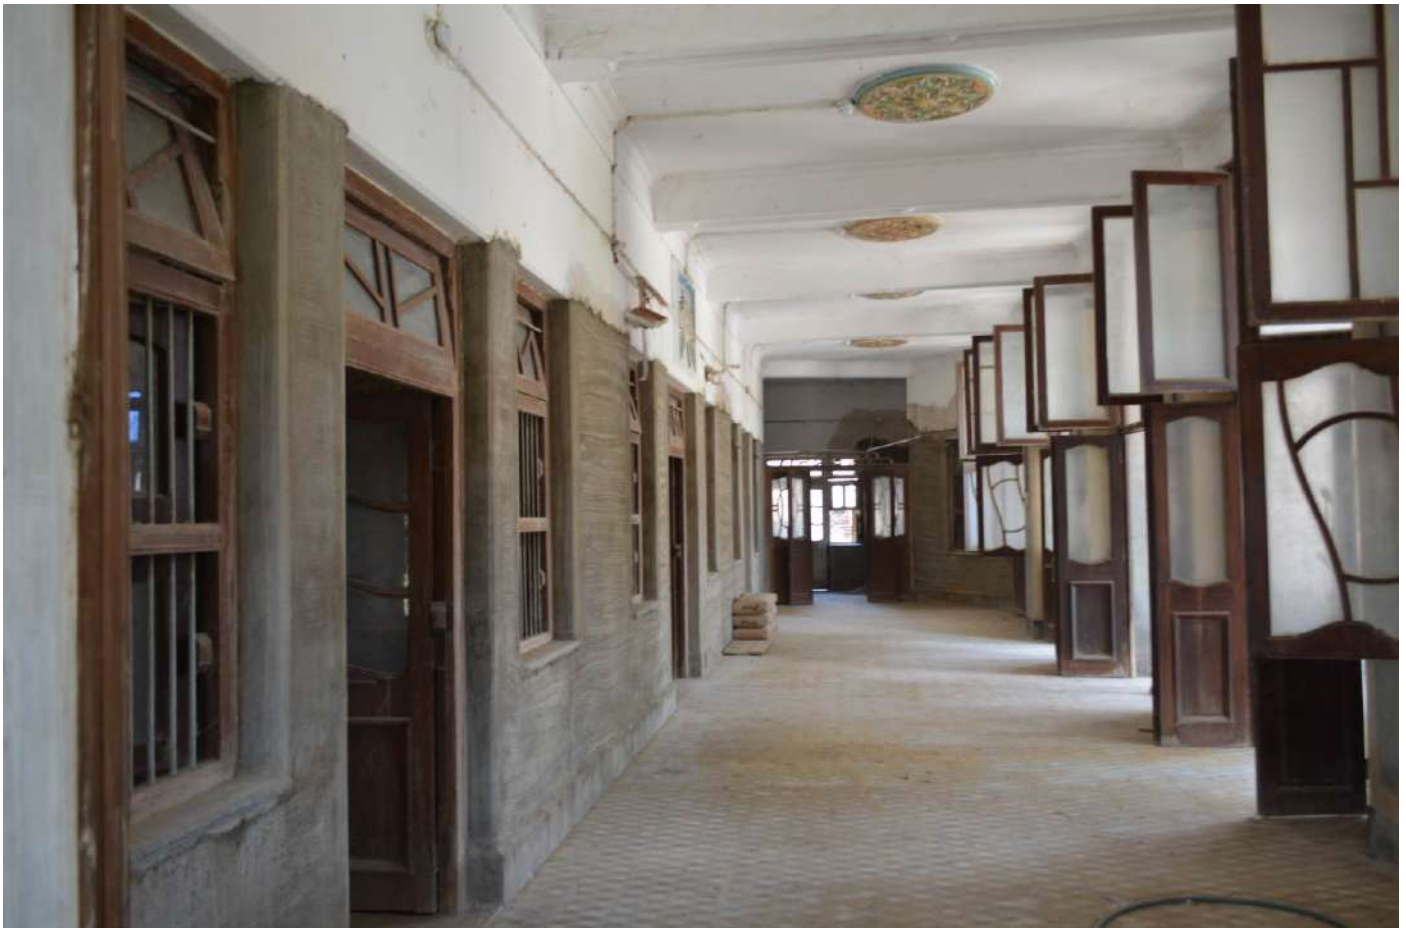
- 2nd Verandah Area is 641.25 Sq-Ft (57'-00" X 11'-3")
- Height of 2nd Verandah is 12'-6".
- 2nd Verandah is decorated.
- Walls of 2nd Verandah are plastered with Cement 1" in thickness, it required re-plaster.

- Interior walls of 2nd Verandah are decorated with mural (fall sealing etc).
- Floor is made with Cemented tiles (Color); almost Tiles are deteriorated and needs removing replacing.

- Doors are made with wood and glass fixed in the doors for sun lightning, painted with wood Polish and all doors need repairing, replacing of glasses & polishing.

INTERIOR VIEW FRONT SECOND VERANDAH

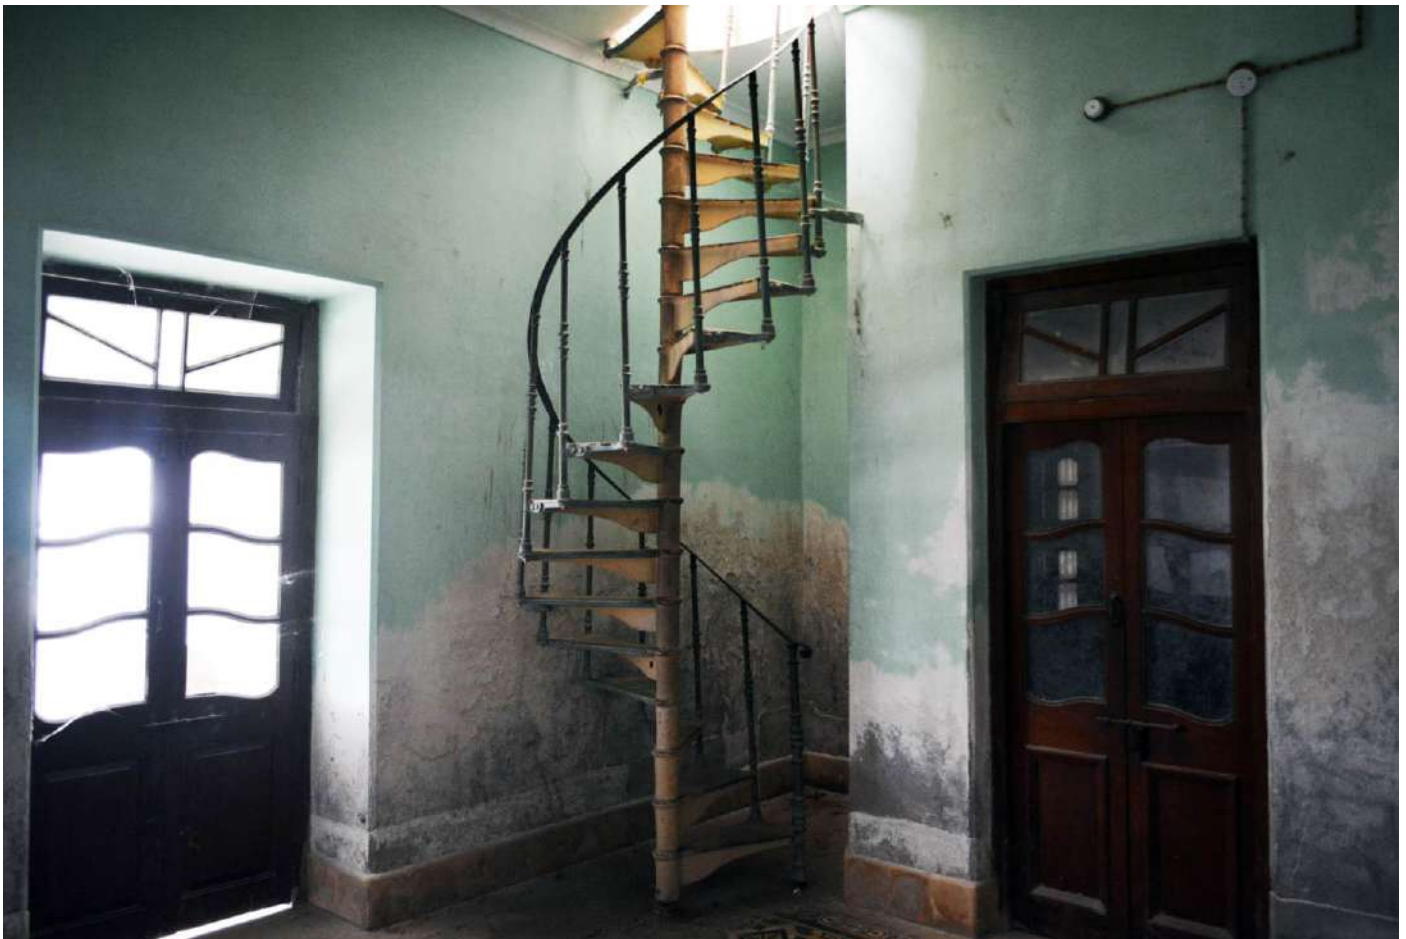
- Room Area (14'-0"X19'-5").
- Height of Room is 12'-6".
- Walls are plastered with Cement, plastered wall below the lintel level is almost removed & weak due to salinity, it needs re-plastered.
- Distemper color is used on interior walls found in fine condition.
- Room Floor is made with Bricks Masonry with cement, few bricks are deteriorated and need replace.
- The Size of Brick used in floor is (1'x6"x3")
- 04 Numbers of Doors and 04 Numbers of windows with 2 panels are fixed in Room, all doors and windows needs minor repair and paint polish.
- Roof of Room no: 1 is made of R.C.C & cement plaster & distemper paint on it and found in fine condition.
- One iron stair for going up to 1st floor.

INTERIOR VIEW OF ROOM NO:1

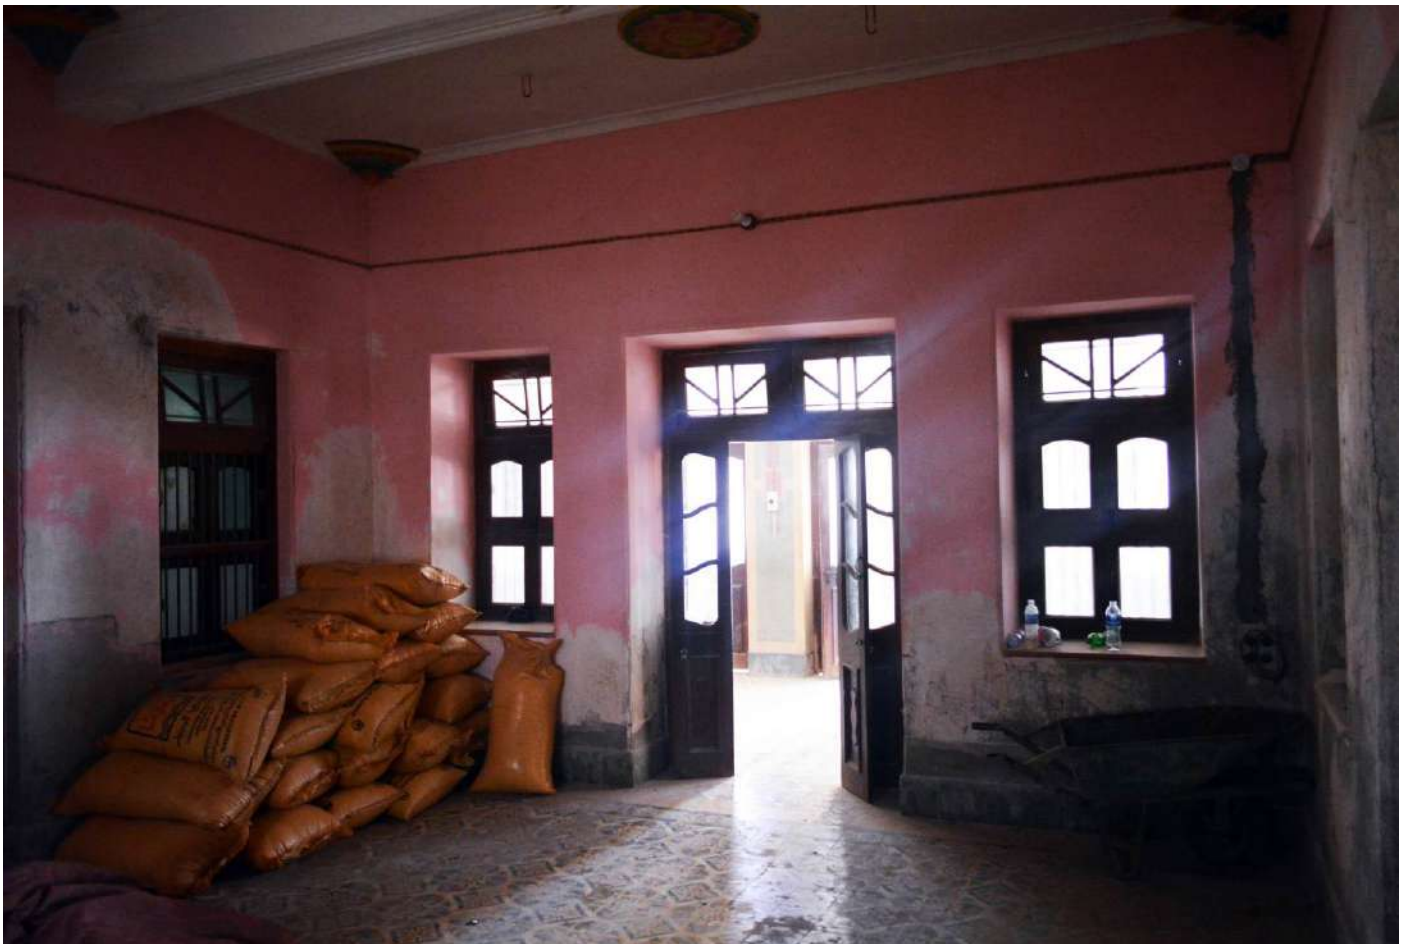
- Room Area (17'-0" X 19'-6").
- Height of Room is 12'-6".
- Walls are plastered with cement sand mortar and scratched from some portions and become a week due to Salinity.
- Distemper color is used on interior walls found in poor condition.
- Minor cracks are appearing on walls bellow the lintel level and major cracks are found above the lintel level.
- Room Floor is made with colored cement tile; floor is deteriorated and need repair & replacing of new tiles.
- The Size of Brick used in floor is (1'x6"x3").
- 02 Numbers of Doors fixed in front (entrance from 2nd verandah) and back side the wall (inn out to back side verandah), 2 Number's of door fixed in right & left side the wall of room to go (Room no: 1, Room no: 3), 04
- Numbers of windows with 2 panels are fixed in Room, all doors and windows need repair, replacing of glasses and paint polish.

INTERIOR VIEW OF ROOM NO:2

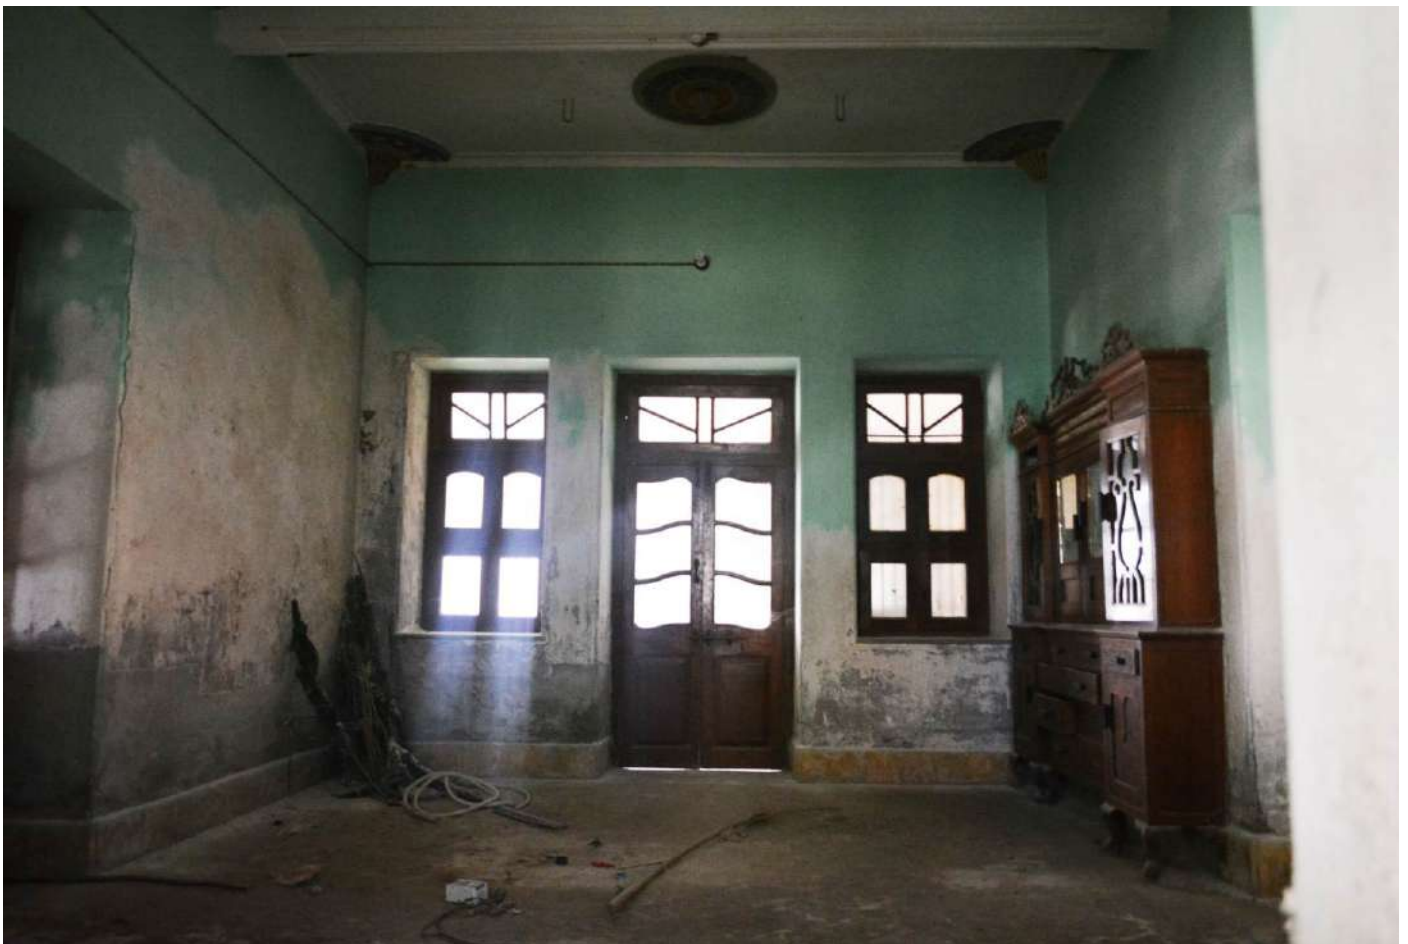
- Room Area (15'-5" X 19'-5")
- Height of Room is 12'-6"
- Walls are plastered with cement sand mortar and scratched from some portions.
- Distemper color is used on interior walls found in poor condition.
- Minor cracks are appearing on walls bellow the lintel level and major cracks are found above the lintel level.
- Room Floor is made with colored cement tile; floor is deteriorated and need repair & replacing of new tiles.
- The Size of Tile used in floor is 8" X 8" X 0.75"
- 02 Numbers of Doors fixed in front (entrance from 2nd verandah) and back side the wall (inn out to back side verandah), 2 Number's of door fixed in right & left side the wall of room to go (Room no: 1, Room no: 3), 04
- Numbers of windows with 2 panels are fixed in Room, all doors and windows need repair, replacing of glasses and paint polish.

INTERIOR VIEW OF ROOM NO:3

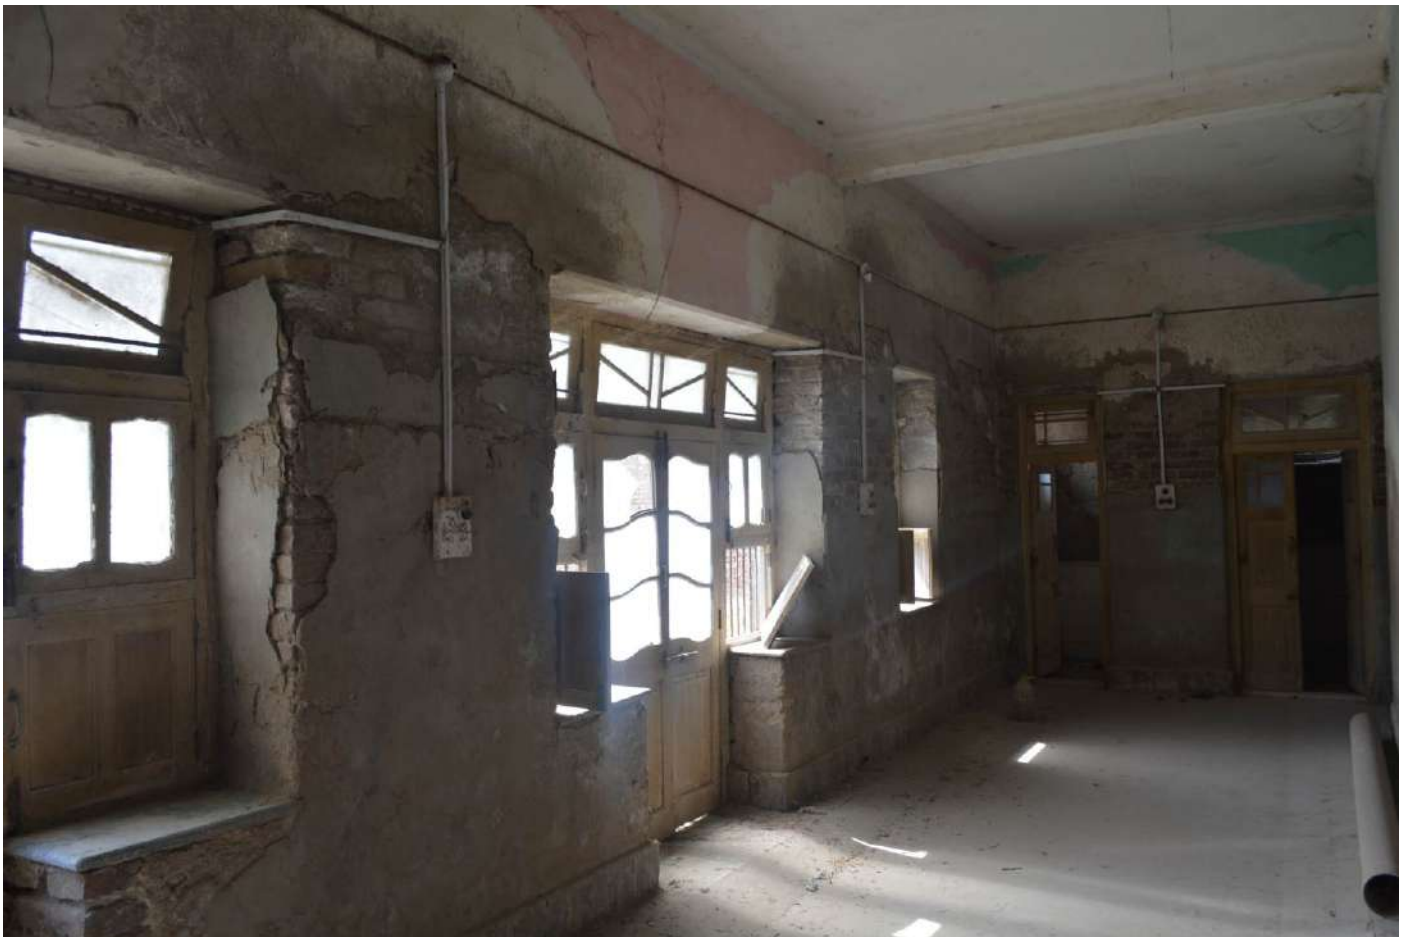
- Area of Verandah is 338.08 (9'-6" X 35'-7").
- Height of Verandah is 12'-6".
- The walls are constructed with Brunt Bricks with cement sand mortar bricks are in fine condition minor cracks are found need pointing work.

- Walls of Main Verandah`s are Plastered with cement and found in minor week Condition needs new cement sand plaster.
- Pillars/columns of verandah found in week condition also need new plaster.

- Verandah`s Floor is totally settled down needs concreting & replacing of new tiles
- Distemper color is used on Walls and 75% paint is scratched.
- Roof is constructed with reinforcement , cement plaster& distemper color used on it and found in fine condition.

- Doors are made with Wood and Glass.
- All Doors and Ventilators are made with Wood (Sag wan).
- All Doors, windows and Ventilators need repair and paint/polish.

INTERIOR VIEW OF LEFT SIDE VERANDAH

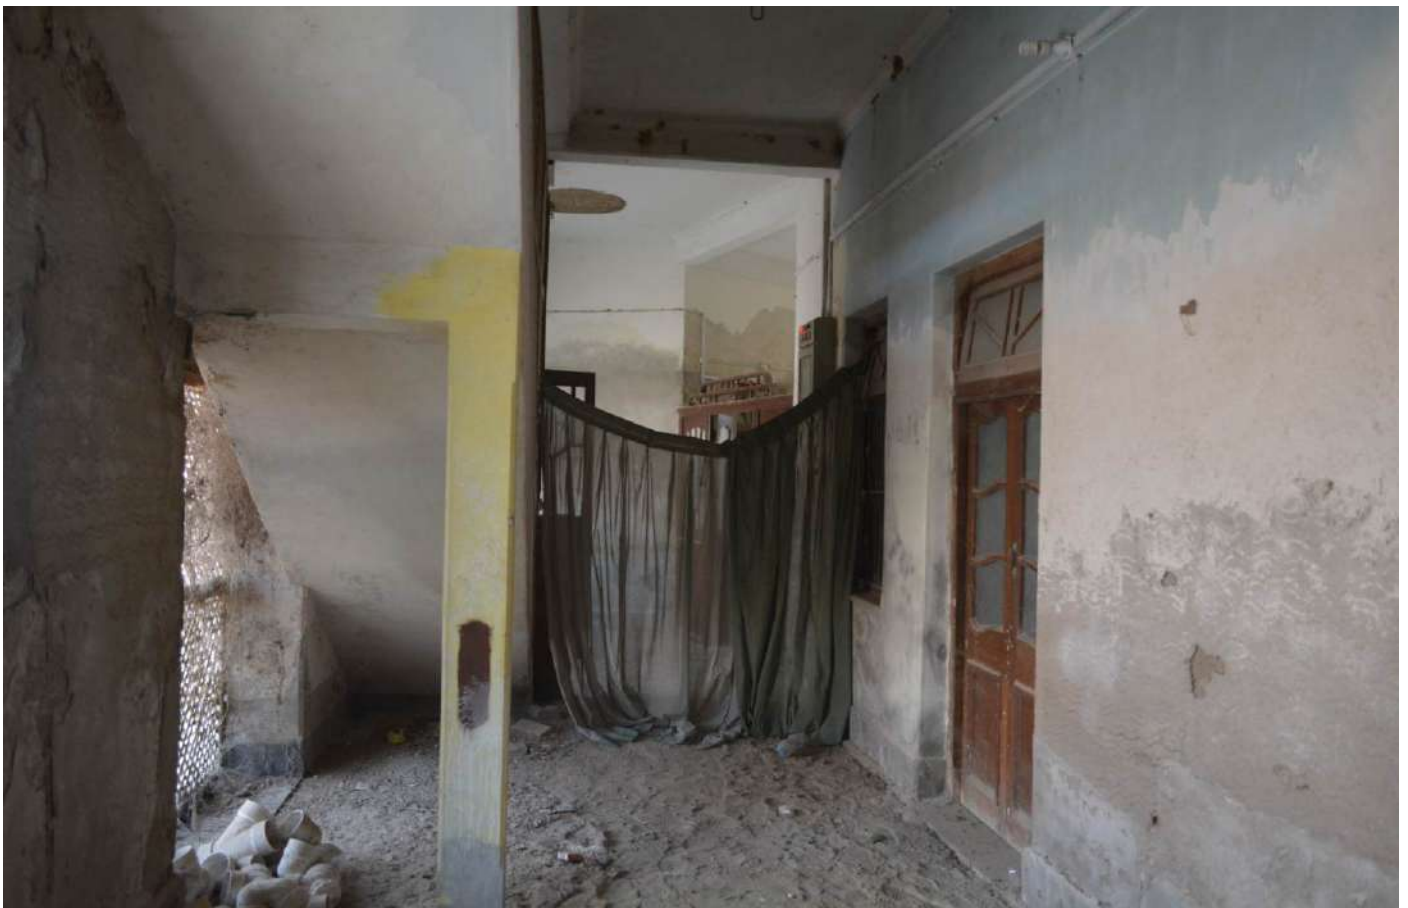
- Walls of Main Verandah`s are Plastered with cement sand mortar, the plaster is scratched from major part of the wall needs repairing.
- Pillars/columns of verandah found in week condition also need new plaster.

- Verandah`s Floor is totally settled down tiles are completely destroyed needs concreting & fixing of new tiles.
- Distemper color is used on Walls and 90% paint is scratched.

- 2nd verandah, and 02 Numbers of windows are fixed in Verandah.
- All Doors and Ventilators are made with Wood (Sag wan) and glass.
- All Doors, windows and Ventilators need repair and paint/polish.

INTERIOR VIEW OF RIGHT SIDE VERANDAH

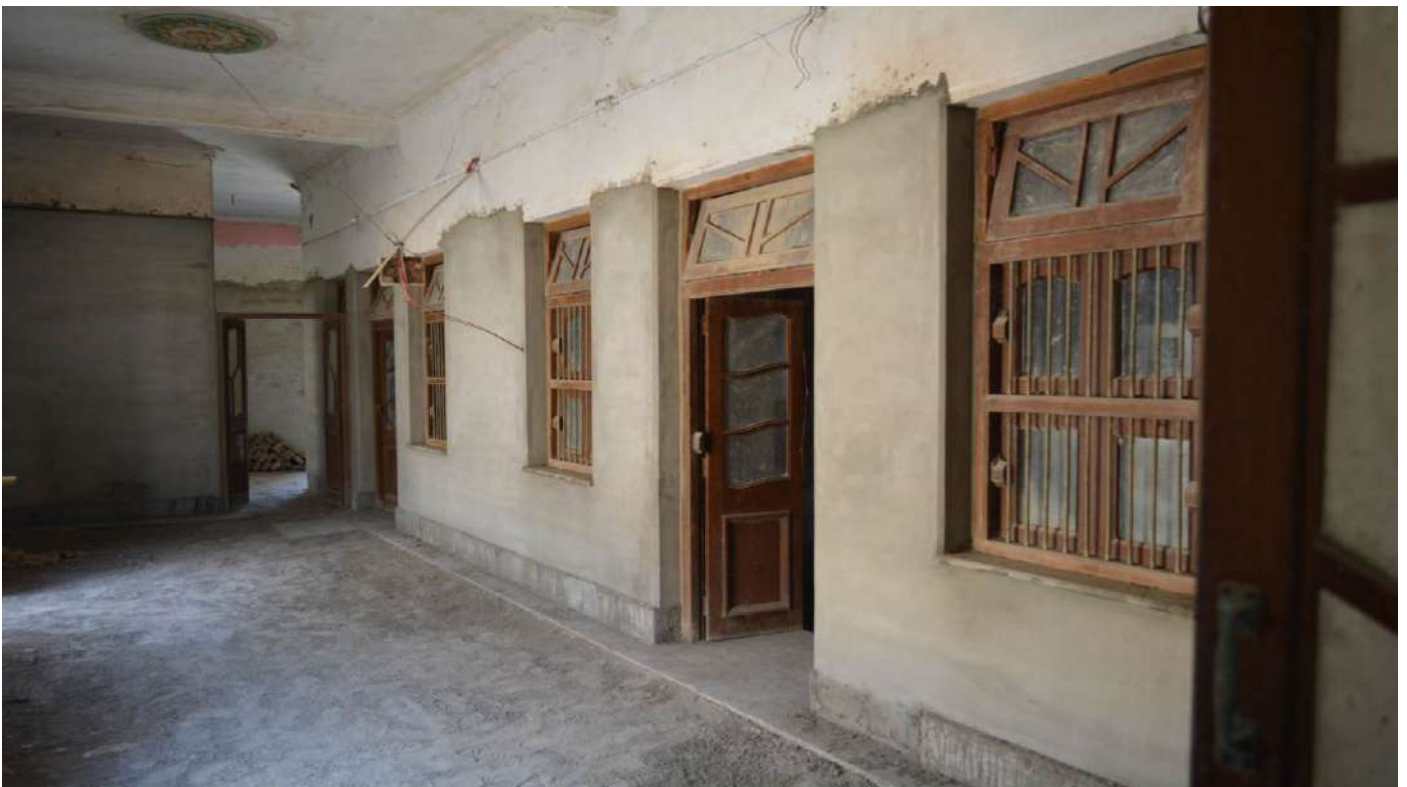
- Walls of Main Verandah`s are Plastered with cement sand mortar, the plaster is scratched from major part of the wall needs repairing.
- Pillars/columns of verandah found in week condition also need new plaster.

- Verandah`s Floor is totally settled down, tiles are completely destroyed needs concreting & fixing of new tiles.
- Distemper color is used on Walls and 90% paint is scratched.

- The verandah needs new plaster & pointing work.
- Tiles of floor of kitchen & bathroom needs replacement with new tiles.
- Steps of verandah made with Cement tiles are in good condition.

INTERIOR VIEW OF BACK SIDE VERANDAH

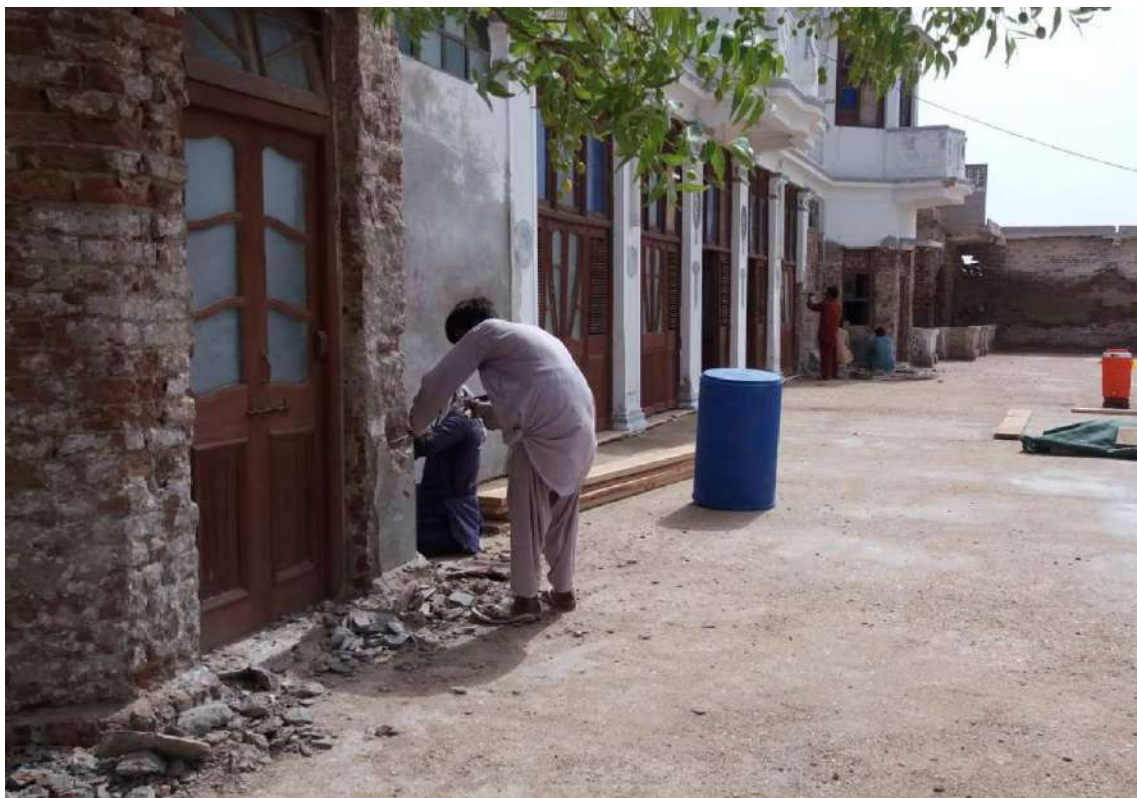
Scraping the moisture affected area of the walls

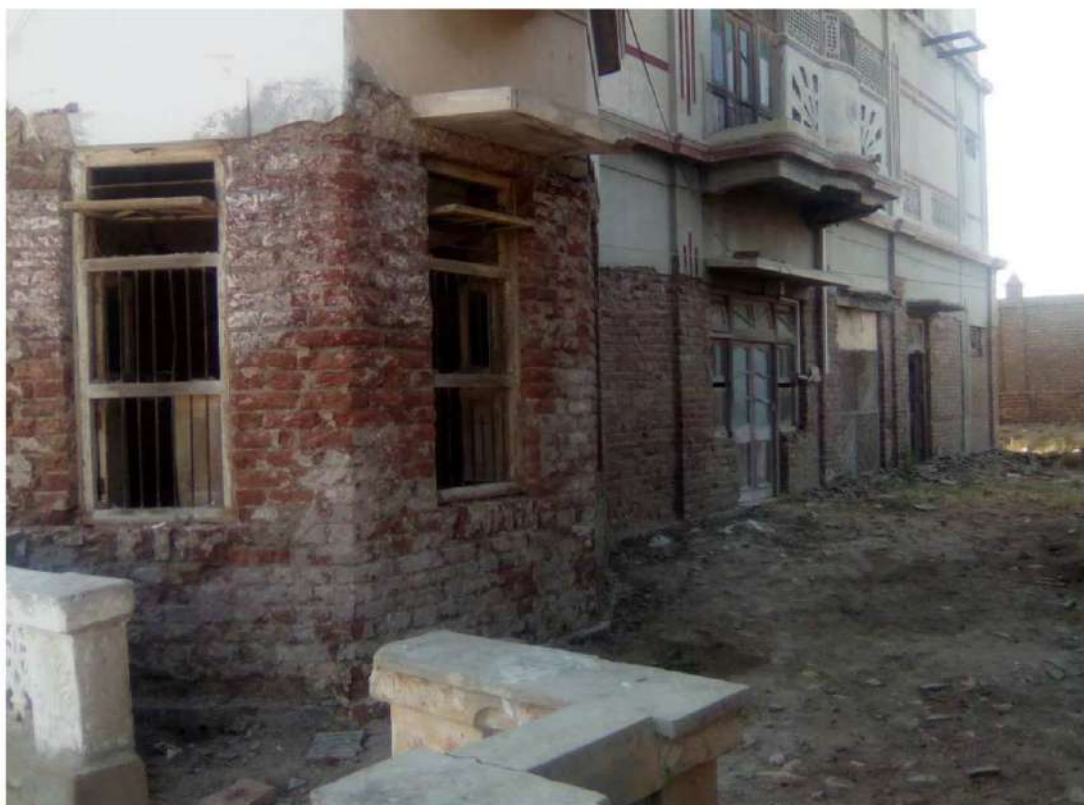
Scraped portion of Sahib Mahal

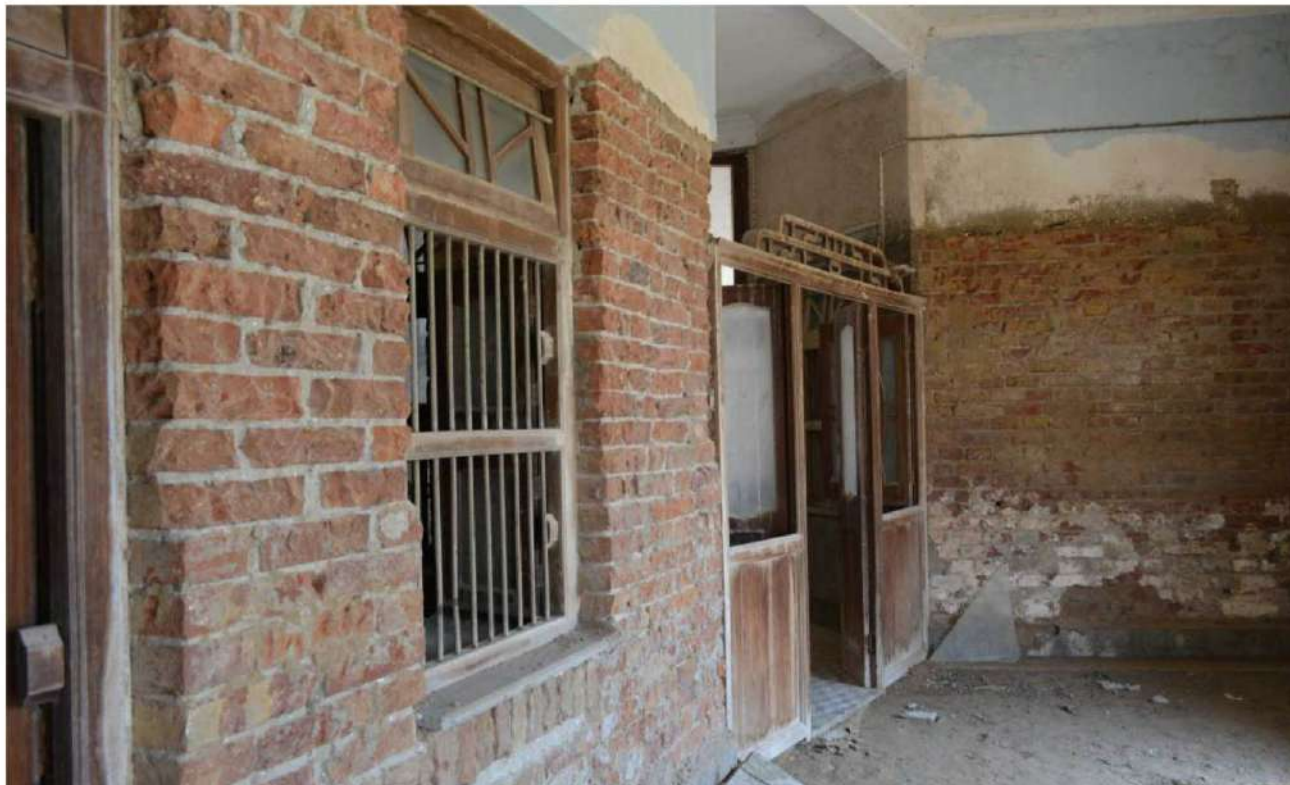
Removal of plaster upto lintel level

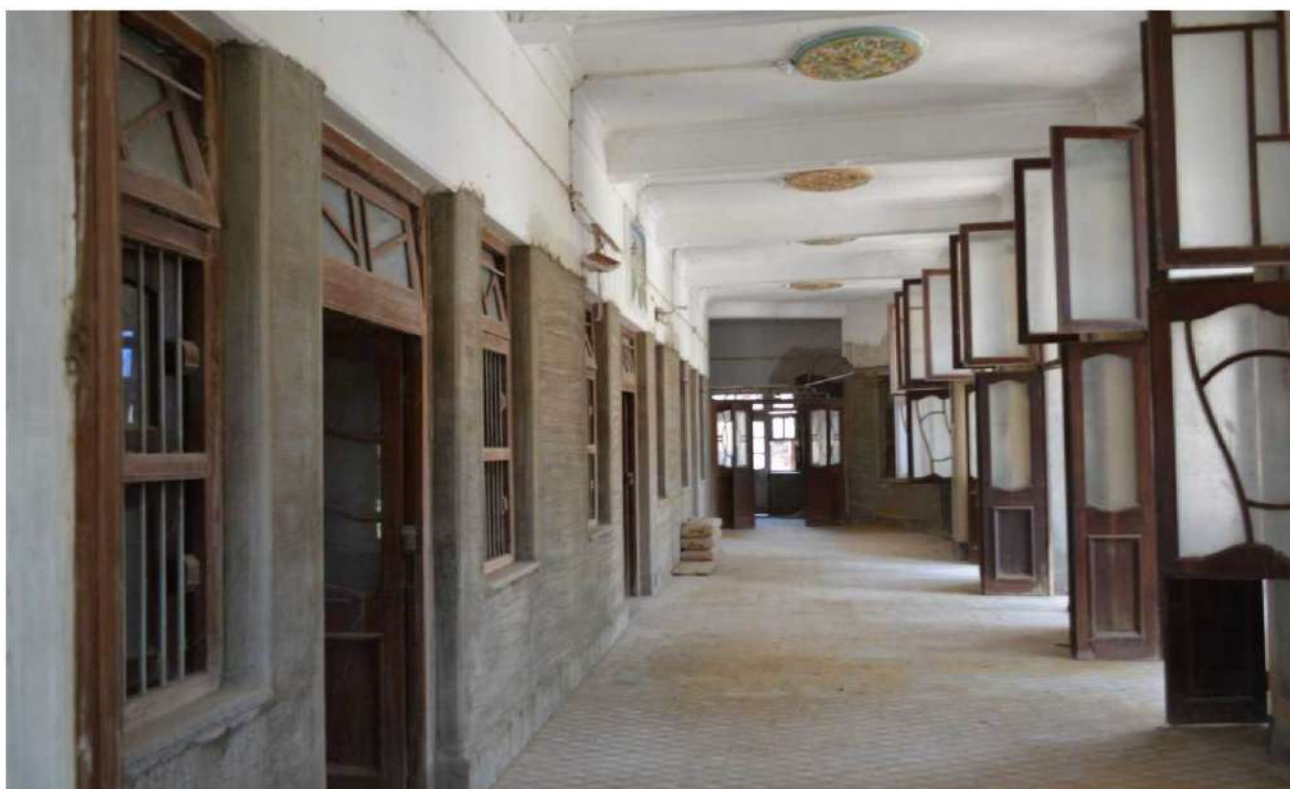
1st coat of plaster
