PROJECT COMPLETION REPORT  
**JAM CHUTTO**  
DECEMBER | 2019

Center for Documentation and Conservation of the Heritage of Sindh  
Endowment Fund Trust for Preservation of the Heritage of Sindh

## CANOPY 1

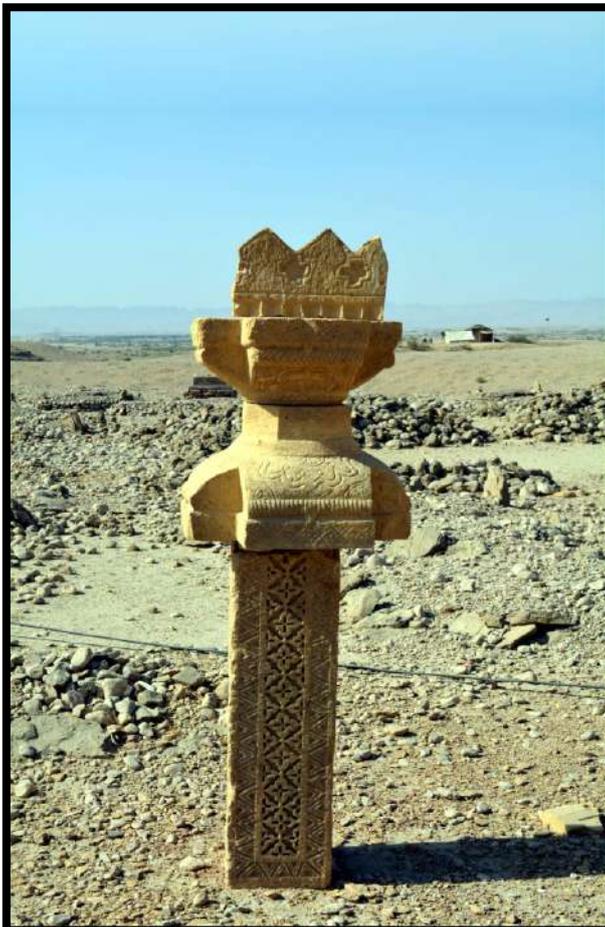
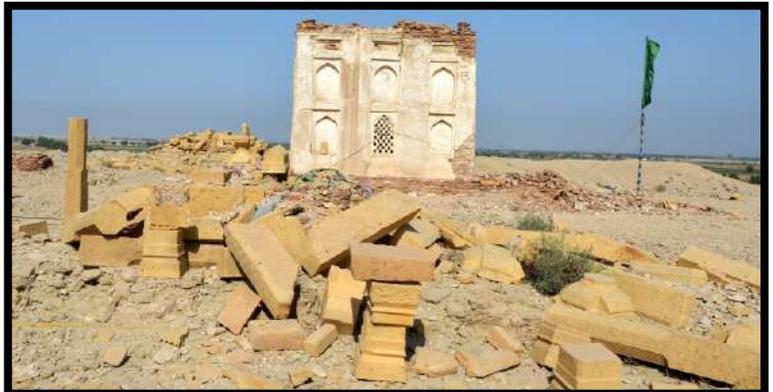
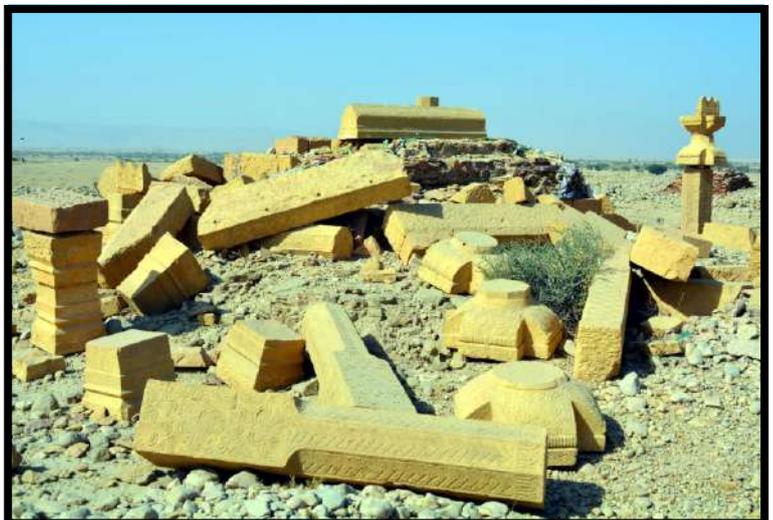
GENERAL VIEWS OF CANOPY 1

The canopy was completely collapsed and remains of the pillars and platform were piled and scattered in the graveyard. The origin canopy structure was erected over a square platform, its dimensions were 17'-6.0" x 17'-6.0" and its covered area 306.250 sq.ft (28.450 sq.m). The canopy was constructed with stone masonry by using lime and *chiroli* and erected with the support of twelve-pillars.

The stones of the platforms are carved and decorated with geometrical designs.

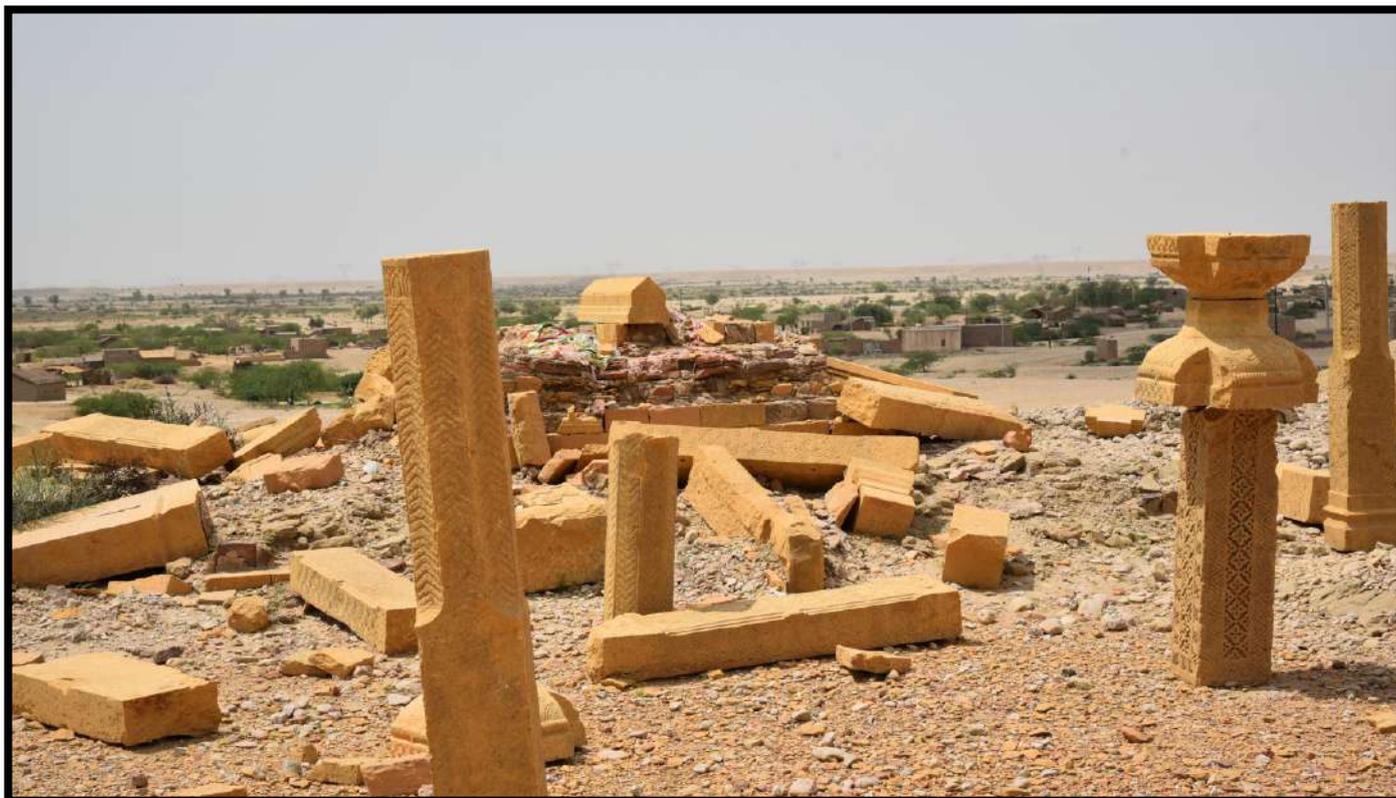
- Parts of the canopy (base, capitals, columns & lintels) were all scattered around in a vulnerable condition.
- Base walls and base floor was completely damaged.
- Originally it consisted of 12 carved stone pillars, nearly 20% of the pillars were broken.
- 3 graves laid in series at the top of platform.
- Canopy is constructed in Two steps.
- Grave is totally demolished and made with stone masonry by using Chiroli and Lime mortar.
- It contain 12 stone pillars and found carving work on them.

Wreckage of the Canopy

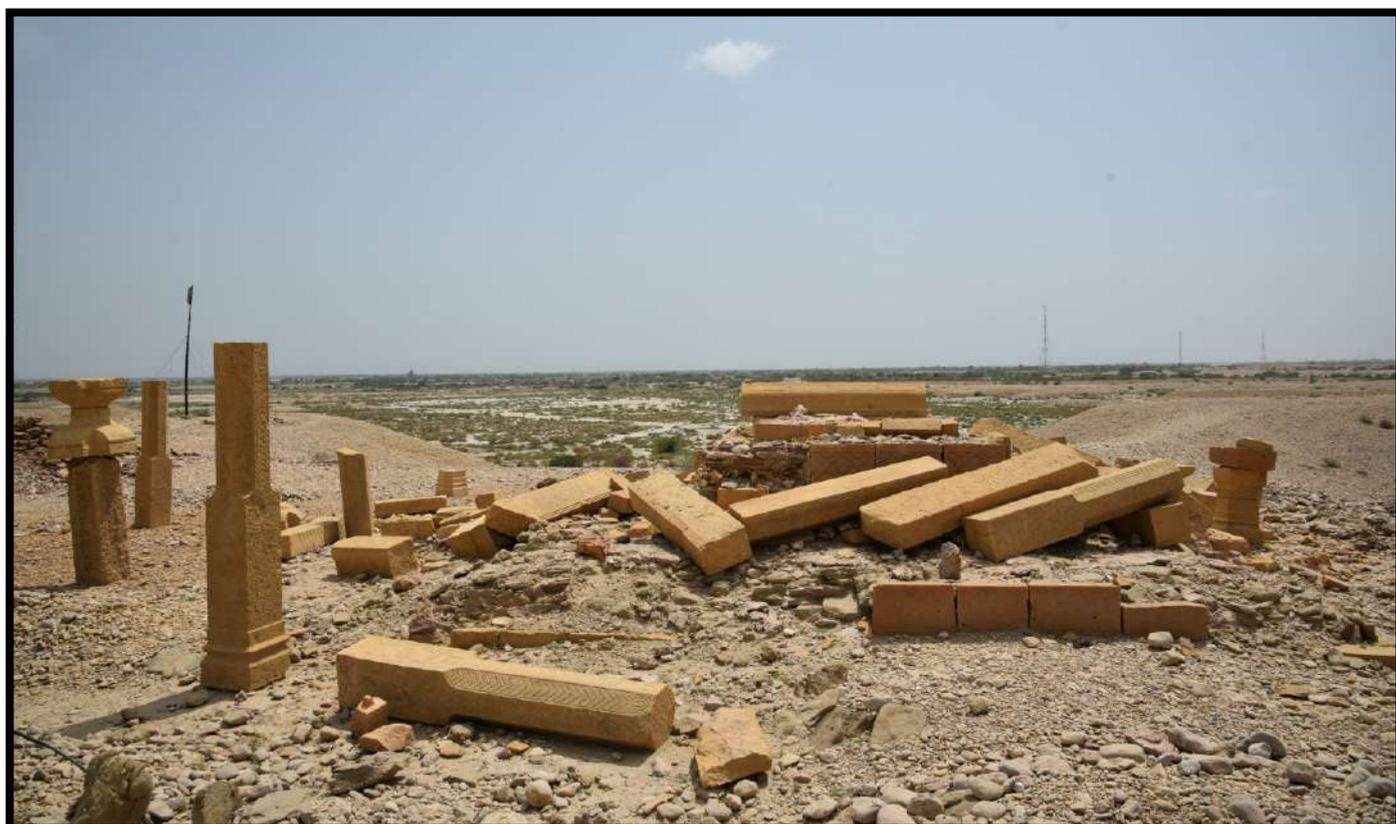
Collapsed Pillars Scattered Around

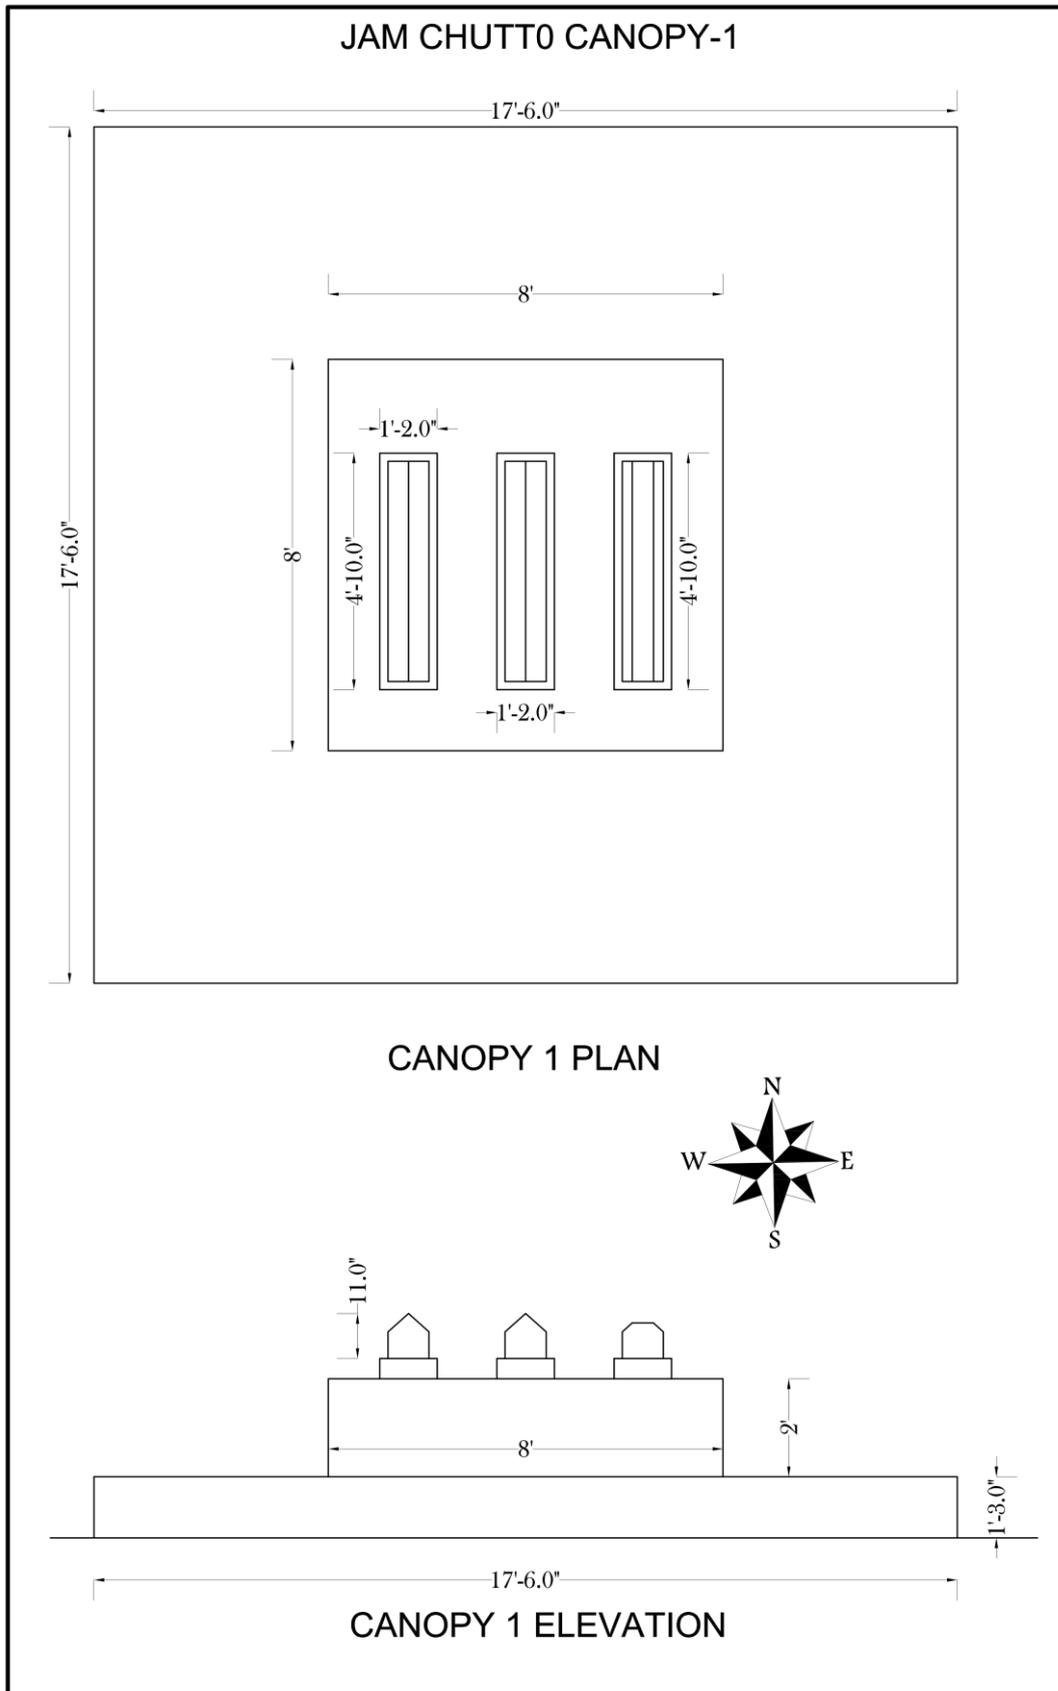
PLAN AND ELEVATION OF CANOPY 1

There are three graves laid on the platform, it measures 8'-0" x 8'-0", constructed with yellow stones, carved with beautiful designs.

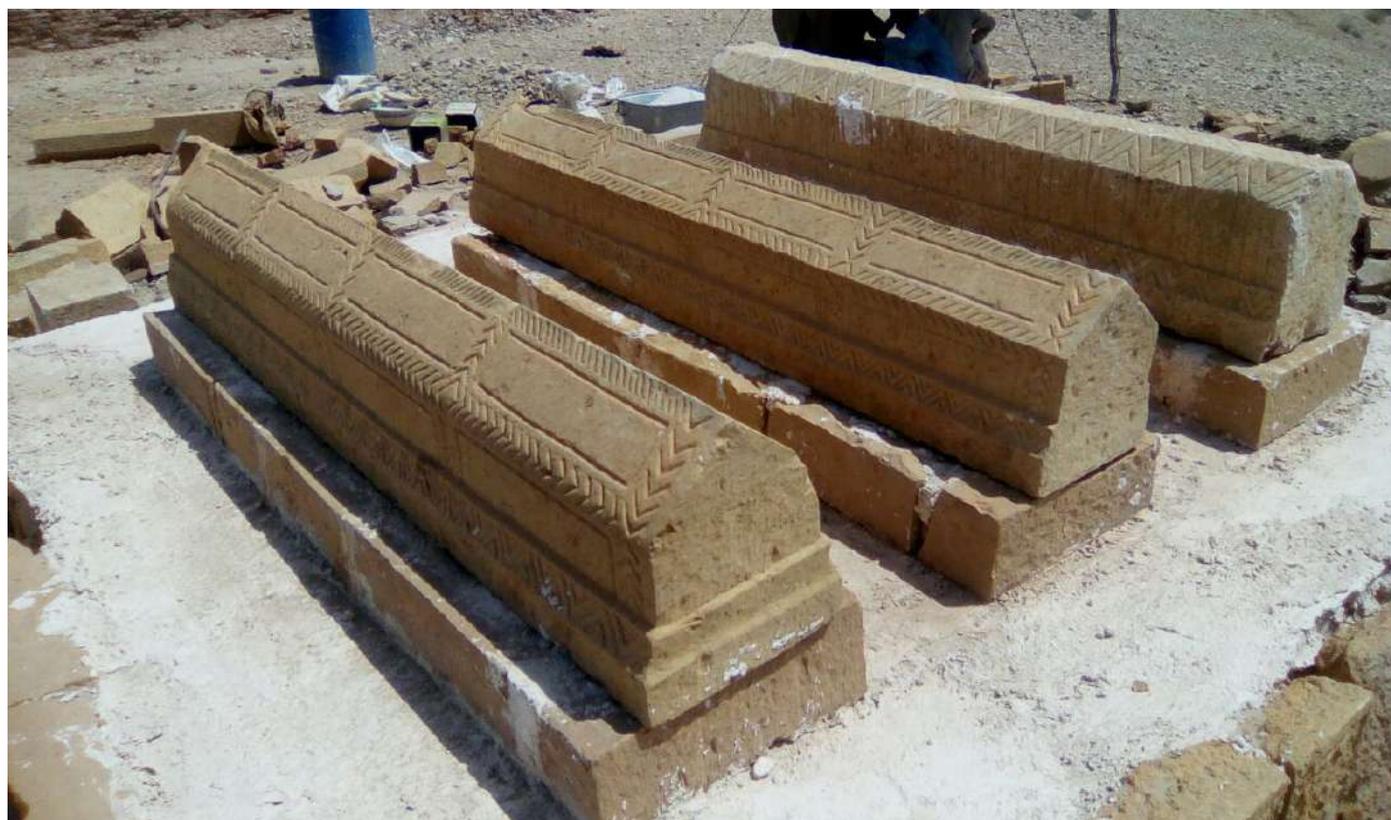
AFTER PLACING GRAVES

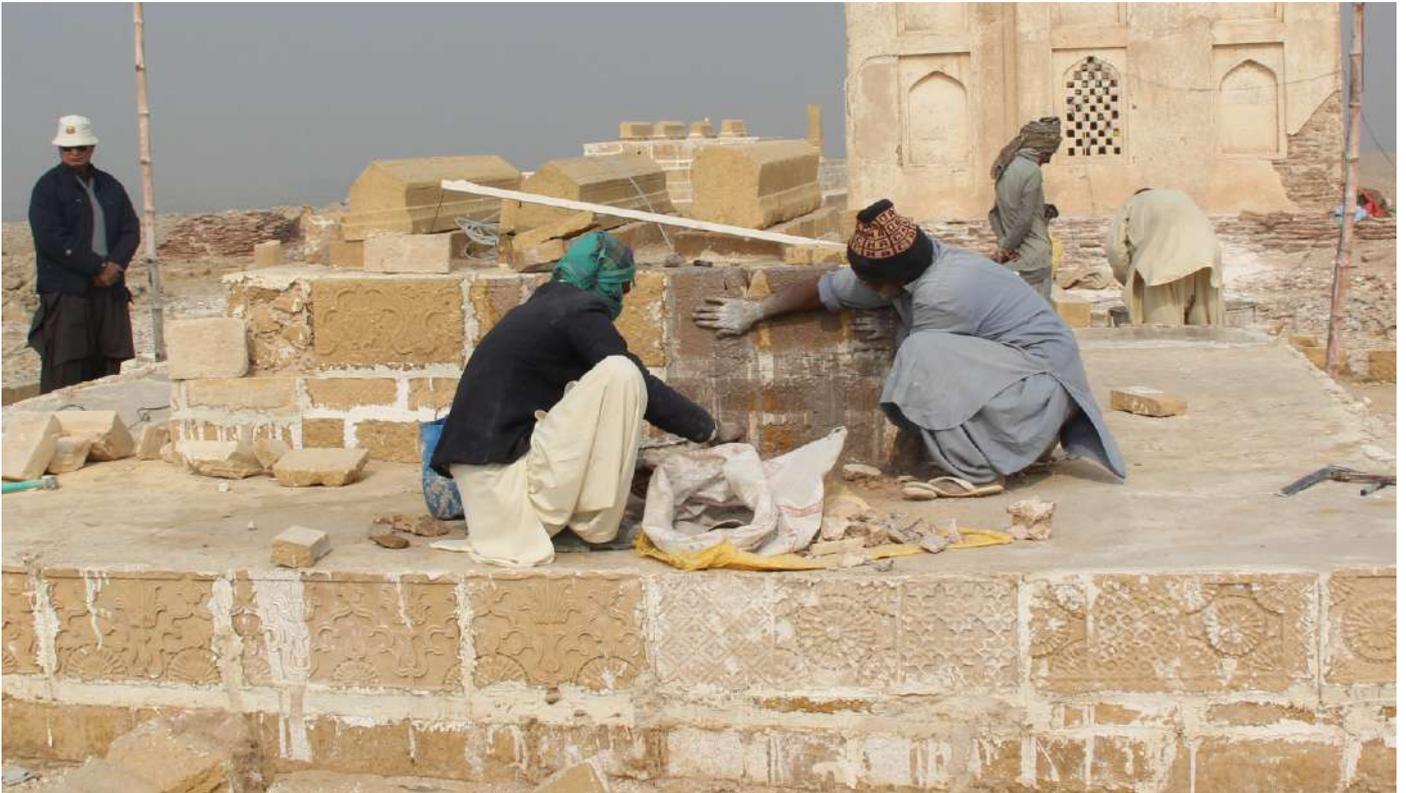
**FIXING OF SECOND STEP STONES**

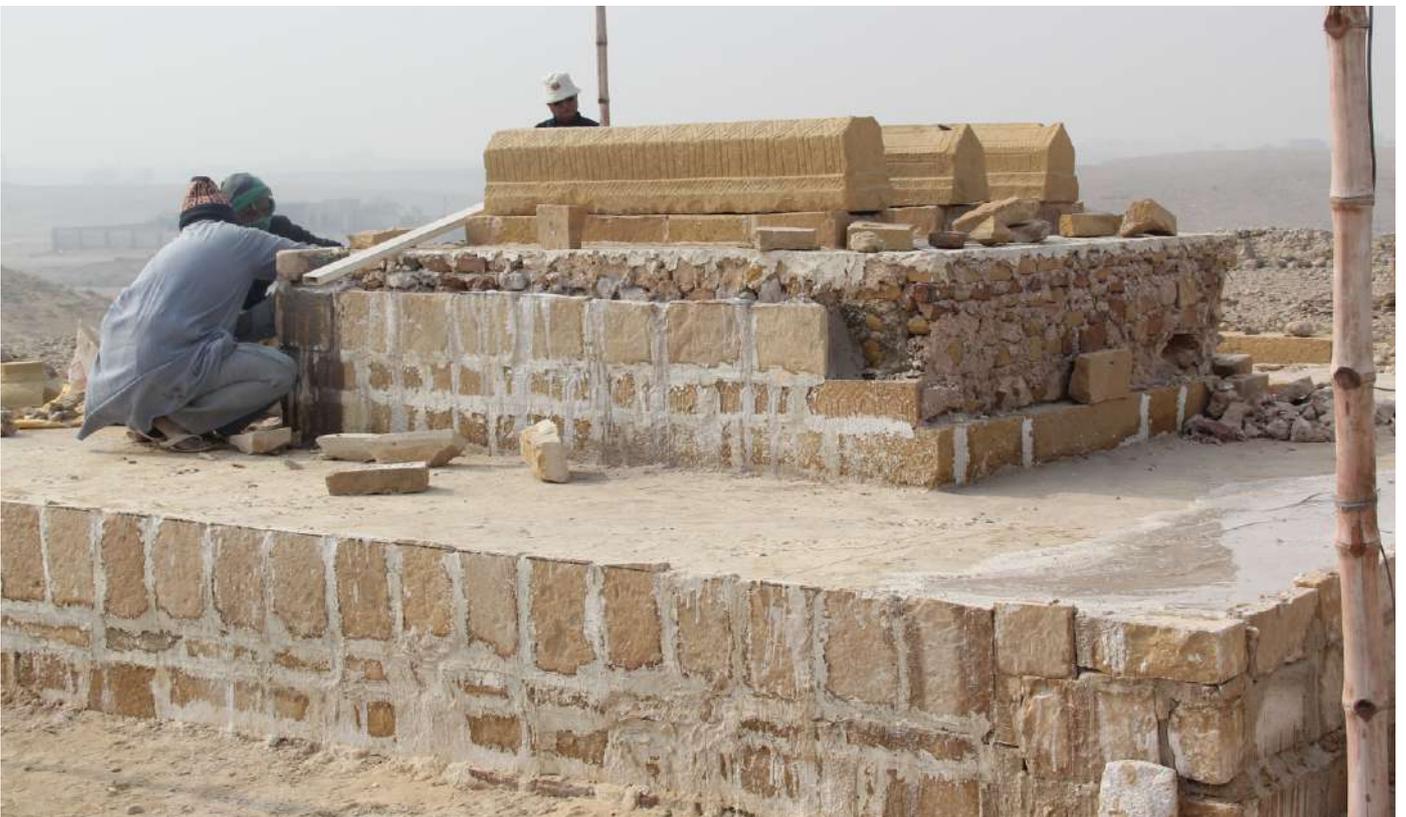
**POINTING DONE ON FIRST STEP**

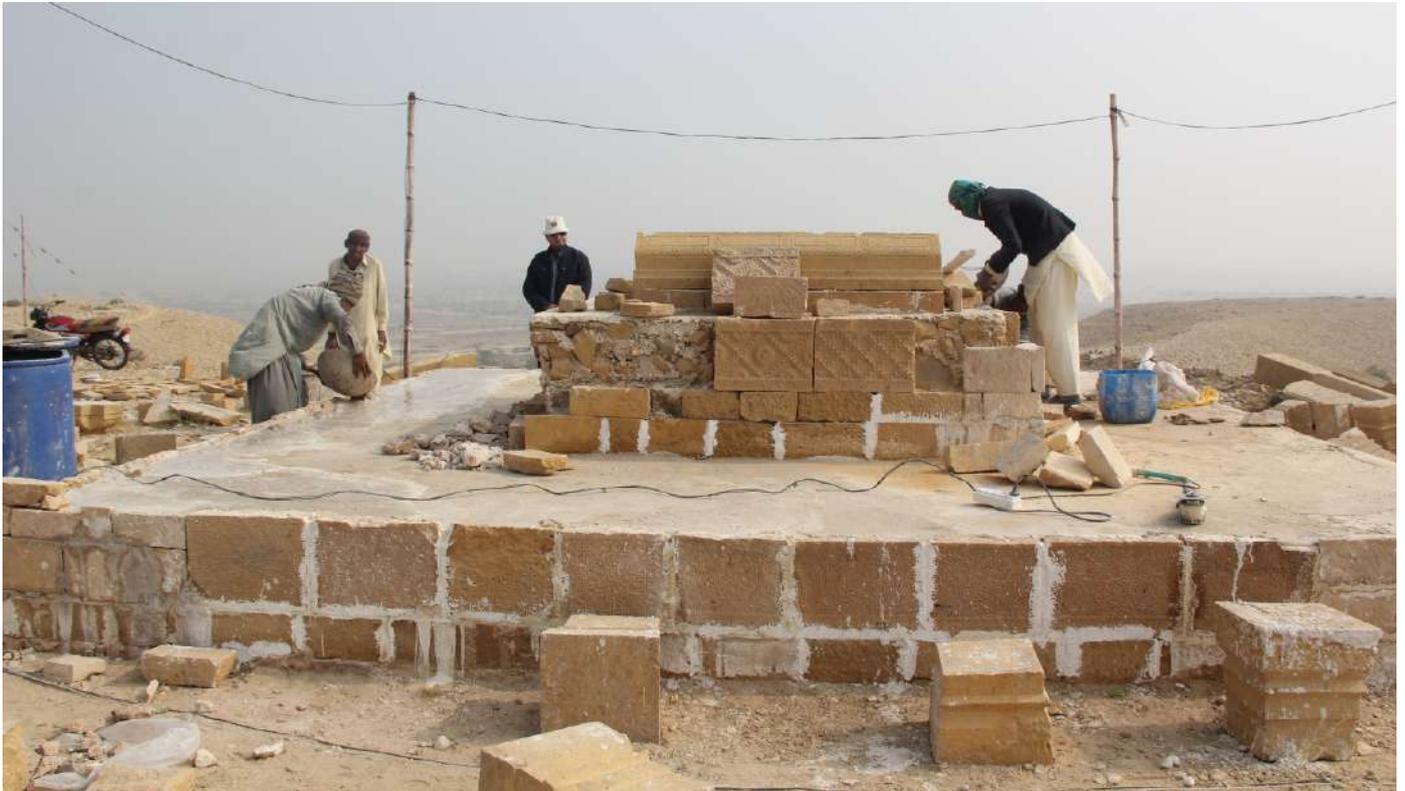
**FIRST STEP LIME CONCRETE LAYER APPLYING**

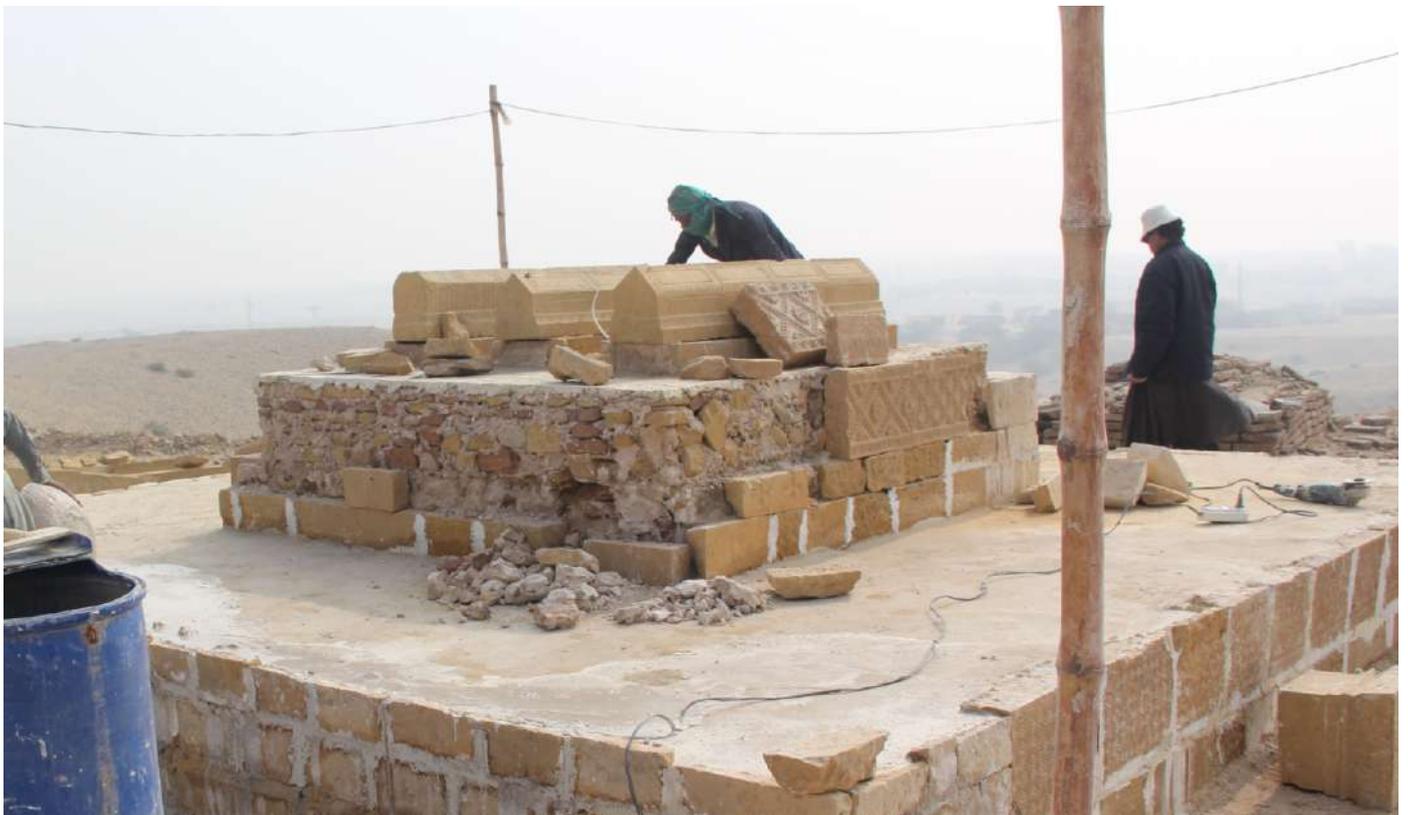
**AFTER APPLYING LIME CONCRETE FIRST LAYER**

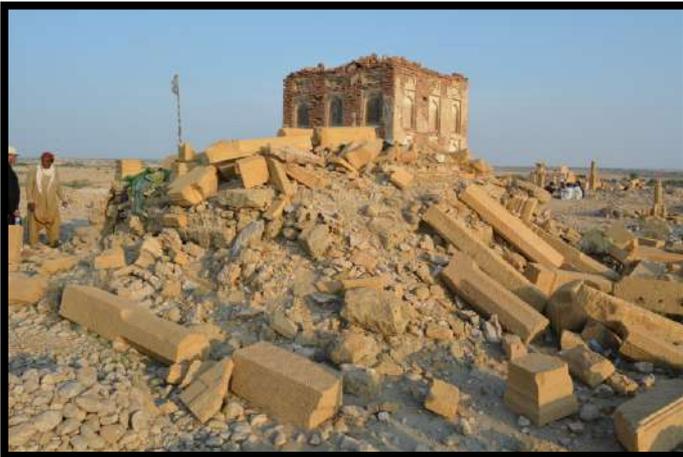
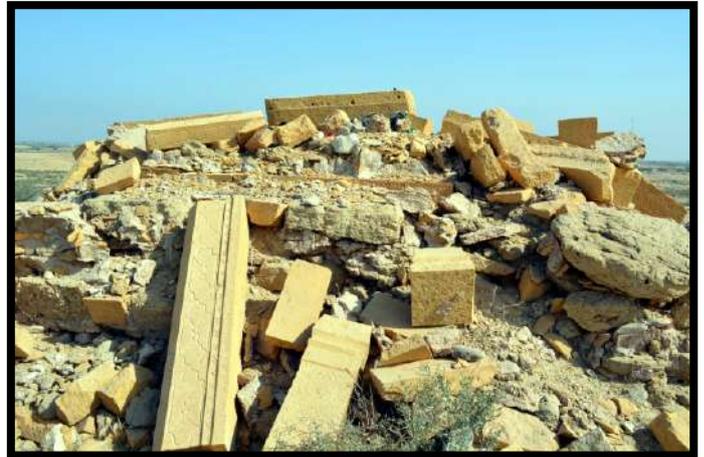
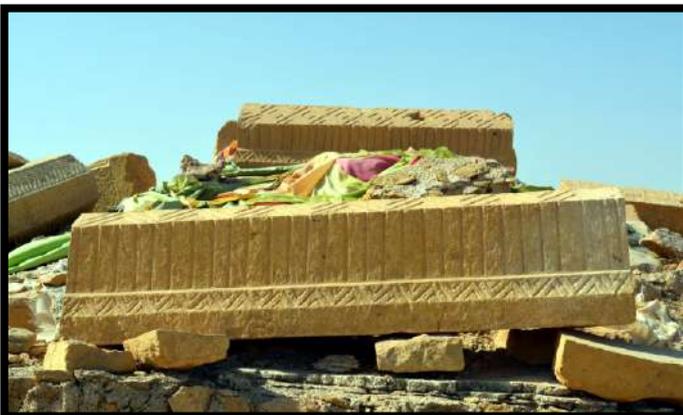
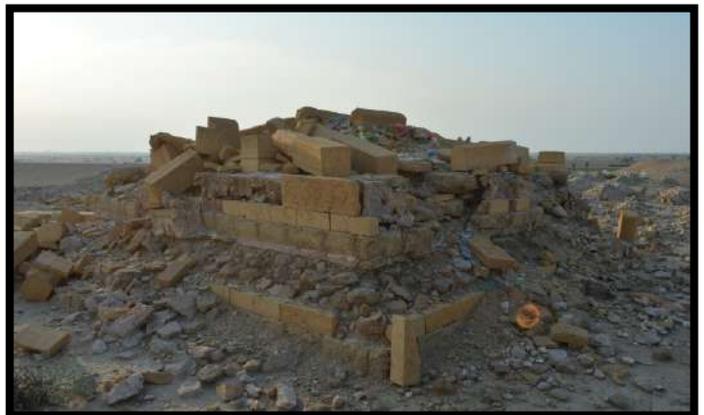
GENERAL VIEWS OF CANOPY 2

This canopy structure belongs to Jam Chutto (name and date 1170 A.H. is mentioned on the pillar). It is totally damaged, the pillars and platforms and other parts of the canopy are concealed under the wreckage. The canopy was originally erected over a double square platforms, the dimensions of the first platform are 20'-9" x 20'-9". The canopy was square in plan, erected on the second platform, measuring 17'-3" x 17'-3", with the support of twelve pillars. Its area is 297.56 sq.ft (27.64 sq.m). The border of the second platform is carved with multi-foil arches with rosette motifs. The canopy was constructed with stone masonry by using lime and chiroli. There are four graves laid on the rectangular platform, measuring 11'-3" x 7'-6".

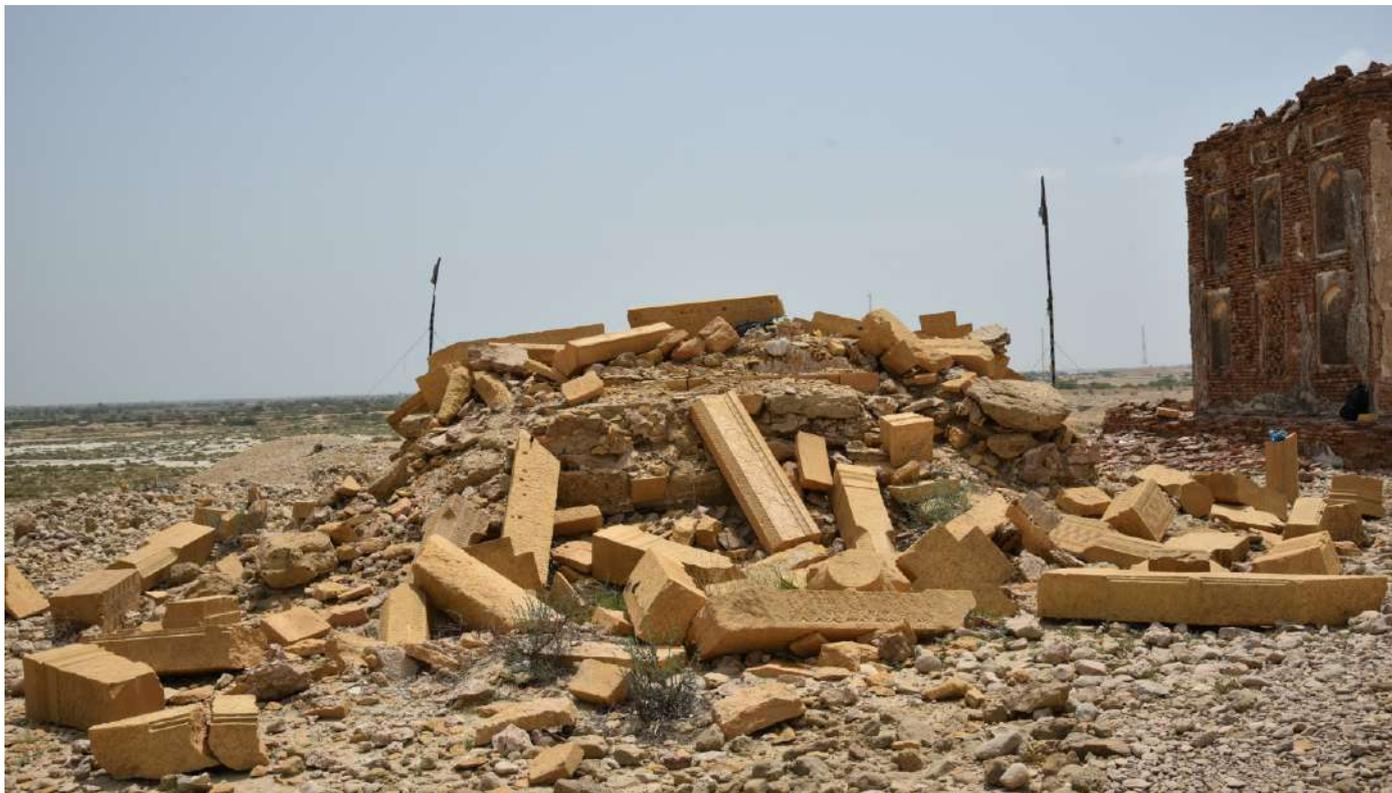
- Grave is constructed in Three steps. 1st step is 20'-9" X 20'-9", Second step is 17'-3" X 17'-3" and
- Third step is 11'-3" X 7'-6".
- Base of Graves is constructed with Chiroli, Lime and Stone Masonry in two steps.
- Base walls and base floor is totally washed.
- Floor of Base is covered with stones and found entirely demolished.
- Graves are constructed with Stones, found in weak condition.
- It contains 12 stone pillars and found carving work on that, 30 % of material (carved stones) is available at site.
- Canopy 2 contain 4 no:s of Graves.

**Canopy Concealed Under the Wreckage**

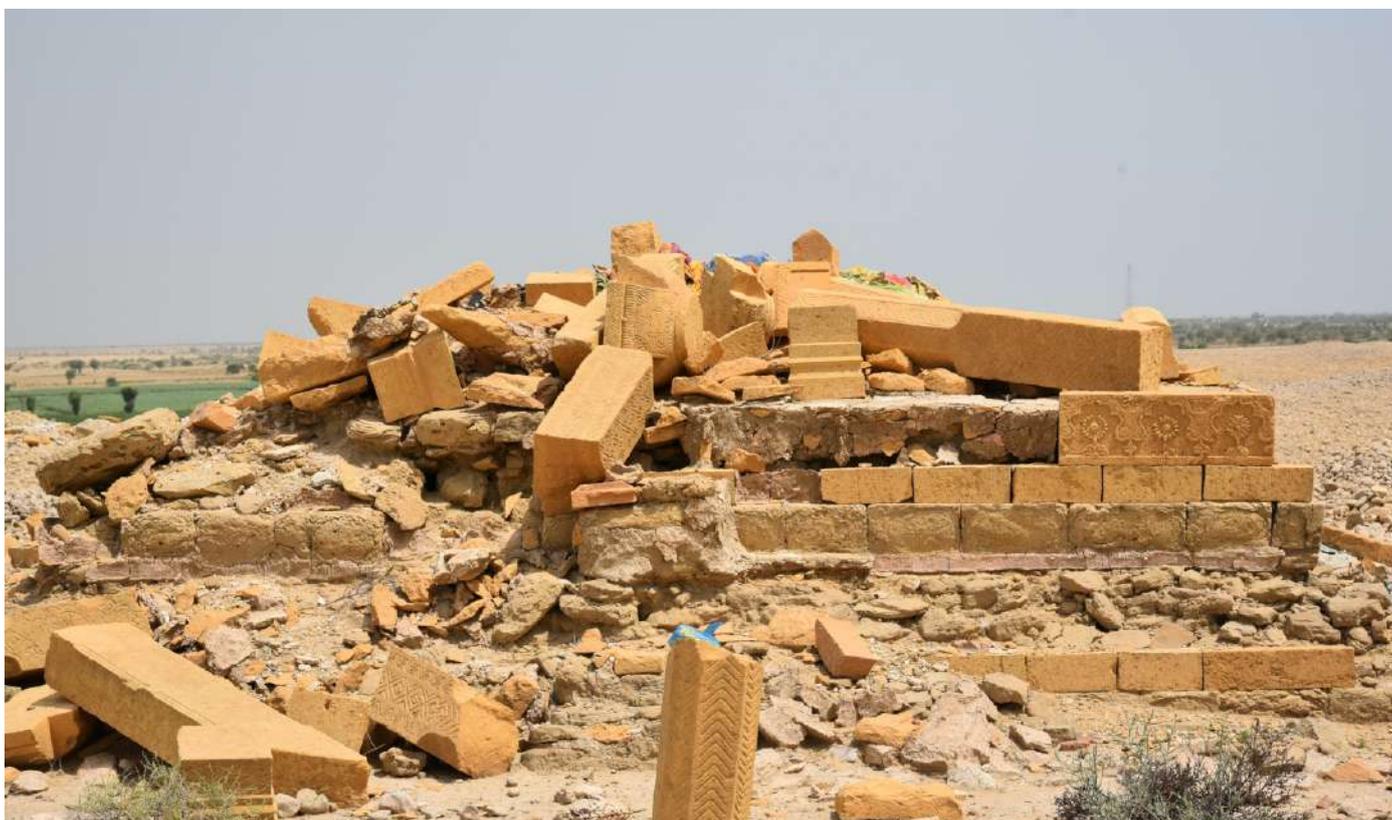
**Second Platform is Carved with Multi-foil Arches with Rosette Motifs**

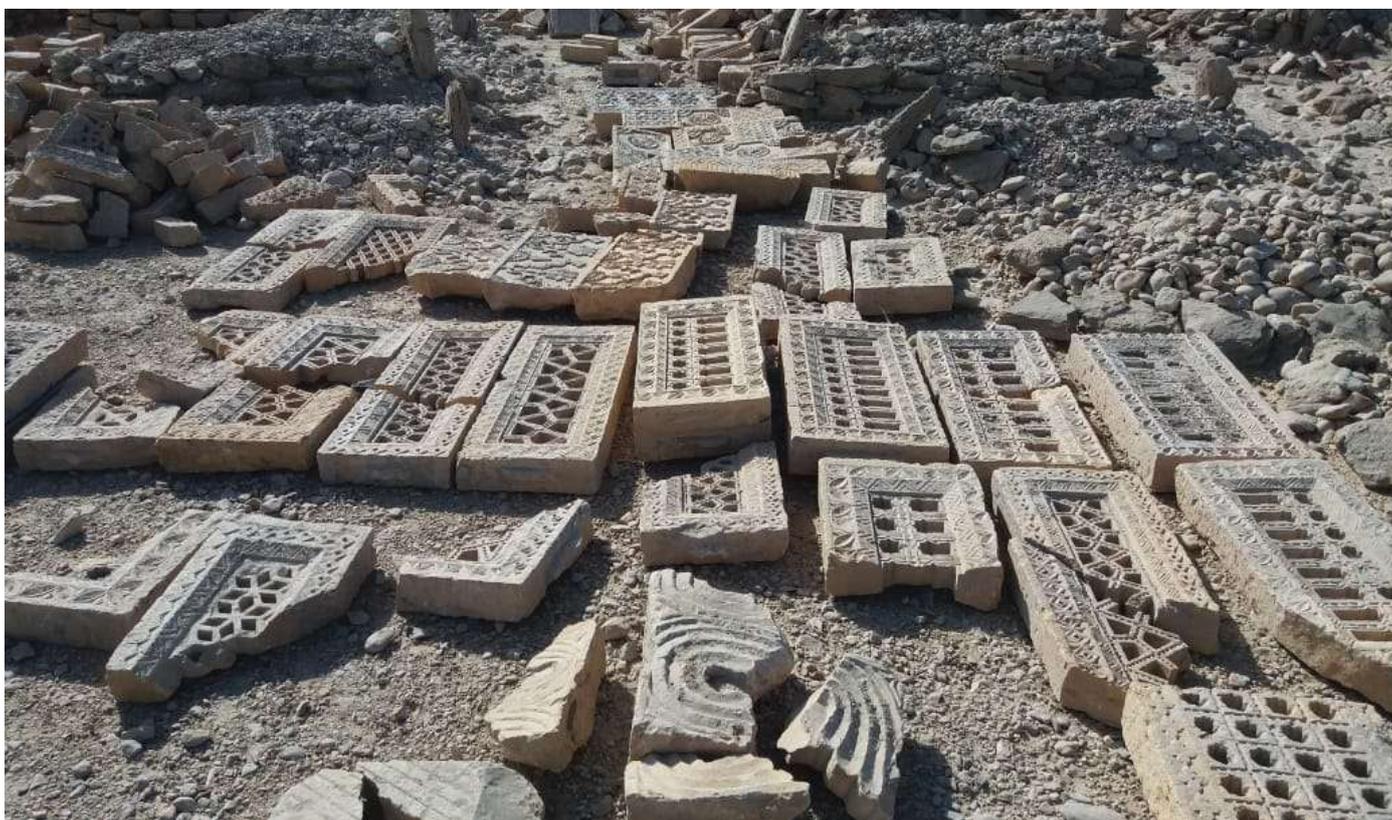
COLLECTION OF PERFORATED DESIGN JALIS

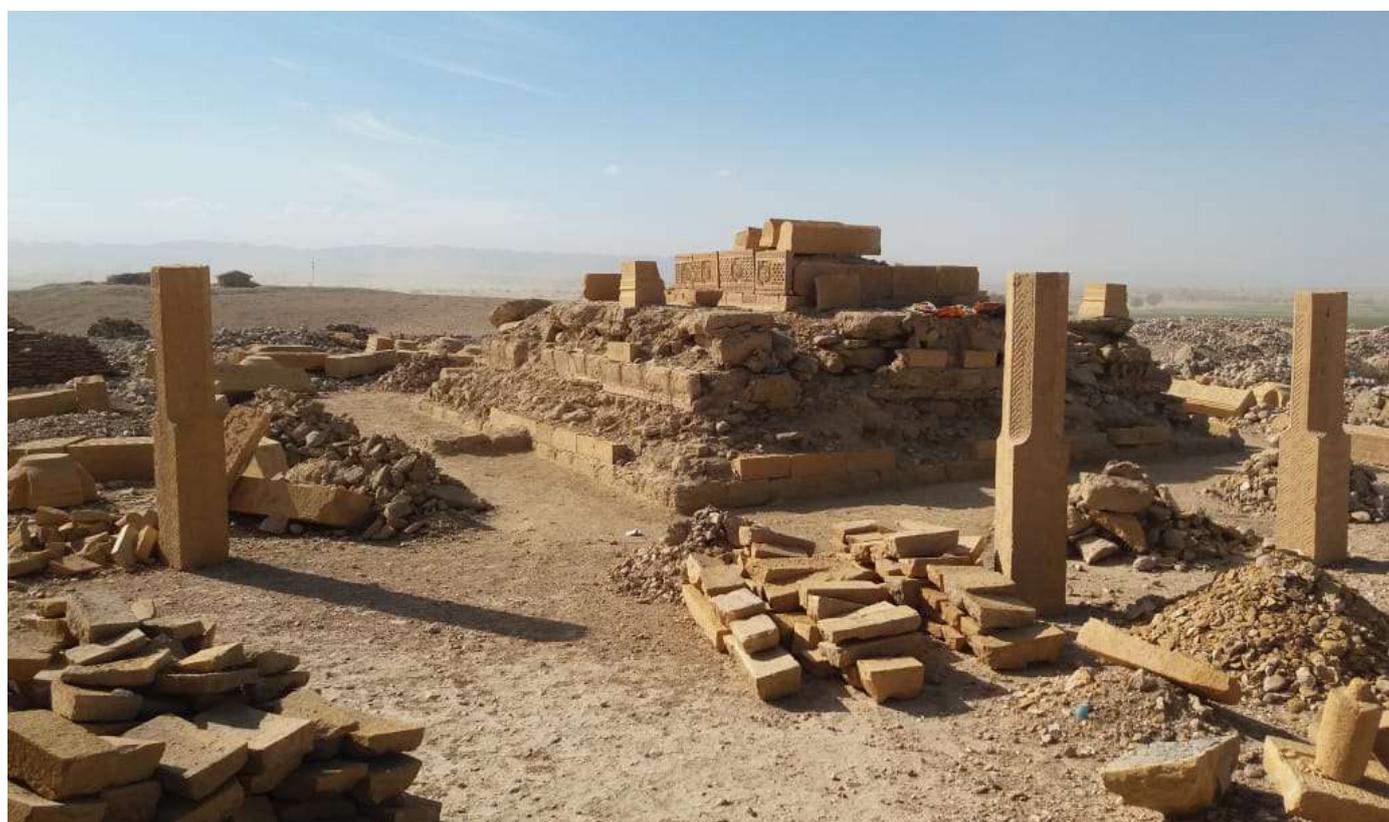
**AFTER REMOVING OF SALTED DEBRIS**

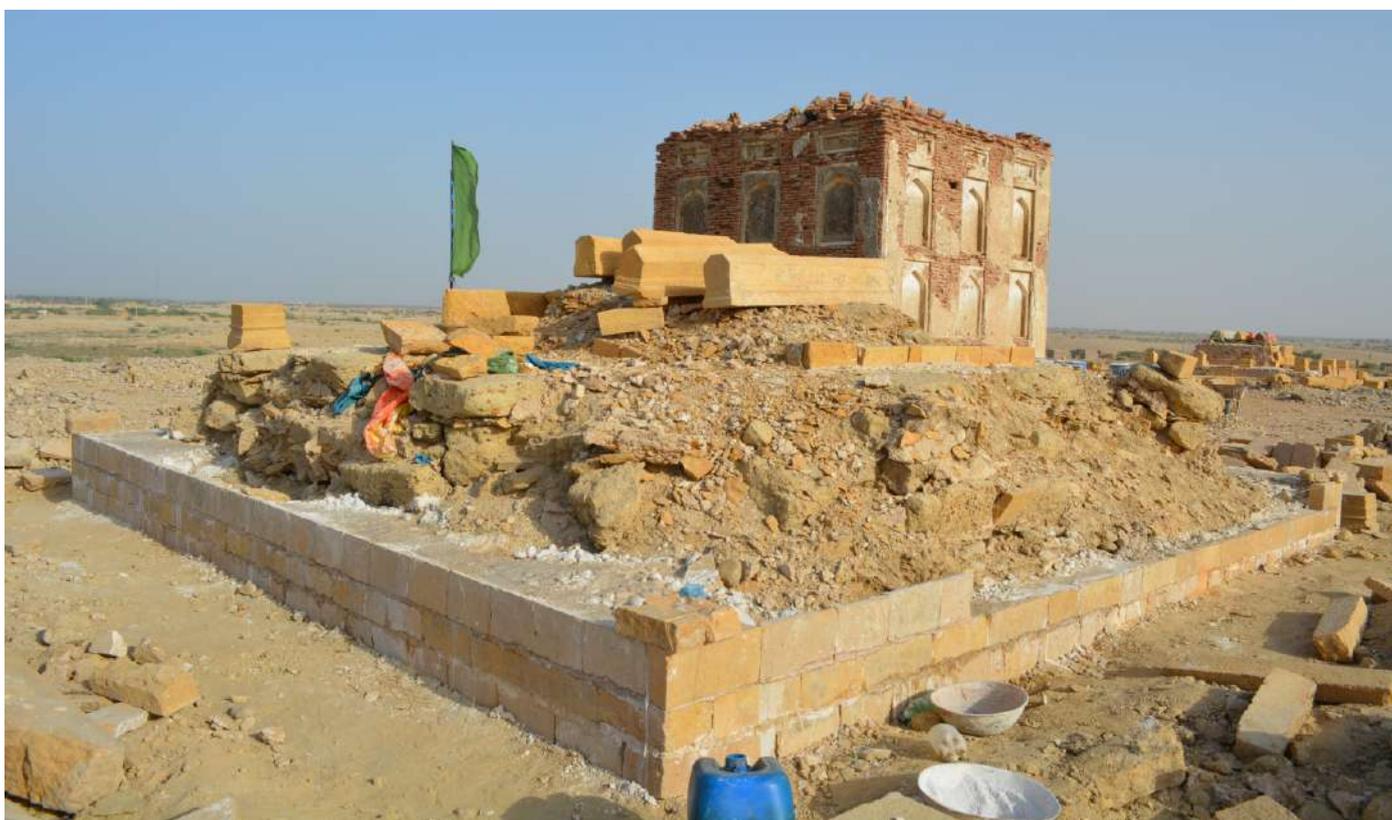
**RESTORATION OF 1ST STEP**

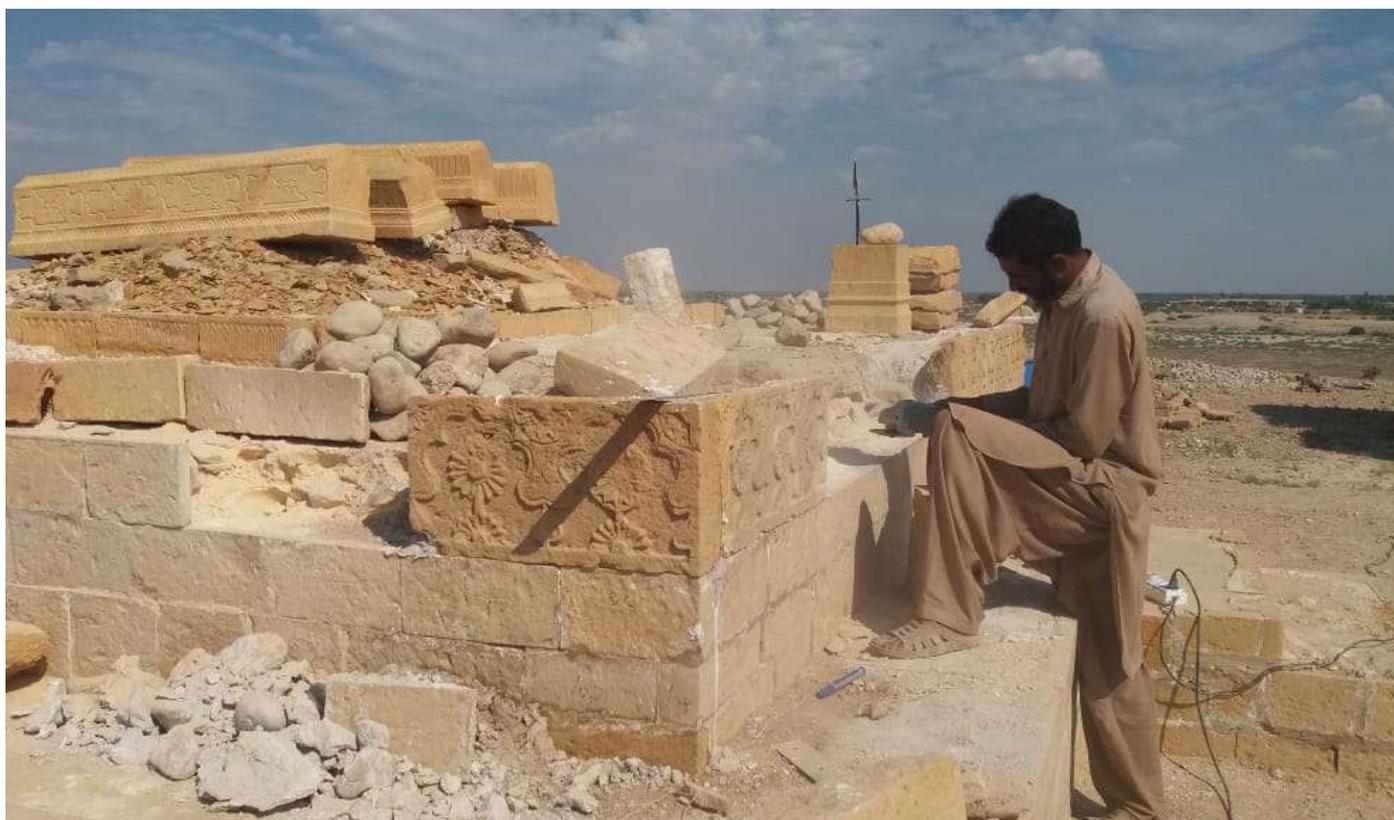
**CUTTING OF STONE BY GRINDER**

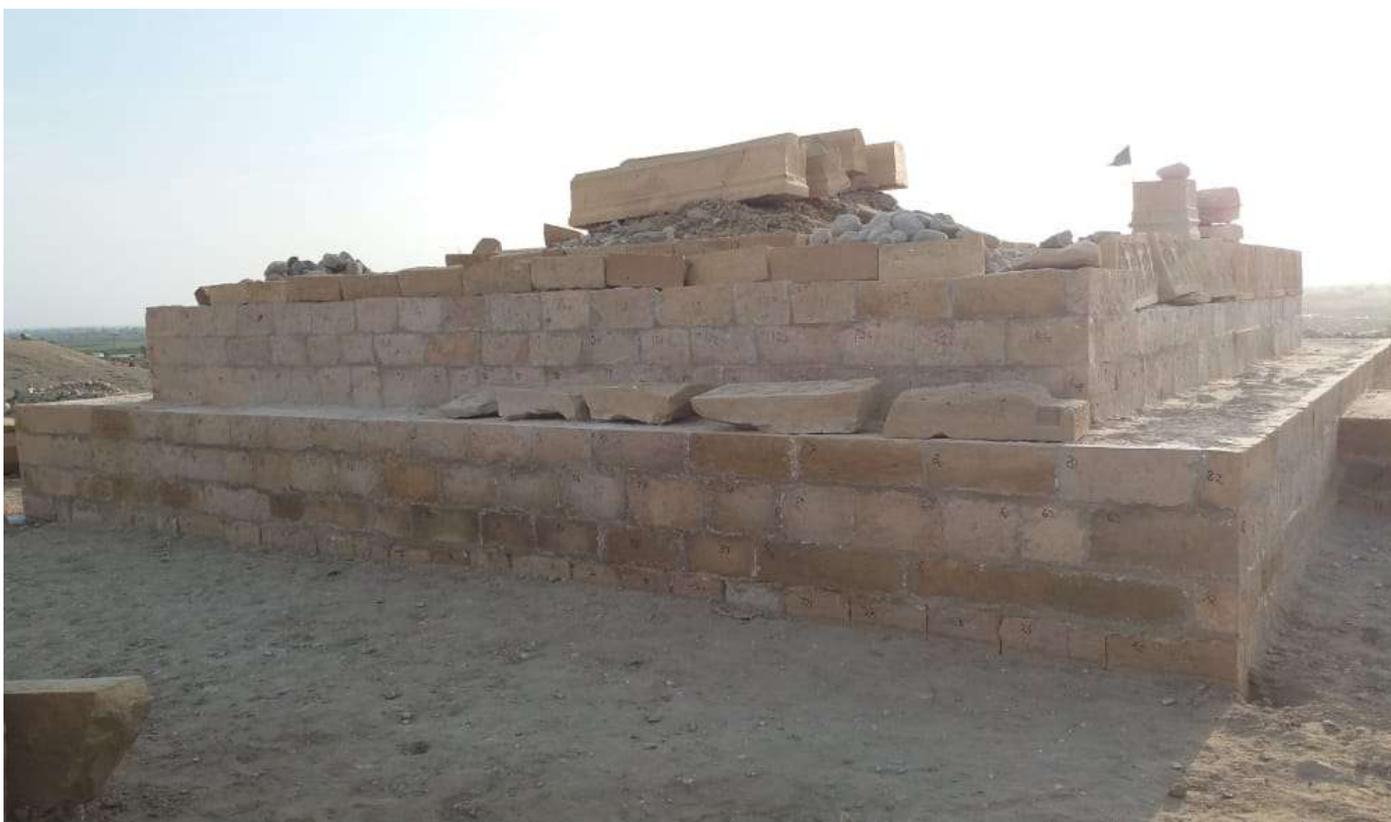
**STONES ARE FIXED ON STEP 1 AND 2**

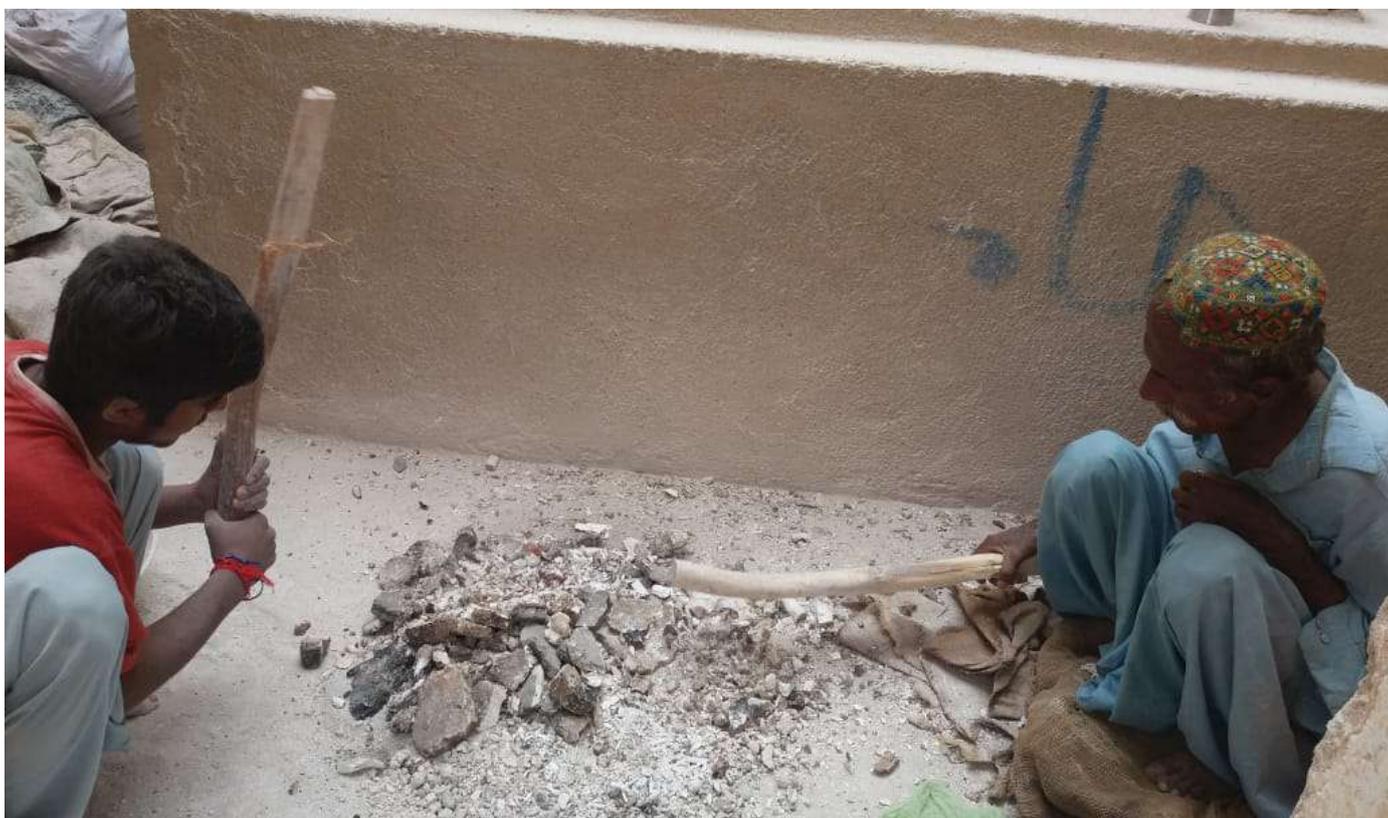
**CHIROLI PROCEDURE**

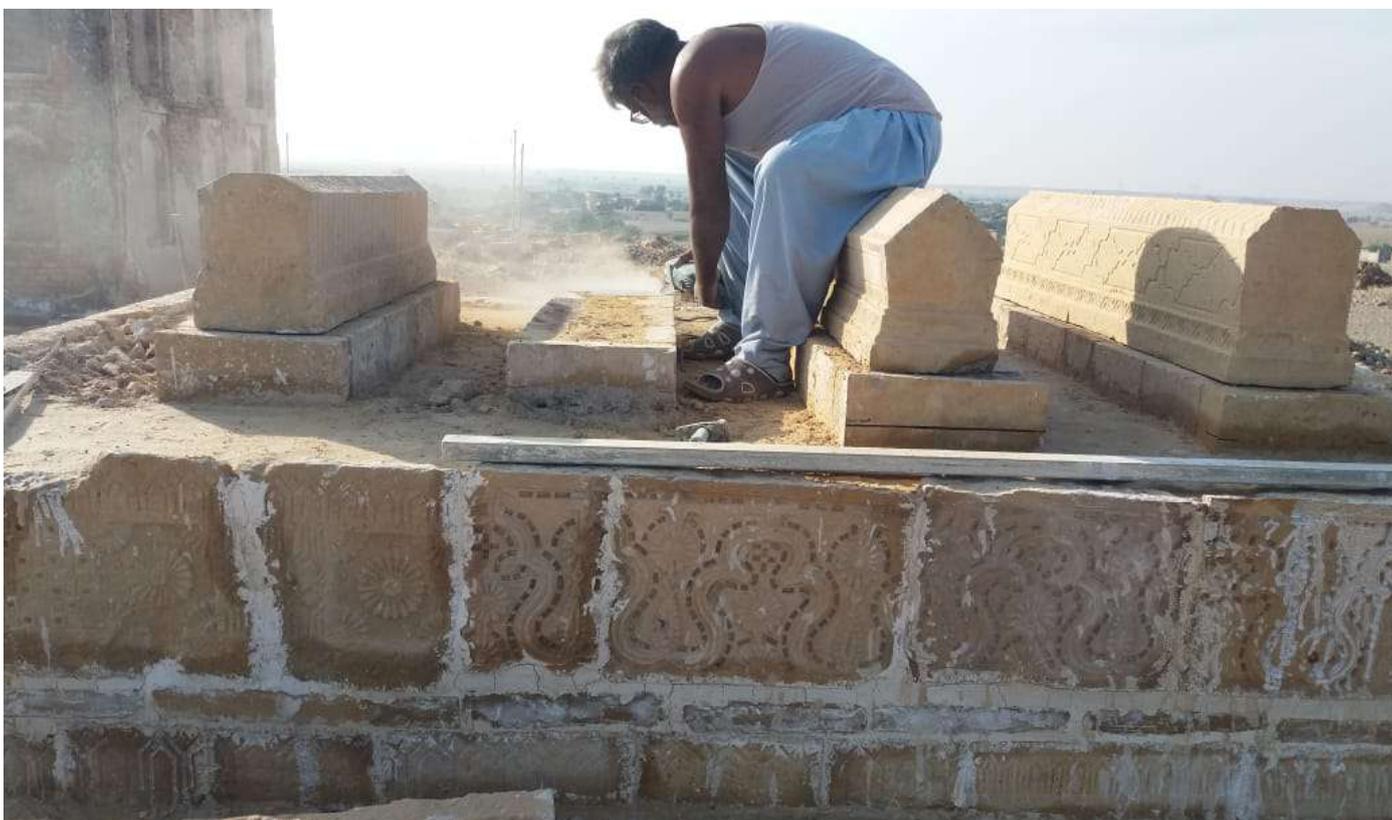
**FINISHING OF STONE BY GRINDER**
