PROJECT COMPLETION REPORT  
**JAM CHUTTO**  
DECEMBER | 2019

Center for Documentation and Conservation of the Heritage of Sindh  
Endowment Fund Trust for Preservation of the Heritage of Sindh

## CANOPY 1

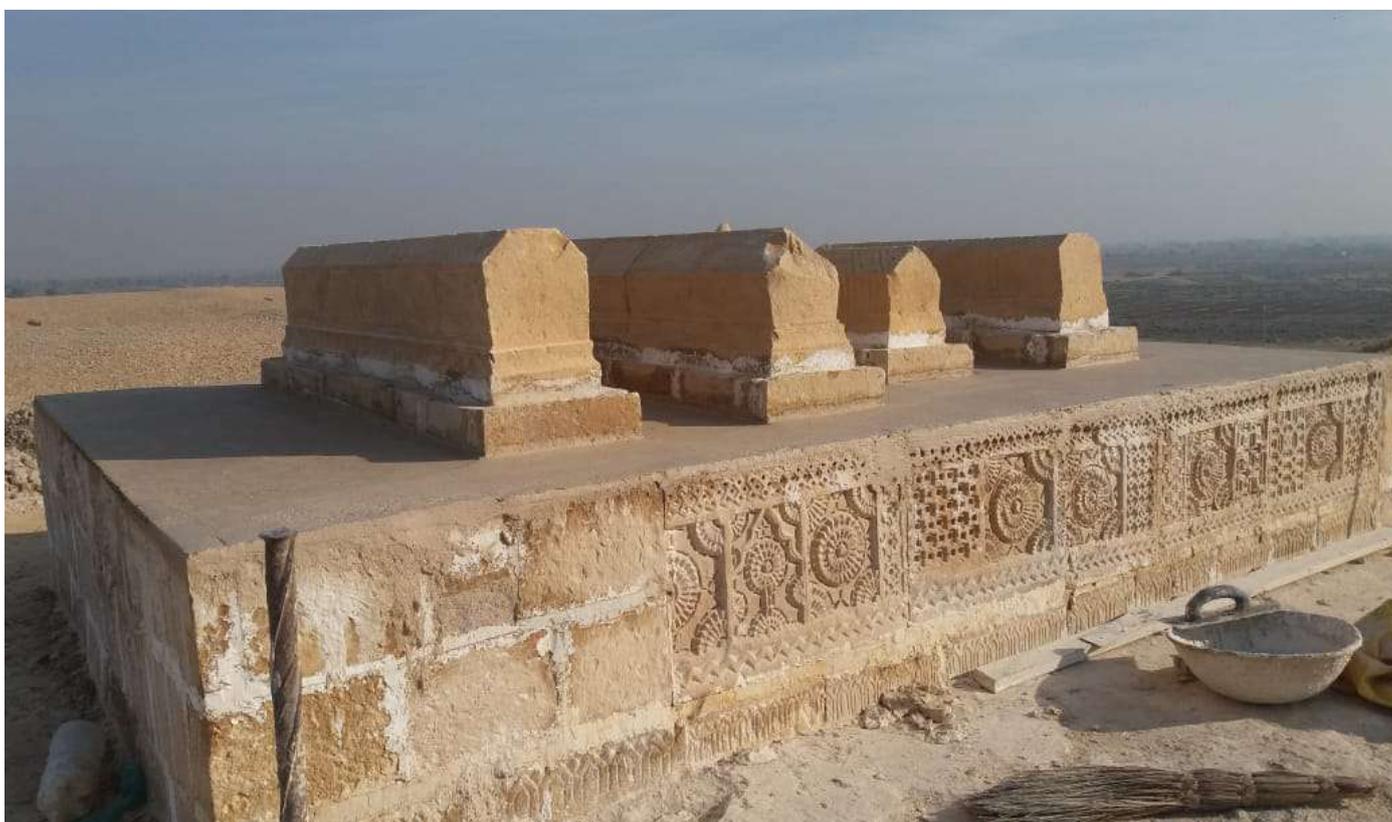
**APPLYING LIME CONCRETE LAYER**

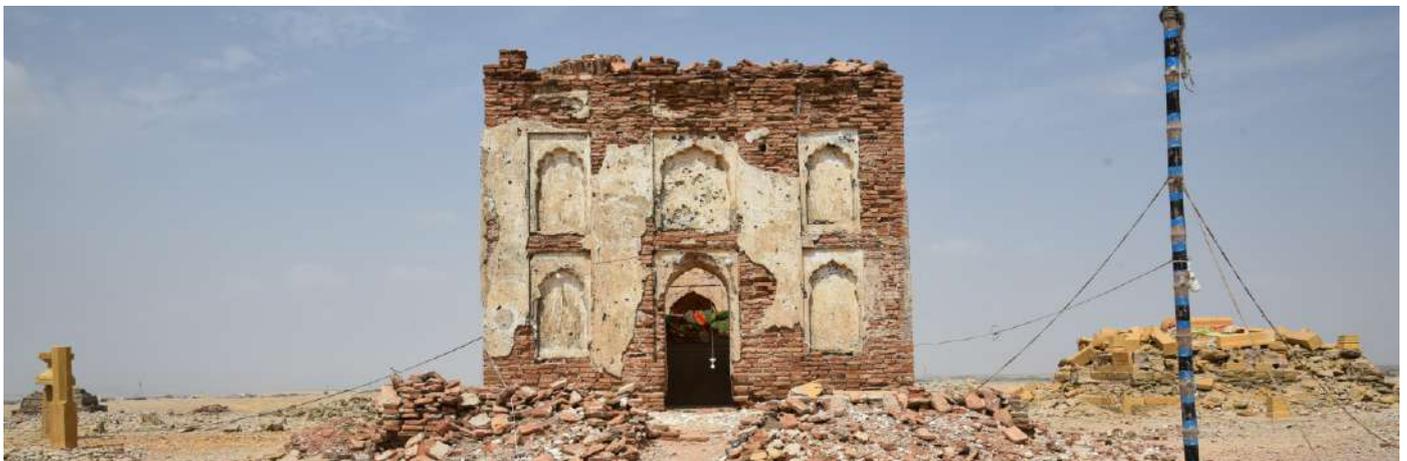
**FACADE OF TOMB**

The tomb structure-01 is erected on a rectangular platform, measuring 23'-2" X 29'-2". The structure is almost square, its dimensions are 18'-7.0" x 18'-5.0" on the exterior and 12'-11" x 12'-10" interior side. Total covered area is 342.243 sq.ft (31.794 sq.m) and wall thickness is 2'-10". The tomb is constructed with burnt bricks (9" x 7" x 2"), *chiroli* is used as mortar and lime applied in plaster. Facade has a tudor opened arch entrance on the eastern side and is flanked by recessed rectangular blind panels with multifoil arches. Above the entrance there are three recessed rectangular blind panels with multifoil arch decorations. The remaining three sides of the tomb has two rows of horizontal rectangular recessed panels with tudor arch decorations. Above these panels, there is a row of recessed rectangular panels. There are two perforated brick *Jali* windows on northern and southern side. Three kiosks are completely collapsed and one is surviving in a damaged condition. The dome is completely collapsed whereas the octagonal drum is in a dilapidated condition. In the interior of the tomb there are four multifoil squinch arches in every corner and two recessed multifoil arch panels within these squinches. Between the squinch arches there is *mehrab* on the western side decorated with muqarnas. On the southern and northern side are recessed tudor arch windows and on the eastern side there is a tudor opened arch entrance. Above the windows, *mehrab* and entrance there are multifoil arch panels. The interior of the drum is adorned with recessed tudor arches. Inside the tomb there are two graves laid on the platform, its dimensions are 8'-1' x 7'-0". The graves and platform are renovated with burnt bricks and cement plaster. The floor of the tomb is renovated with cement.

- The unknown tomb in Jam Chutto graveyard is in a vulnerable condition and needs to be stabilized and preserved in its original condition.
- Plaster and mortar has eroded from the platform and the structure, due to which the bricks have loosened and detached from the masonry unit.
- Gaps are found in brick masonry and separated from the pattern from the exterior and interior structures, due to change in volume (expansion or contraction).
- Coving and spalling is observed in the structure.
- Black crust layer is observed on the plaster of the structure due to moisture and pollution.
- The dome has fallen off and drum is in a vulnerable condition.
- Three kiosks have collapsed, whereas one kiosk is in a dilapidated condition.
- One perforated brick (*Jali*) window of the structure is in a damaged condition.
- The graves, platform and the floor are renovated with cement.

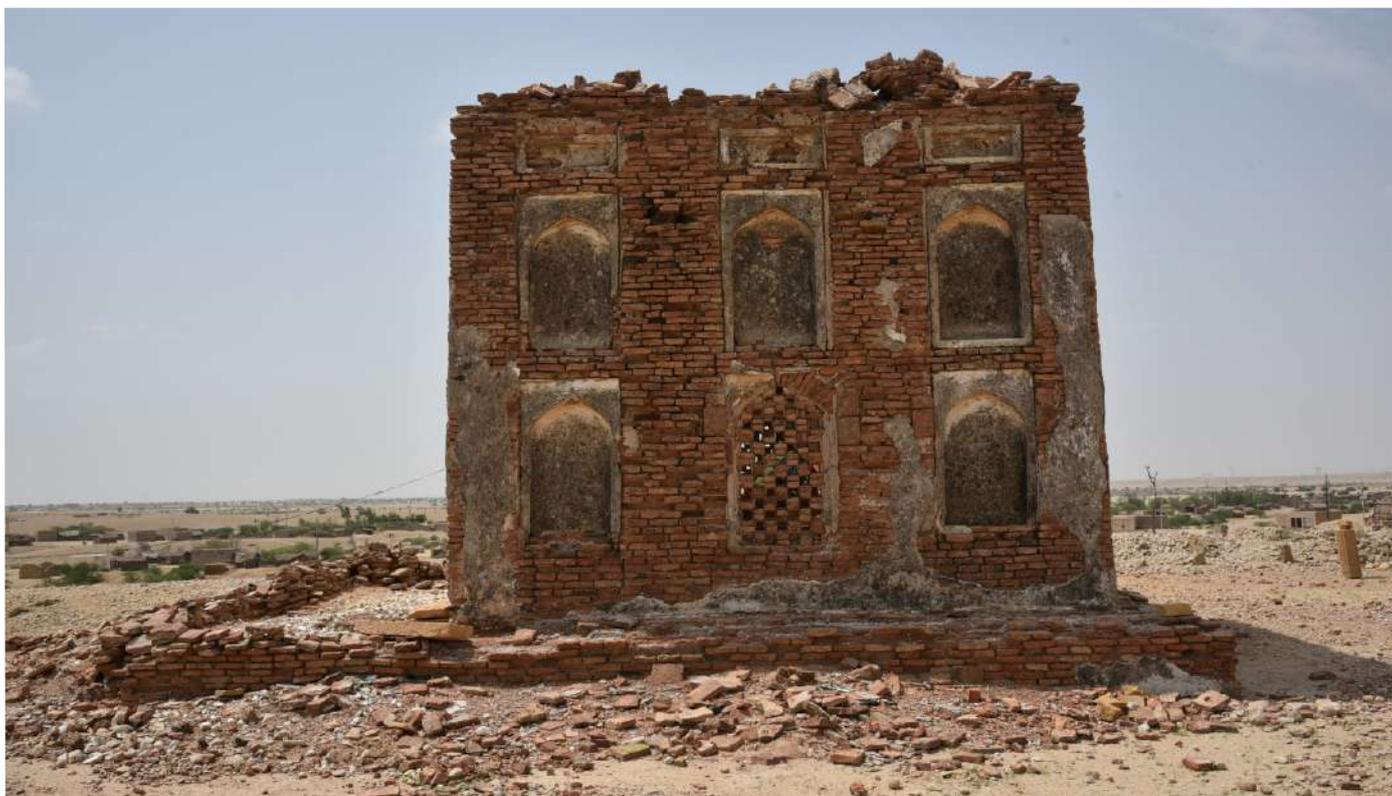
**Black Crust Layer Appear in the Plaster & Damaged Perforated Brick *Jali***

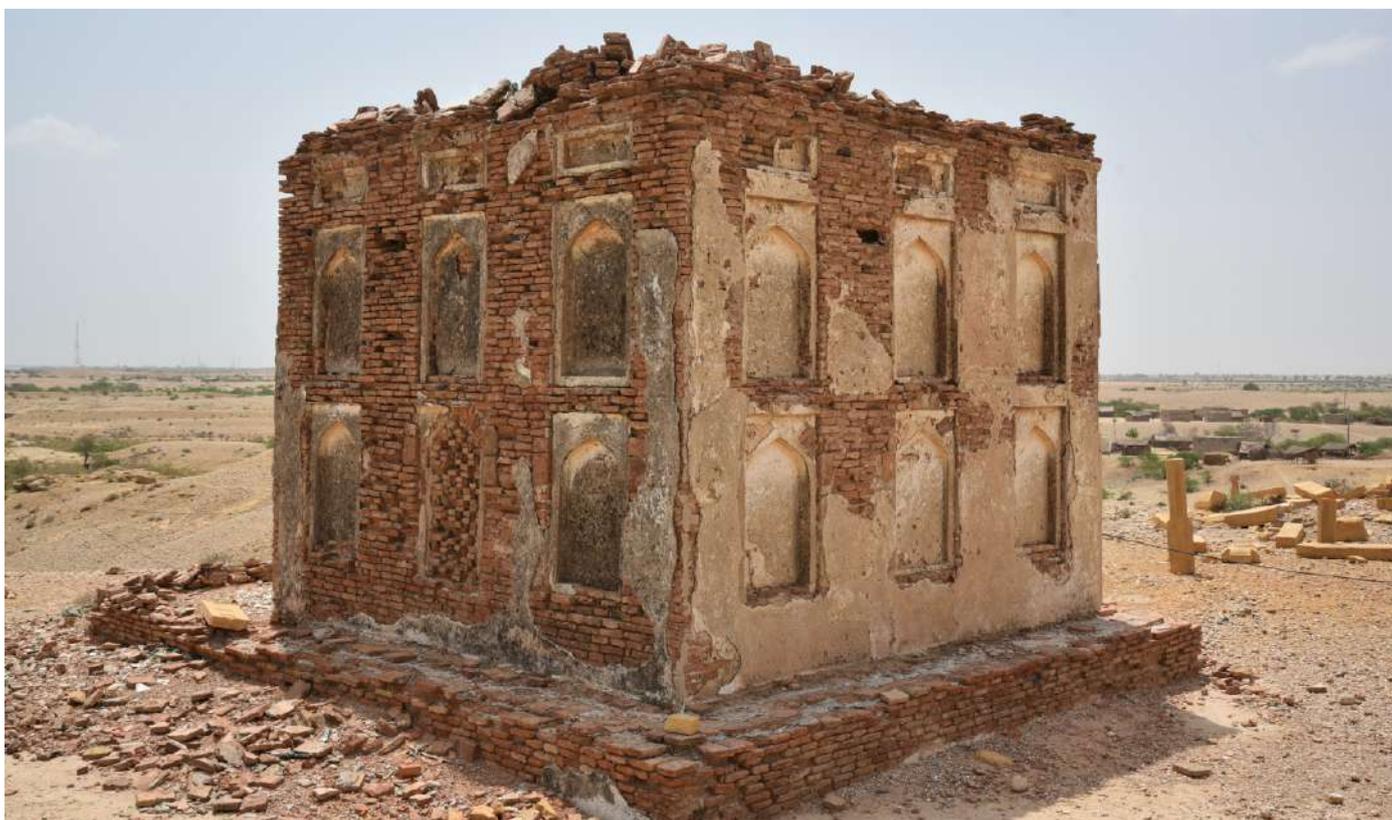
**Vulnerable Condition of Platform & the Structure**
