PROJECT COMPLETION REPORT

SUHAGAN & DUHAGAN TOMBS

OCTOBER 2019

Center for Documentation and Conservation of the Heritage of Sindh
Endowment Fund Trust for Preservation of the Heritage of Sindh

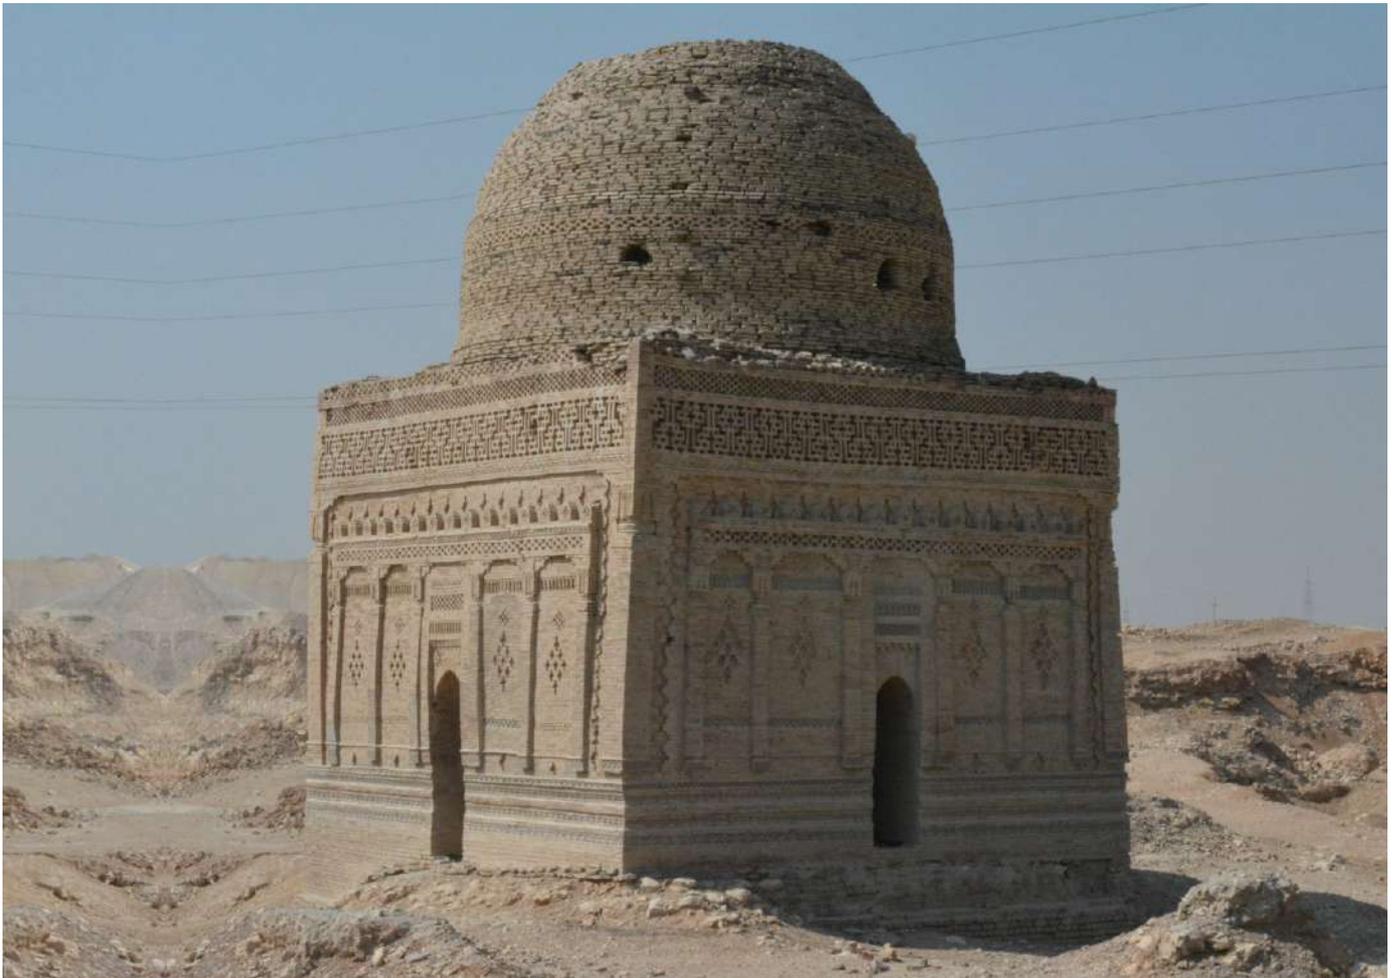
The tomb of Suhagan as the name carries belongs to Suhagan meaning a lady whose husband is alive. It is square in shape, its dimensions are 26'-8" x 26'-8" on the exterior and 21'-6" x 21'-6" interior, its height is 36 ft. The total covered area is 711.110 sq.ft (66.062 sq.m) and wall thickness is 2'-7". The tomb is constructed with burnt bricks (10" x 7" x 1.5") mud and chiroli are used as mortar. The exterior of the structure is decorated with naked/dressed (exposed) brick architecture in the shape of geometrical and floral patterns. There are four round arch shaped openings (one on each side), its measurements are 2'-6" x 8'-3". There are six composite cut bricks pilasters (three on each side of the openings/entrance) and there are four composite pilasters on all four corners. The composite pilasters on all four sides of the elevation give the shape of segmental arches, within these segmental arches there are various cut/dressed brick decorations. Above the segmental arches there is border in chain design surrounding the structure with merlon shaped decoration in cut/dressed brick ornamentation above it. Top of the structure is ornamented with geometrical and honey-combed pattern borders. All four sides of the tomb is similar in design and decoration. The high dome (imperial period style) with chain like cut bricks border around the middle of the dome. In the interior, each corner has squinch arch supporting the dome. Above these squinch arches there is circular border with denticulated bricks decoration.

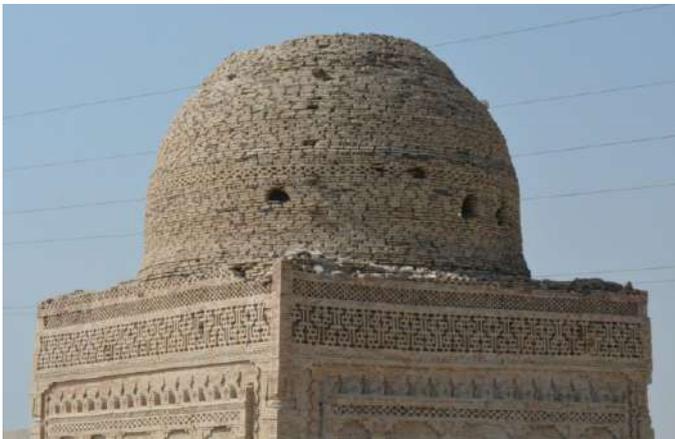
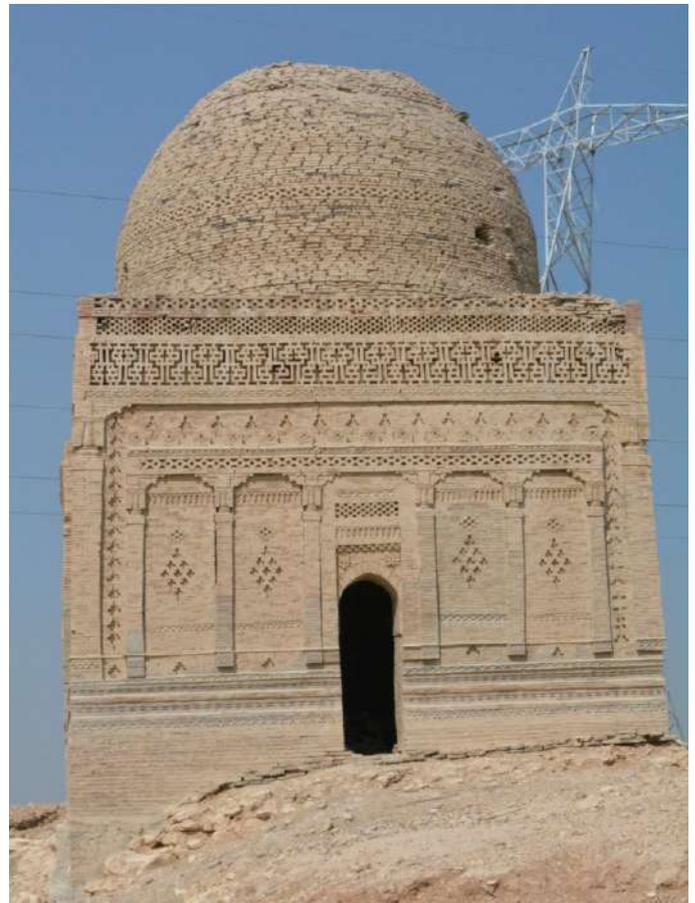
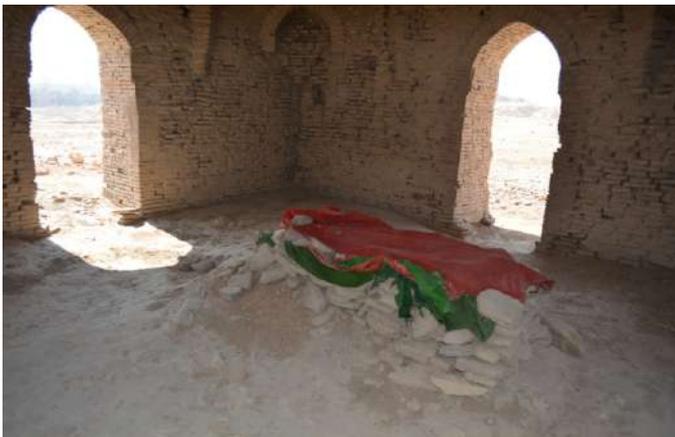
Condition Report

- The Endowment Fund Trust has carried out restoration work at the tomb of Suhagan and the following are the details of the work done:
- Platform has been constructed with stone masonry, lime mixed with hill sand and straw are used as mortar.

- Stepped platform is constructed on all sides except the south-eastern side of the tomb.
- The dome is 40% reconstructed with chirol, lime mixed with hill stone bits and straw are used as plaster. Wooden bamboo sticks tied with wire were fixed below the lime plaster layer (work was on-going exterior side).

- After clearing the floor level, evidence of six graves was found inside the tomb.
- Pointing with chirol was done in the interior part of the tomb.
- Semi-circle five steps were constructed on the northern side of the platform to approach the tomb. These were constructed with stone blocks with lime used as mortar.

- The site pictures shows the condition before, on-going and after the restoration work of the tomb of Suhagan.

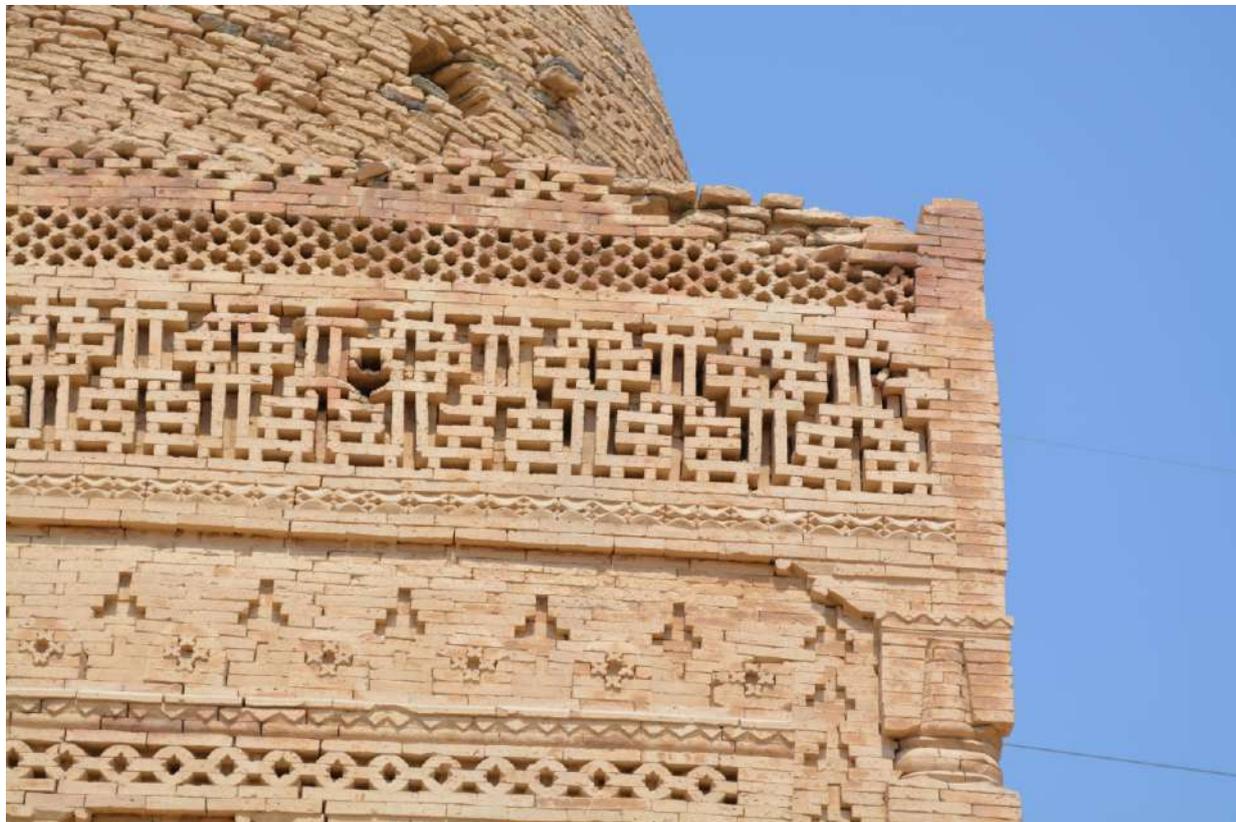
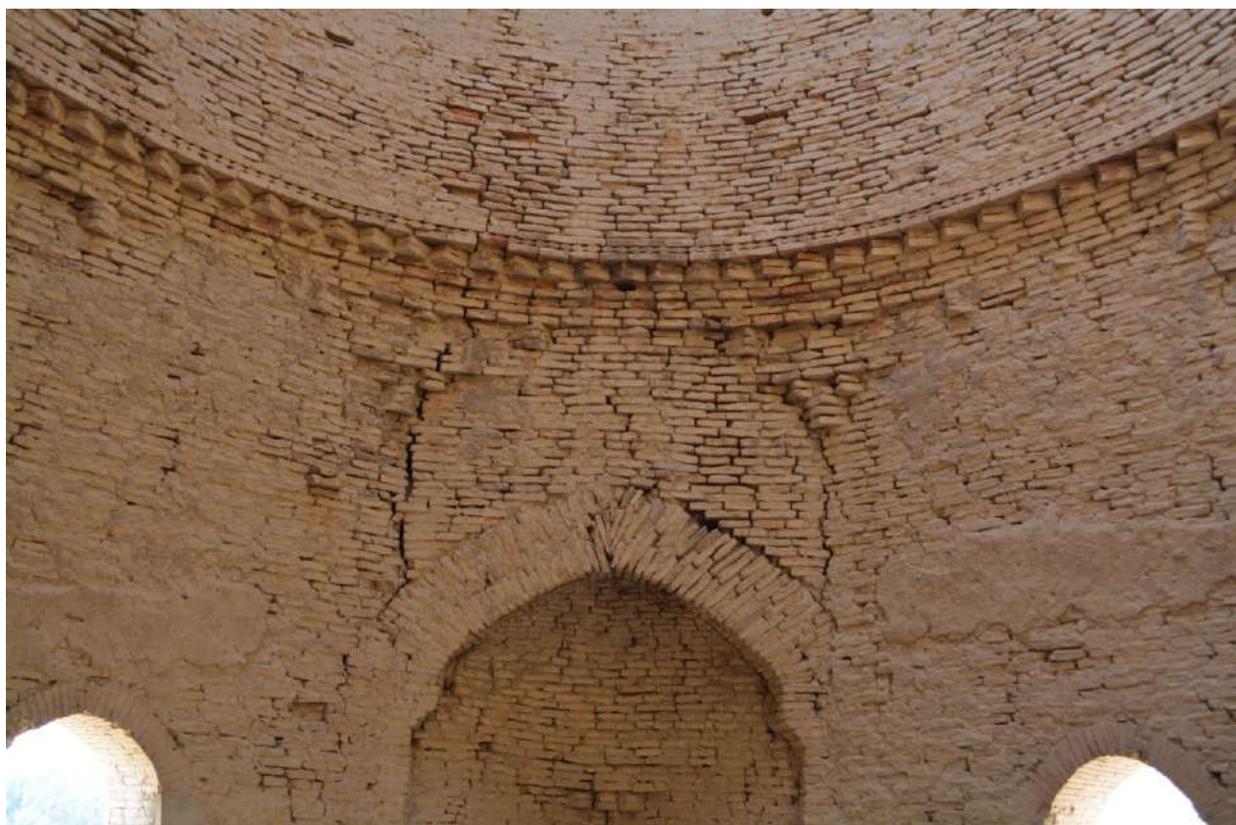
Condition Report

- The noticeable condition of tomb of suhagan, major diagonal or vertical cracks at present. Local spalling and detachments are present. The dome itself has outer main shell and inner as false shell. Outer dome shell has collapsed from the top distorting the round geometry and looks critical. The inner dome has very damaged condition with lots of spalling, pitting or detachments may be sort of crumbling or just the damage by birds keen to making holes or nests. This part is serious and need to be supported immediately by some sound arrangement before proper conservational strengthening

- Some portion of the masonry leave its original position it may be due to internal movements accruing & deformation is also found in some of the bricks.

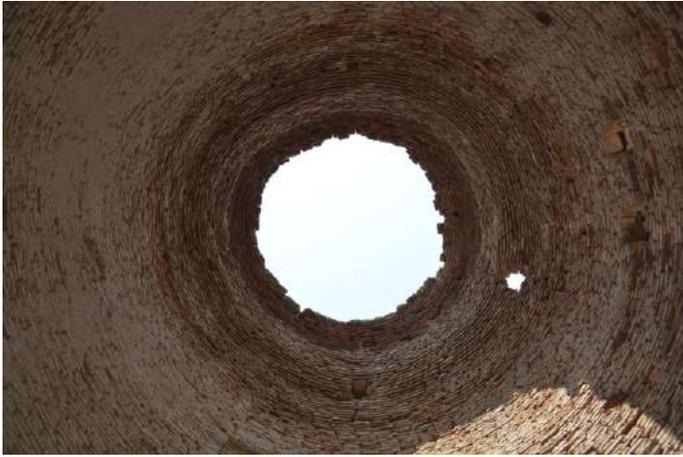
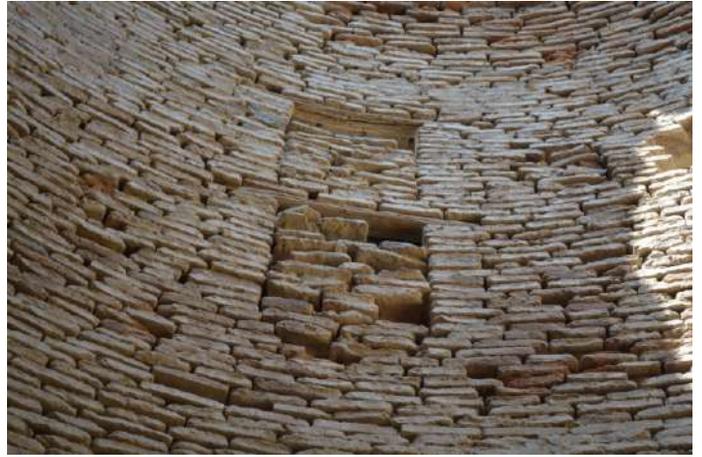
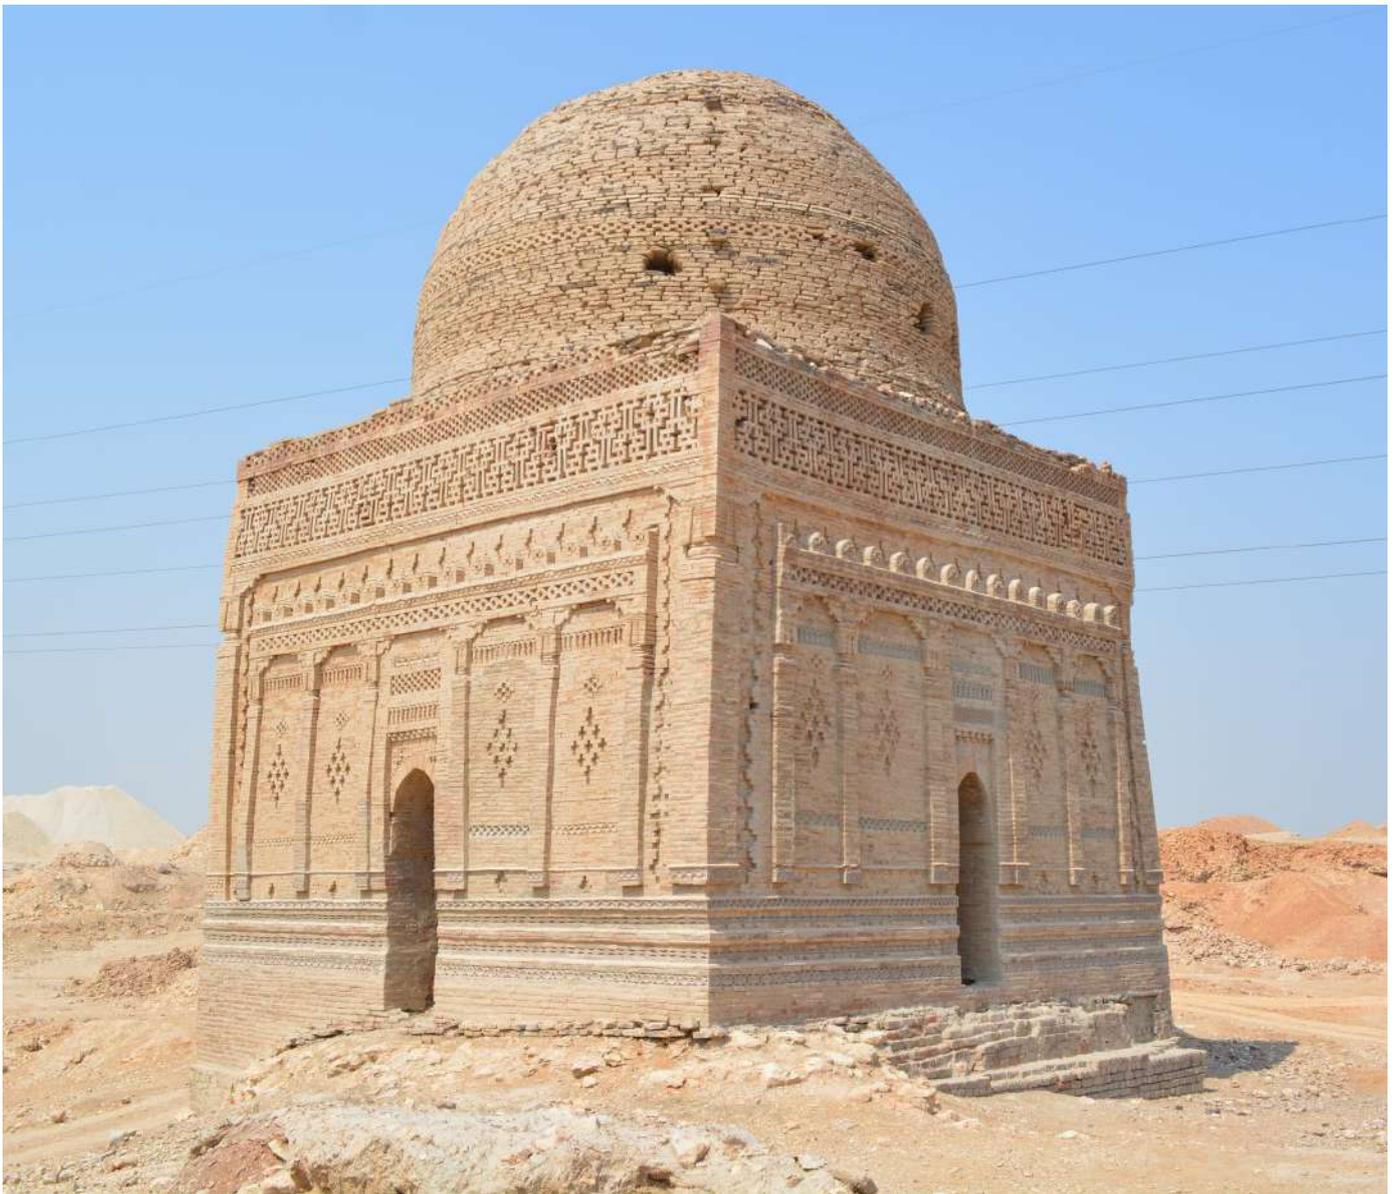
Condition Report

- Burnt Bricks measuring 10.5" X 7" X 1.5" & mud are used in masonry & binding material
- It is load bearing structure envisaged that the Foundations of the Tomb are at shallow depth of the order of 3-4 ft below natural sub grade.

- It is build on top of the hill which is ---- ft elevated from the natural ground level.
- It is consists of one grave which is in ruin condition.
- Floor is constructed with flat bricks , at this time floor is in rough level.

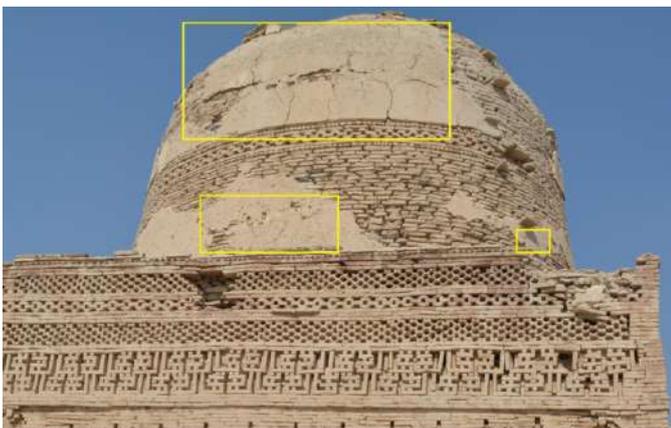
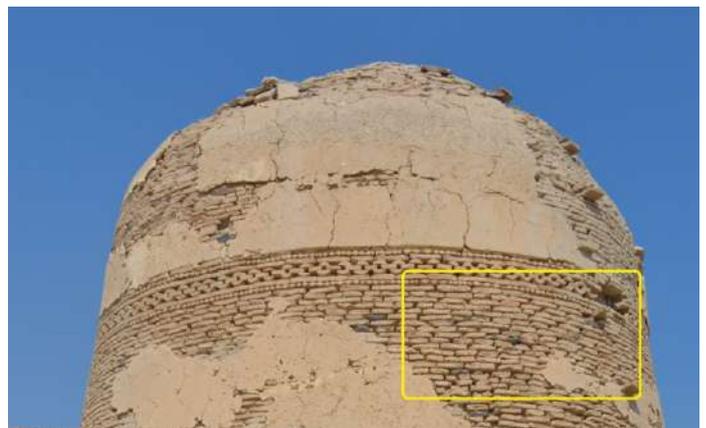
Condition Report

- ◆ Structure consists of one dome , top of the dome is collapsed open to sky.
- ◆ Outer elevation is decorated with 4 pier 9'-3" in height which is formed by engaged cylindrical bricks existing at the right & left side the door & 2 pier are in corners of the structure.

- ◆ The noticeable condition of tomb of suhagan, major diagonal or vertical cracks at present. Local spalling and detachments are present. The dome itself has outer main shell and inner as false shell. Outer dome shell has collapsed from the top distorting the round geometry and looks critical. The inner dome has very damaged condition with lots of spalling, pitting or detachments may be sort of crumbling or just the damage by birds keen to making holes or nests. This part is serious and need to be supported immediately by some sound arrangement before proper conservational strengthening

- ◆ Some portion of the masonry leave its original position it may be due to internal movements accruing & deformation is also found in some of the bricks

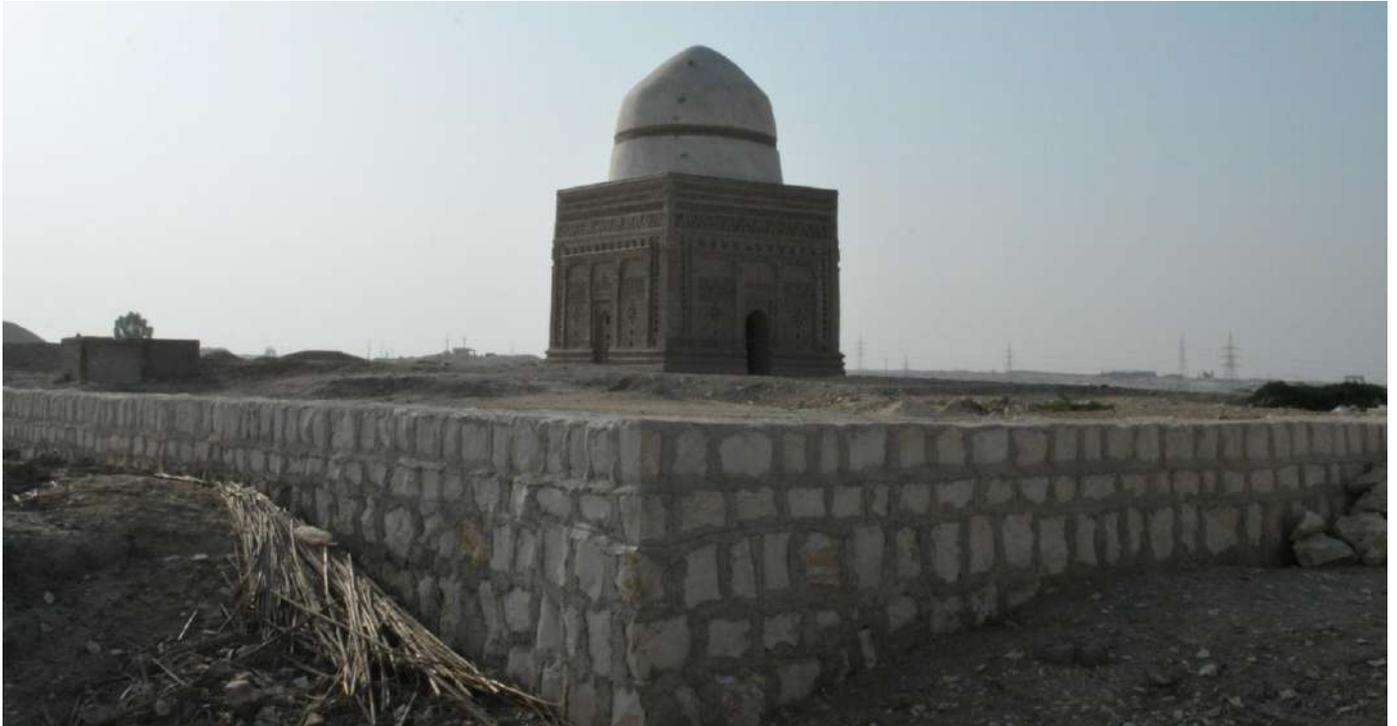
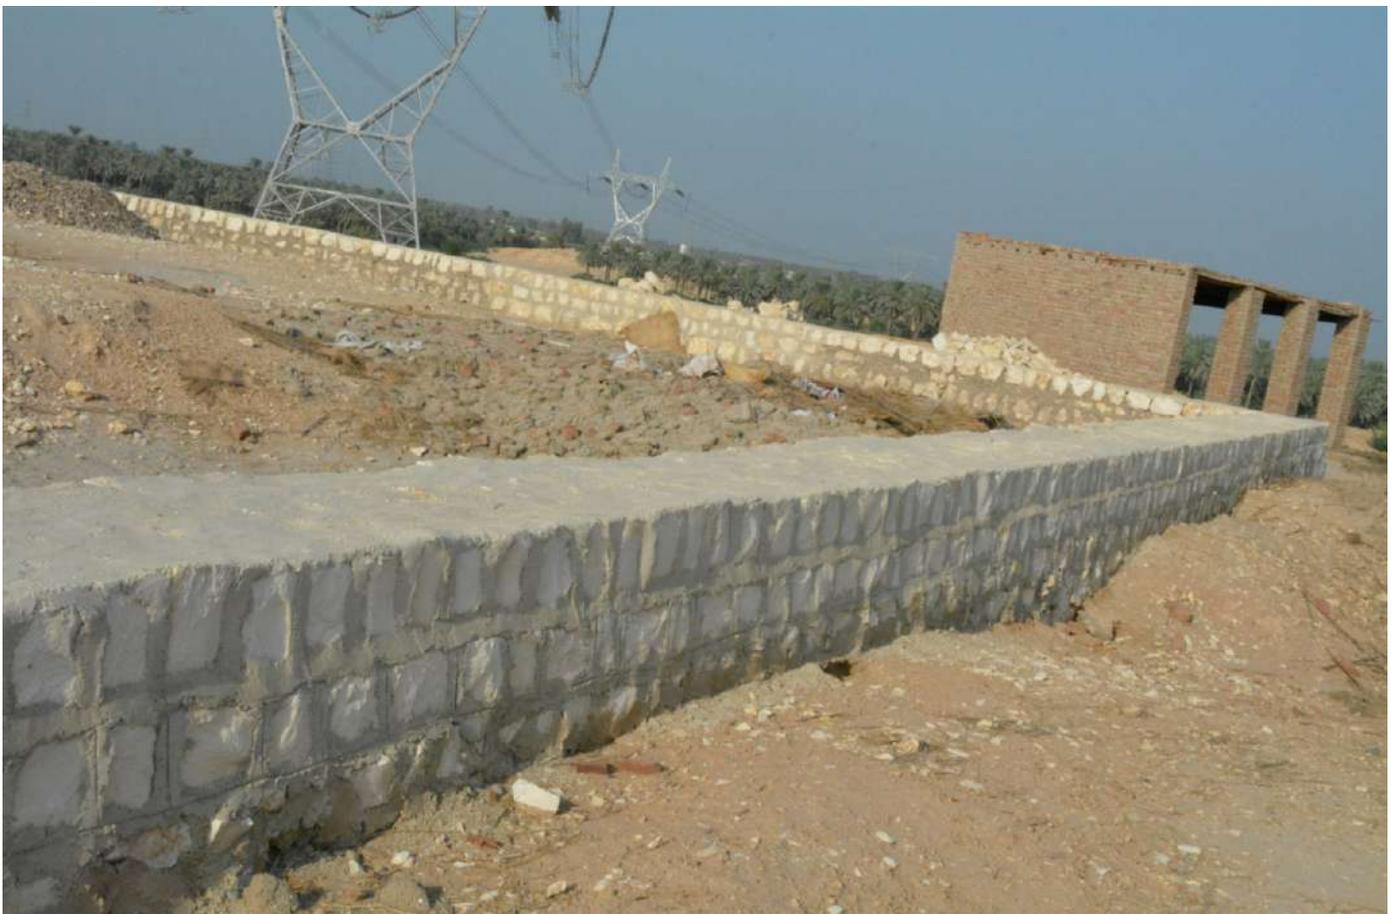
Construction of Boundary Wall

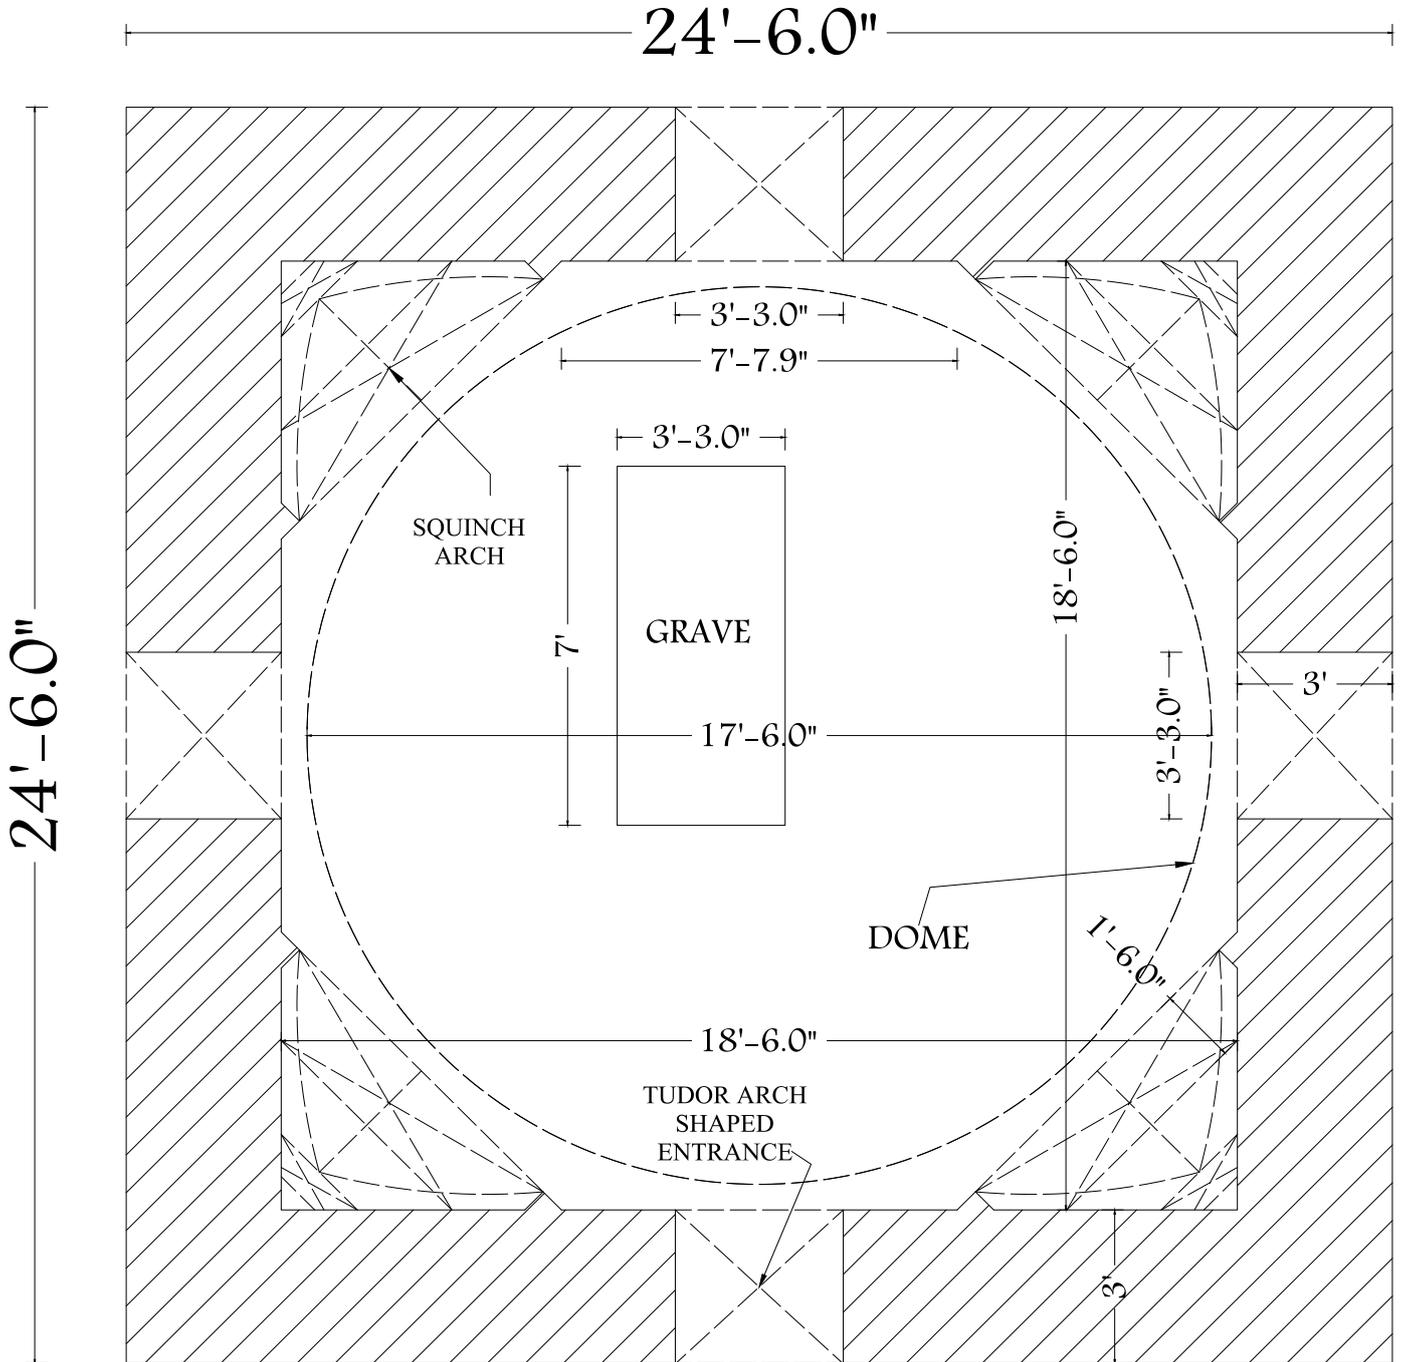
PLAN OF DUHAGAN TOMB

- Structure is constructed in square in shape measuring 24'-6" X 24'-6" and 36' in height which have 4 arched shaped entrances/openings measuring 2'-6" X 8'-3"

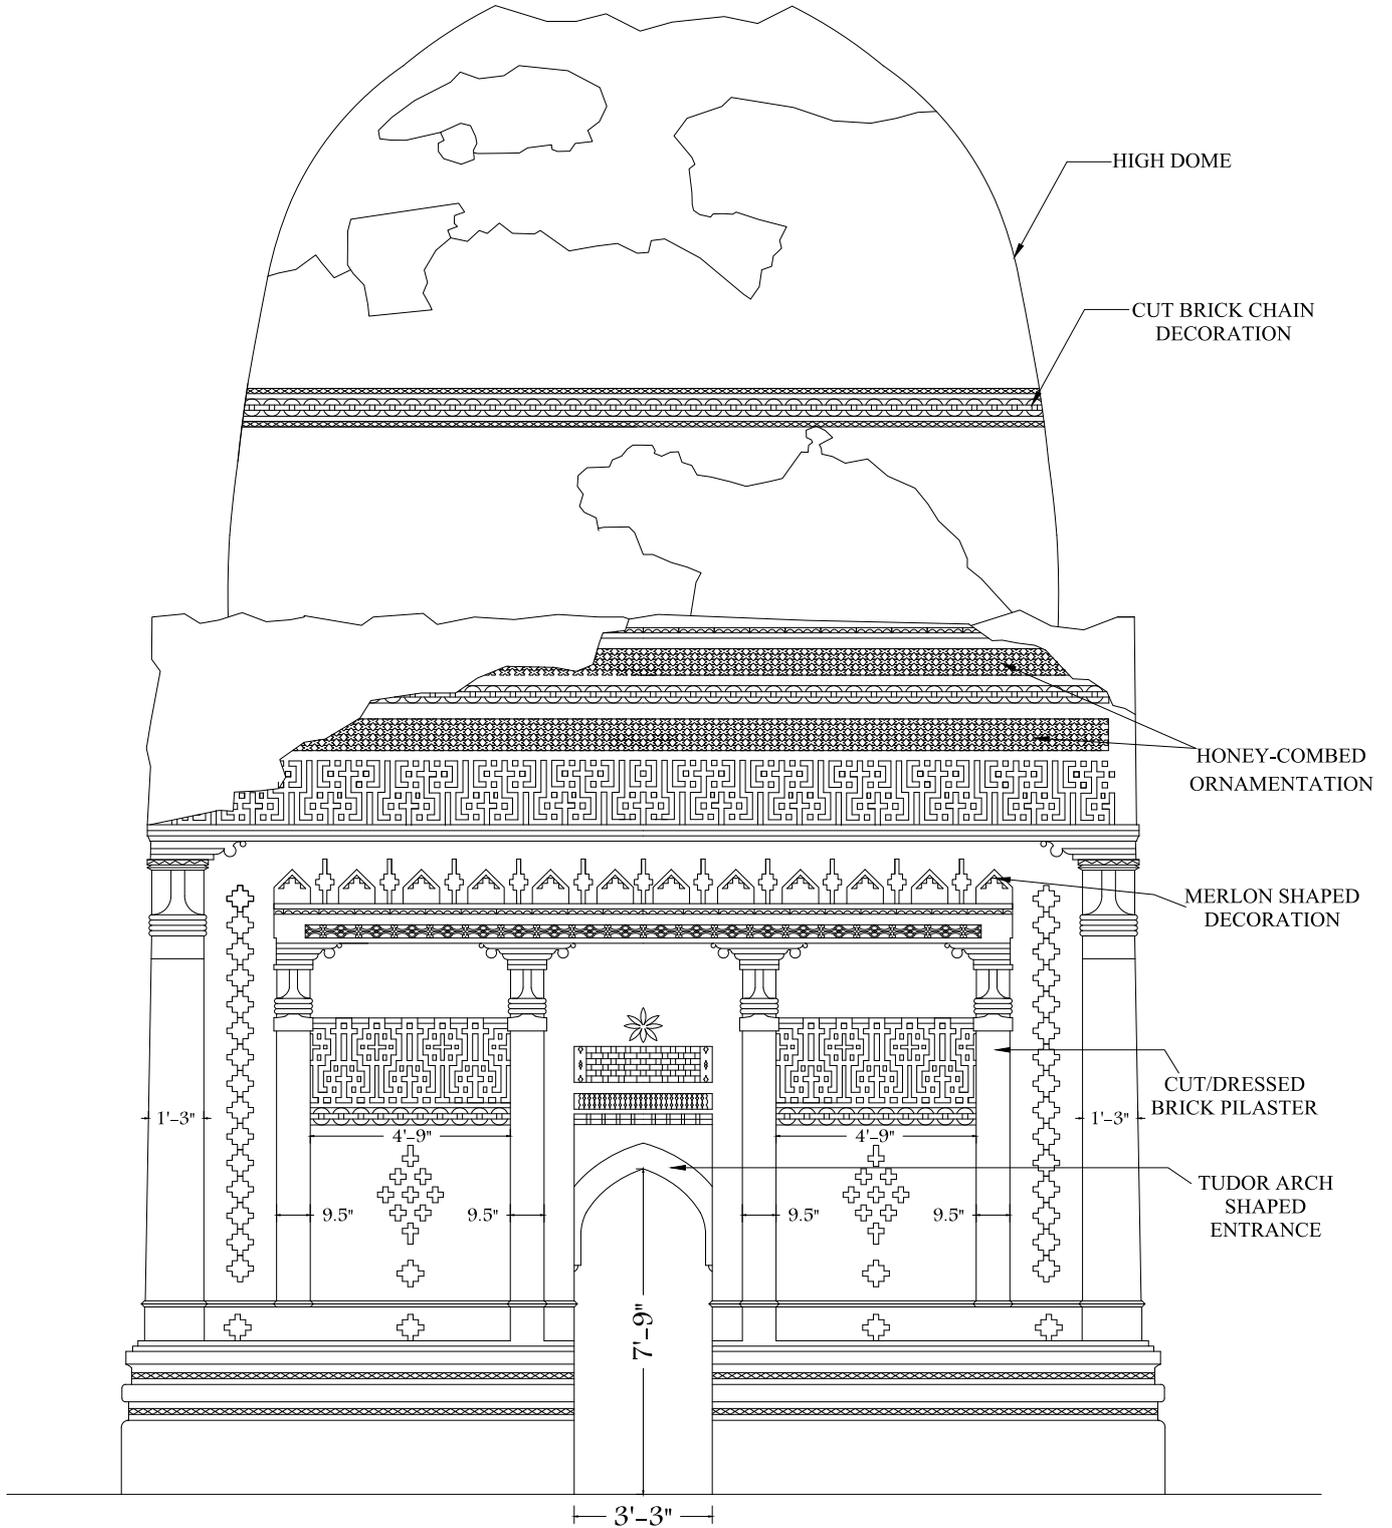
WESTREN SIDE ELEVATION OF DUHAGAN TOMB

- Structure consists of one dome , top of the dome is collapsed open to sky.
- Outer elevation is decorated with 4 pier 9'-3" in height which is formed by engaged cylindrical bricks existing at the right & left side the door & 2 pier are in corners of the structure.
