Project Completion Report

ADAM KHAN MARI TOMB

September 2019

Endowment Fund Trust for Preservation
of the Heritage of Sindh
Center for Documentation and Conservation
of the Heritage of Sindh

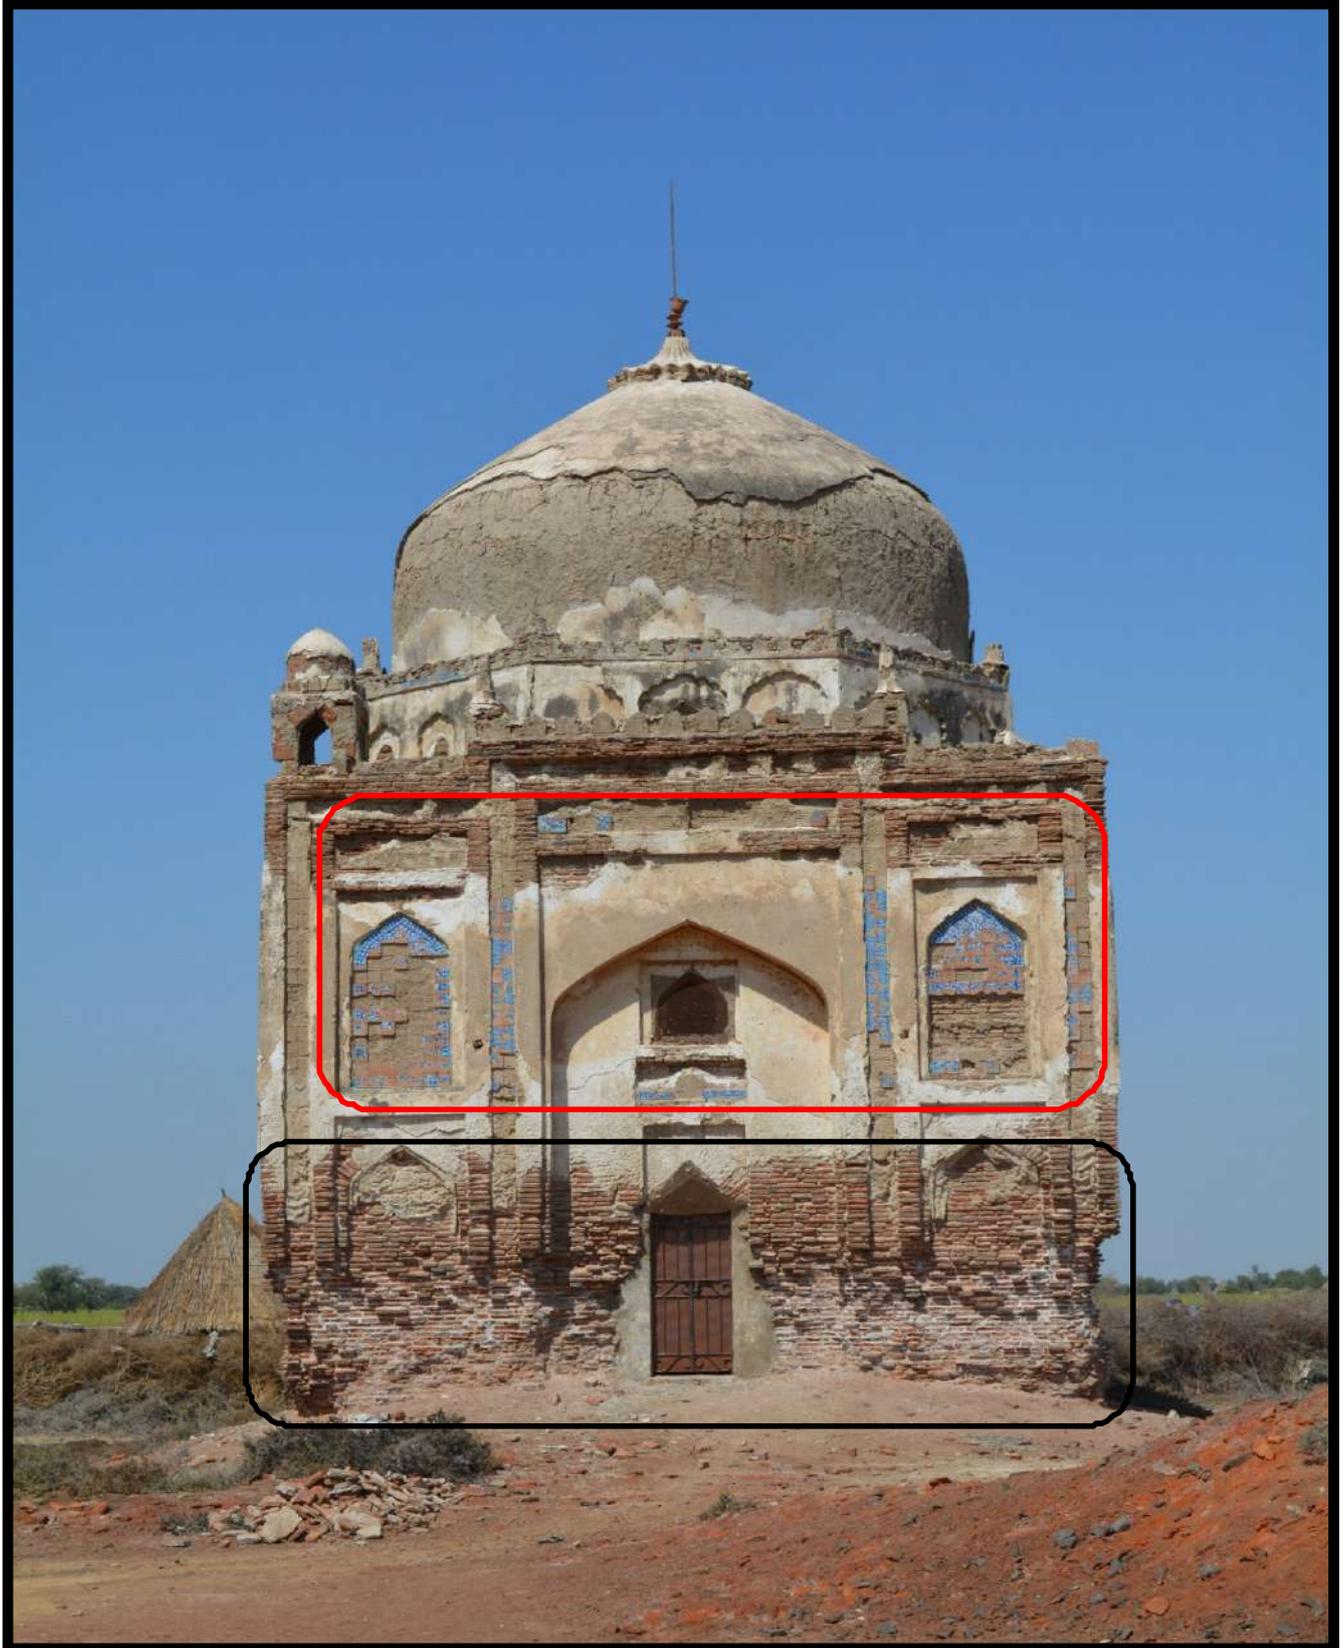
Deteriorated lower part and efflorescence is visible. Kashi tiles are in damaged condition

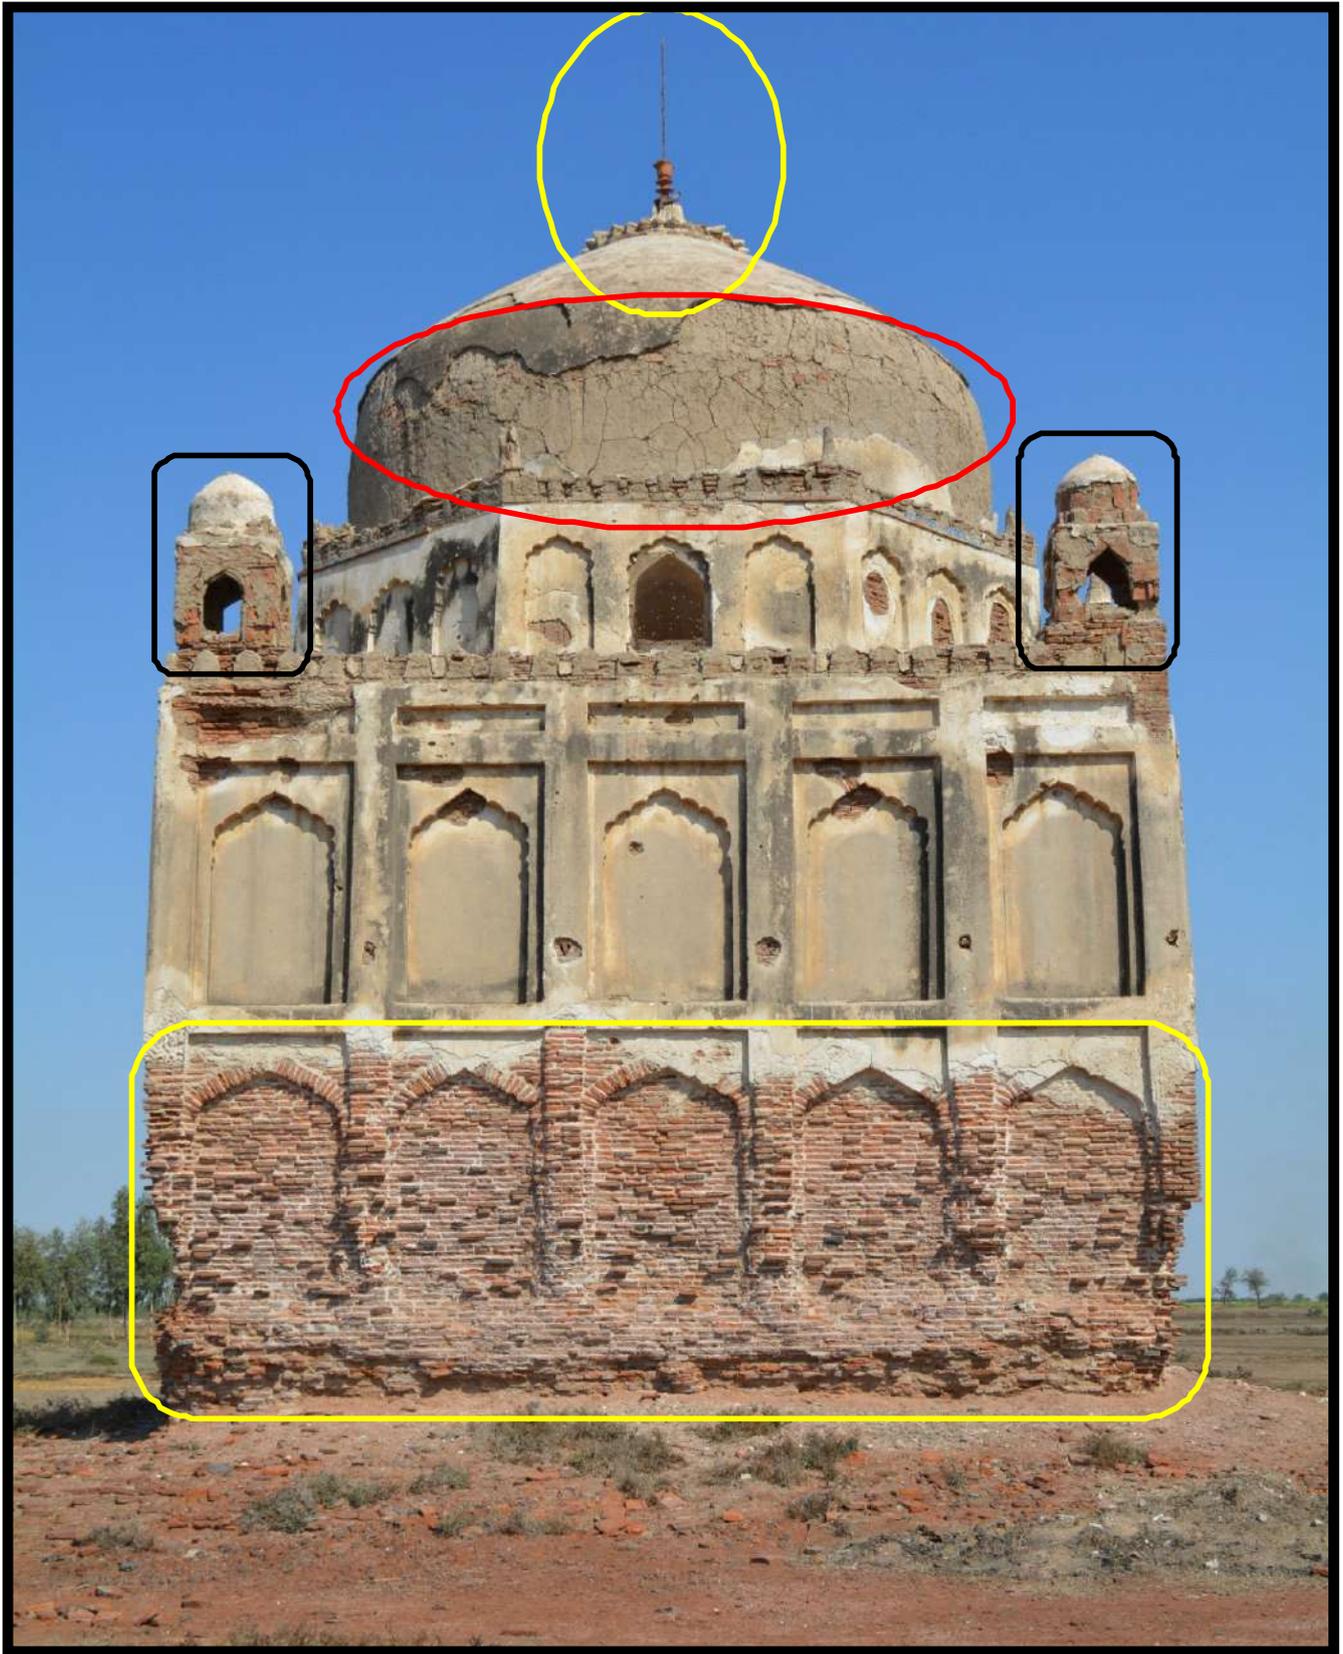
Damaged lower part, kiosks, lime plaster and finial

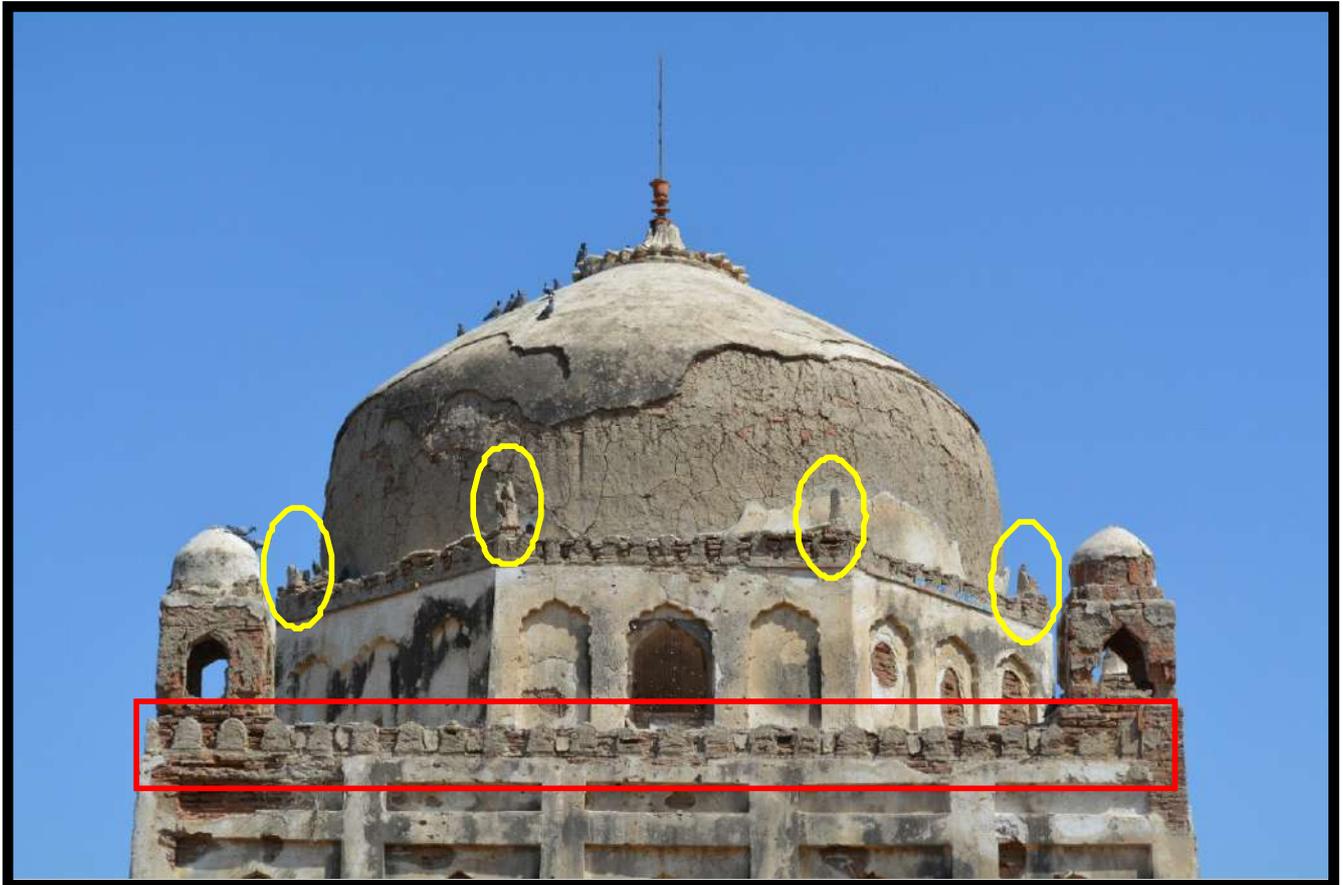
Parapet wall & turrets are in vulnerable condition

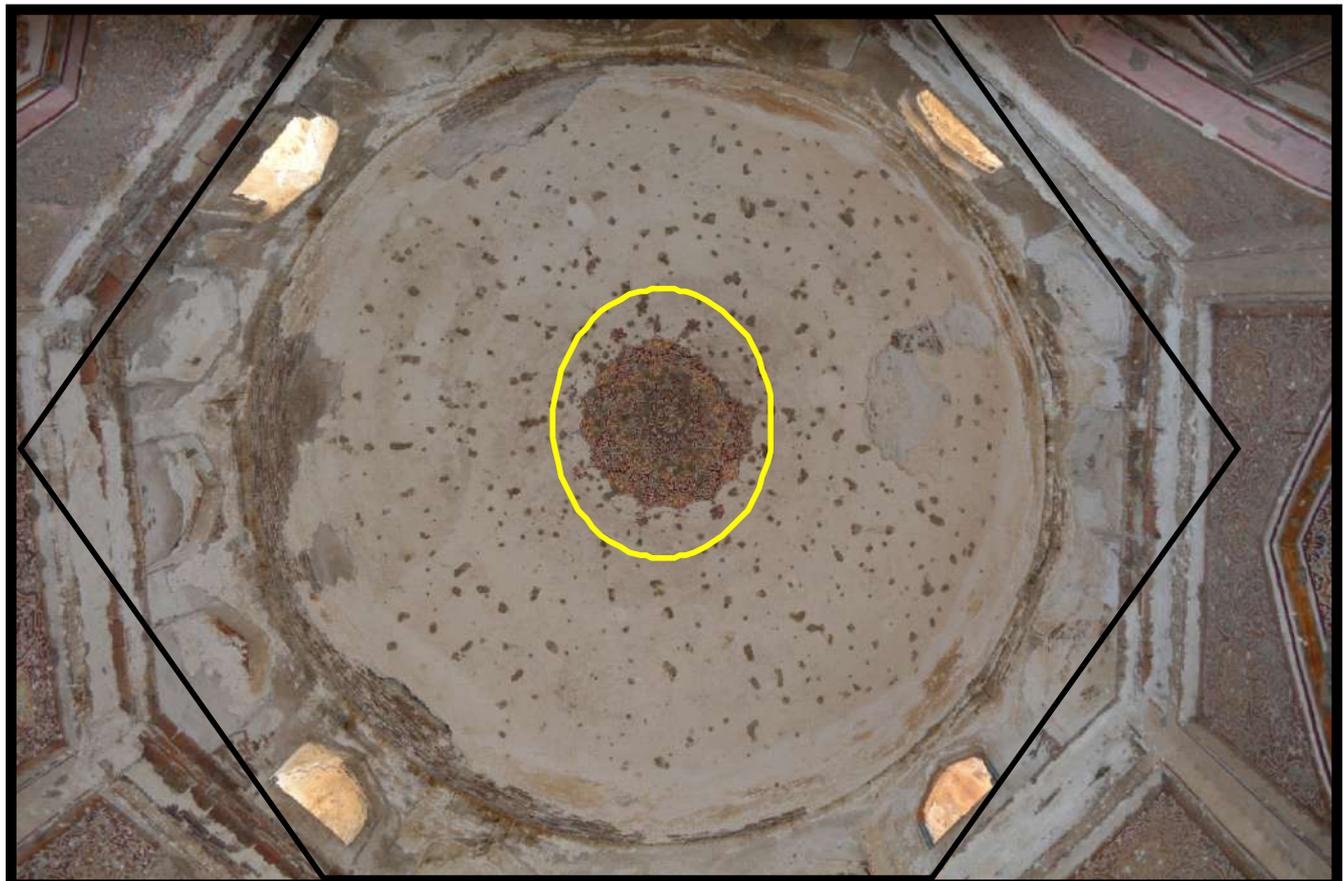
Eroded lime and faded fresco from interior drum & dome

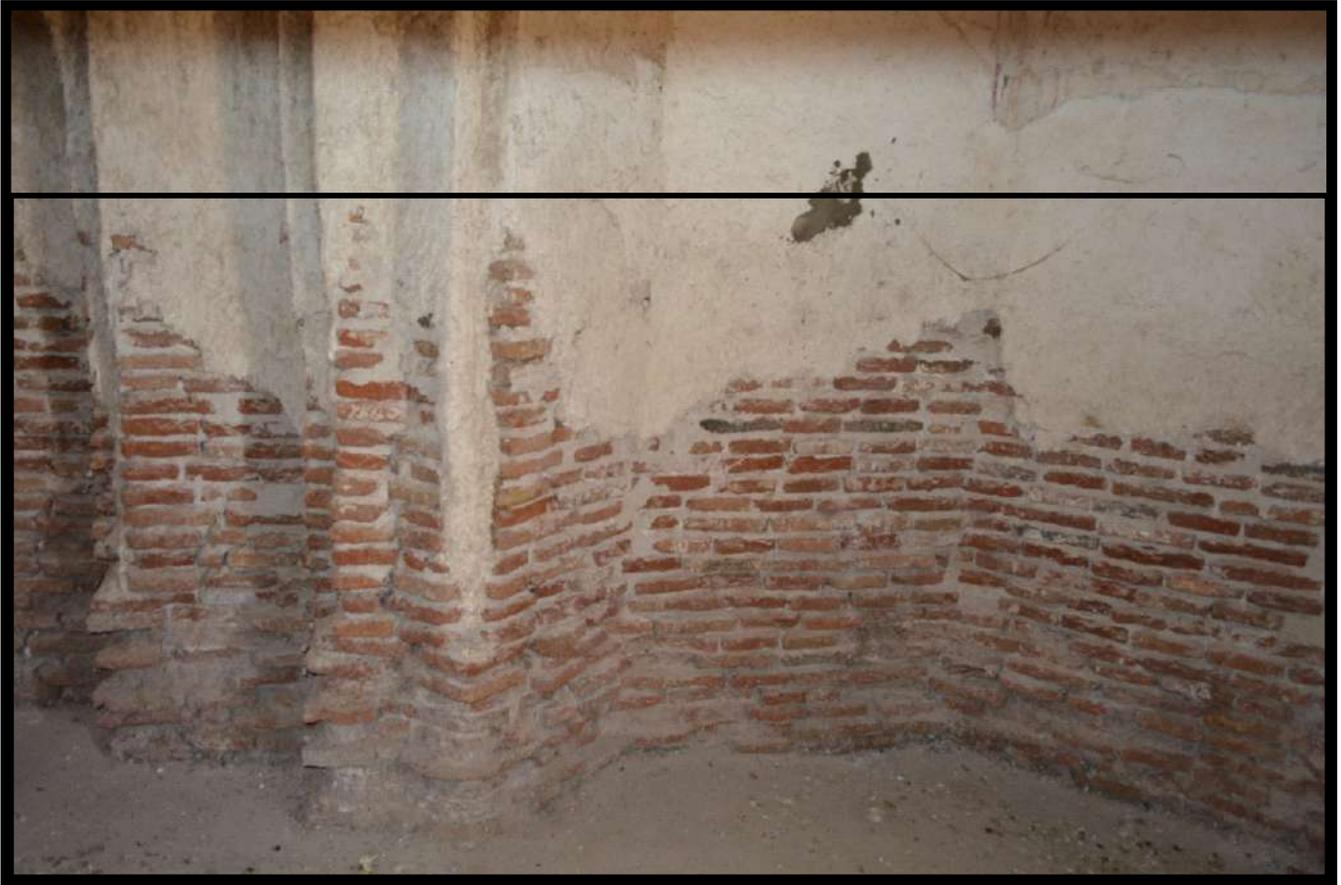
Damaged base of the walls (interior)

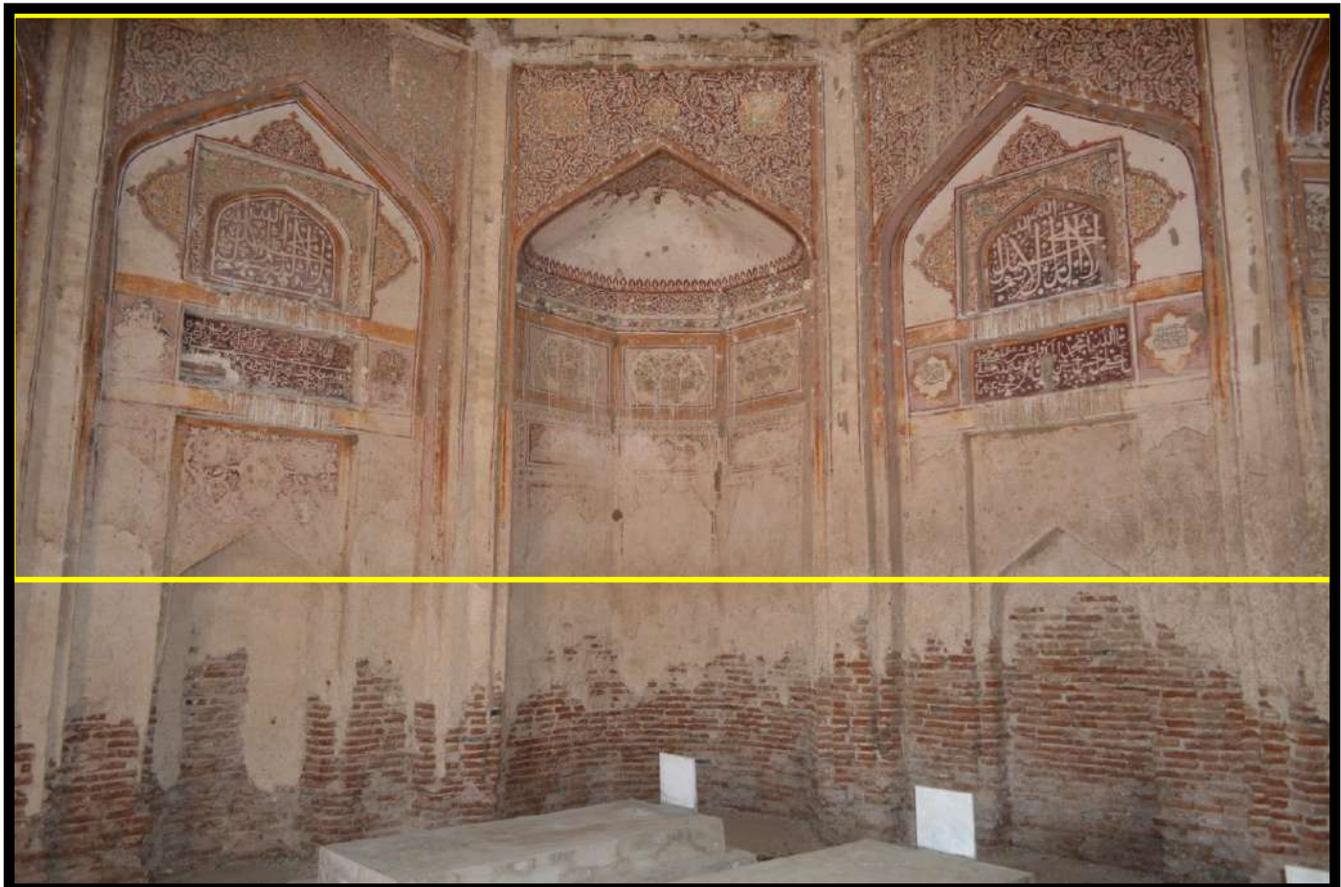
Faded interior fresco

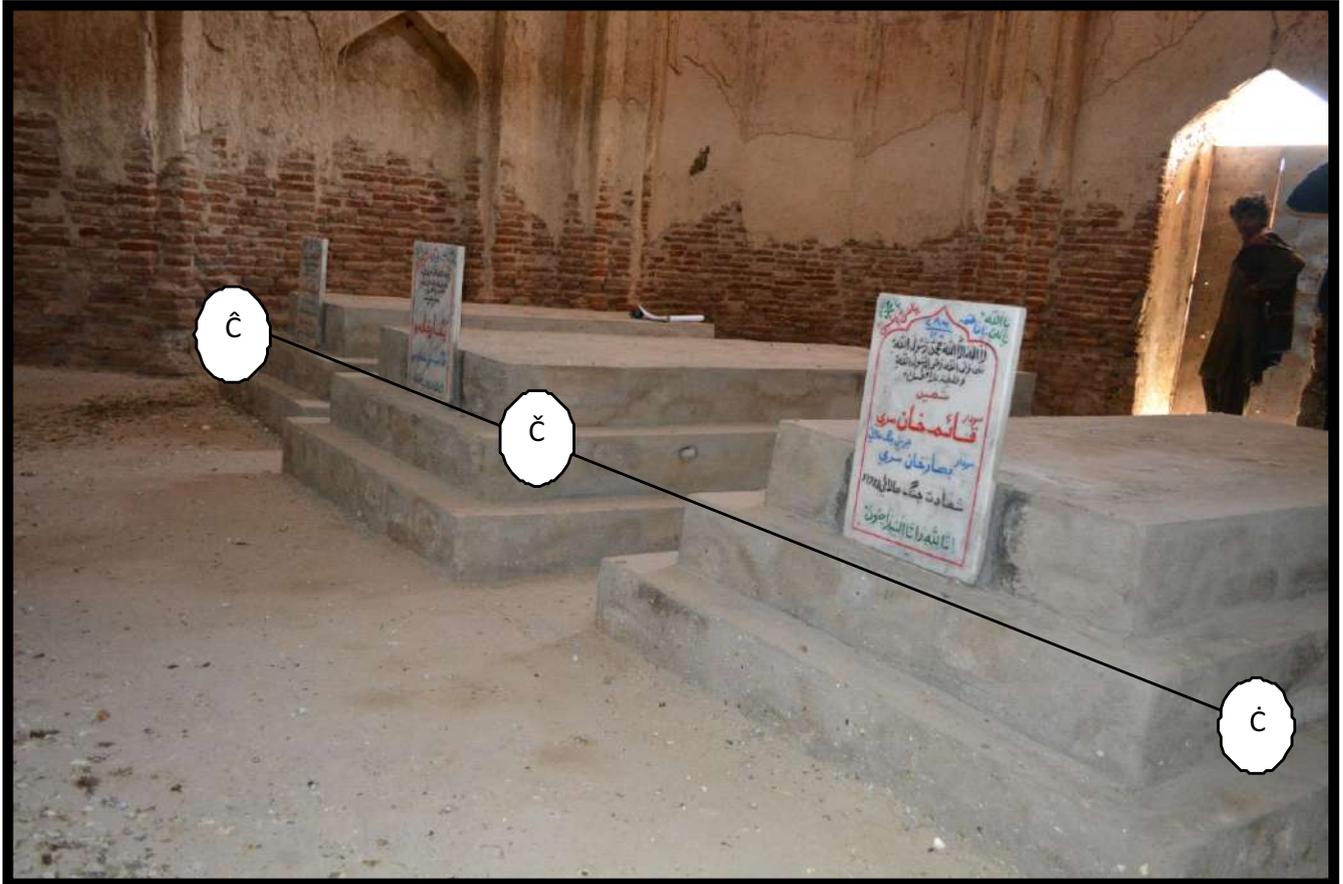
Three cemented graves inside the structure
