PROJECT COMPLETION REPORT DOOLEH DARYAH KHAN OTAAQ

May, 2021

ENDOWMENT FUND TRUST
FOR PRESERVATION OF THE HERITAGE OF SINDH

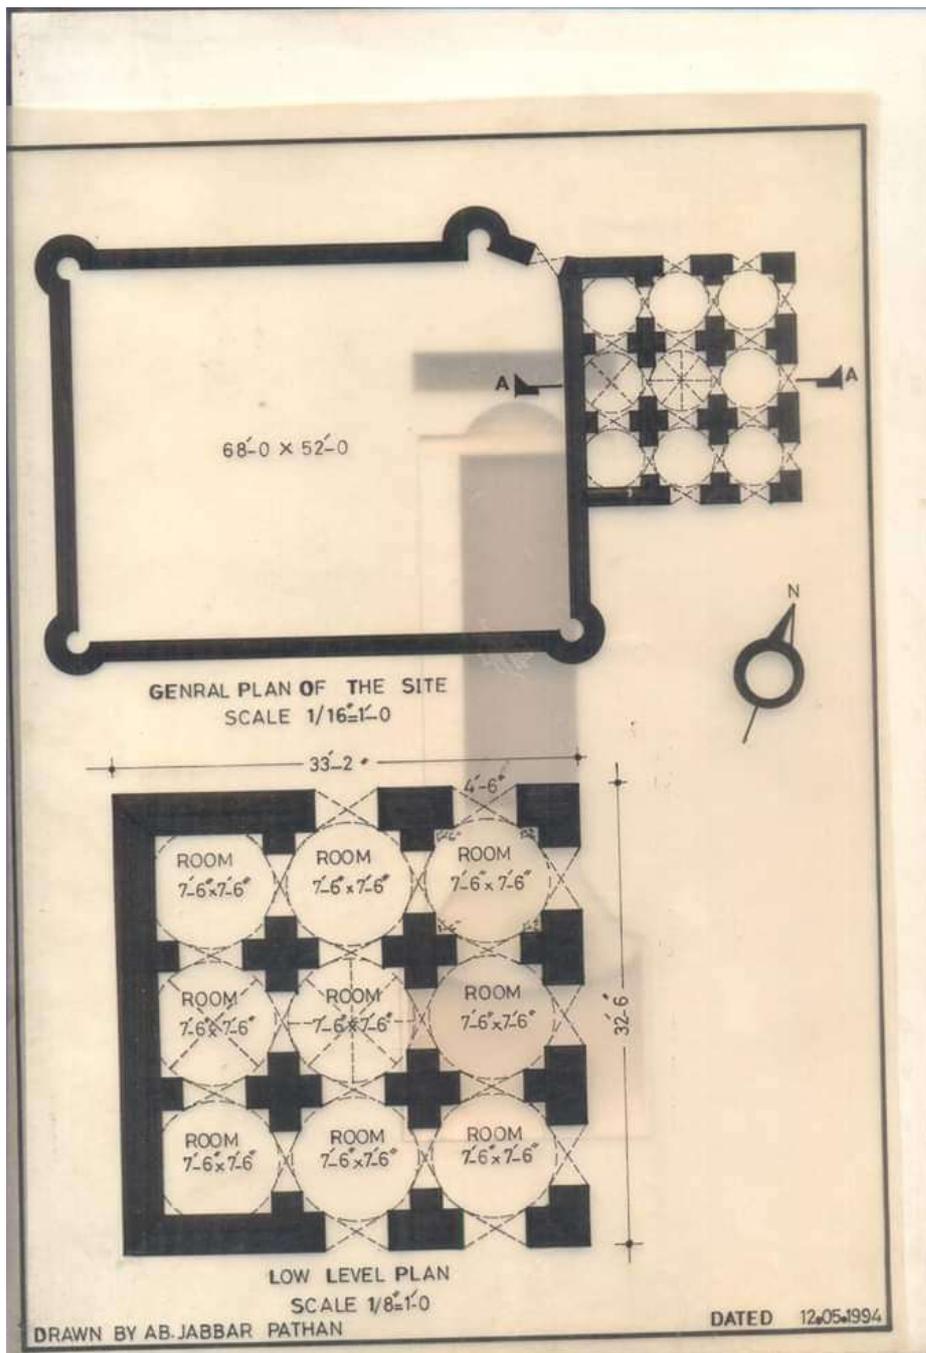
Old map of the Otaaq and Fort (Courtesy of Syed Hakim Ali Shah)

These photographs proved helpful in designing the actual plan of the structure. Moreover, the photographs also helped in the elevation design so the conservationist would know how the structure used to look.

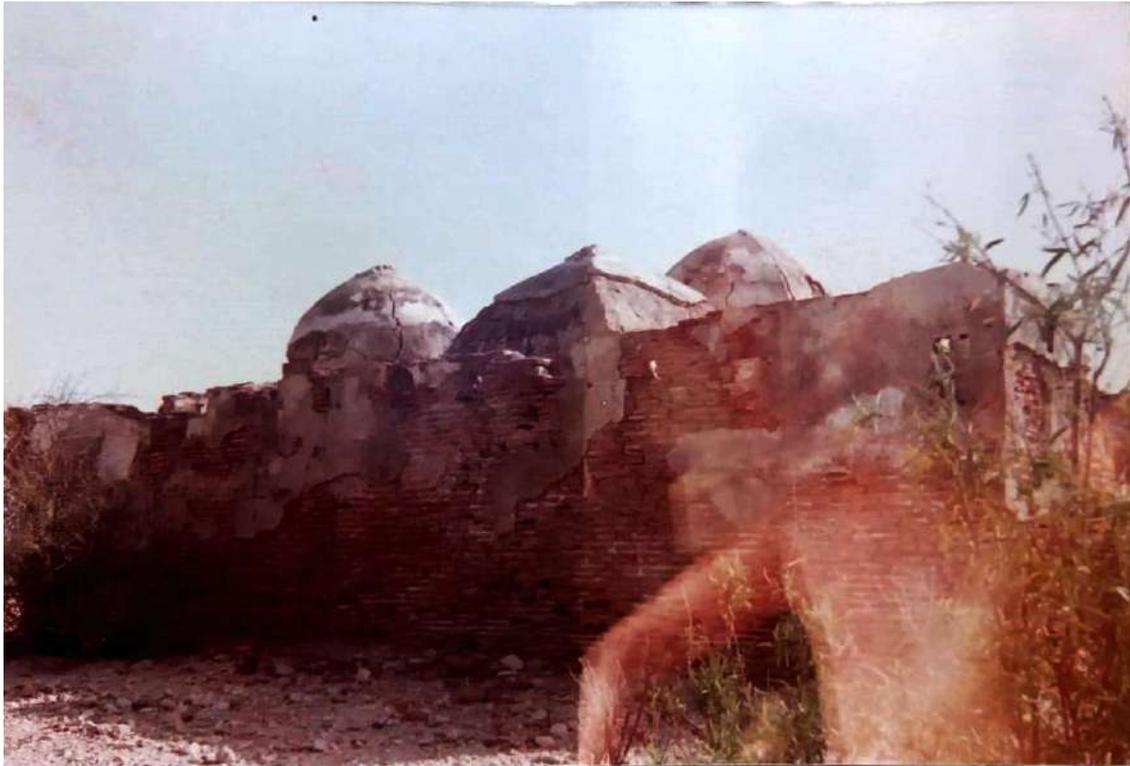
Old Photograph of the Western Side showing the Vaulted Roof (Courtesy of Syed Hakim Ali Shah and Mr. Badar Abro)

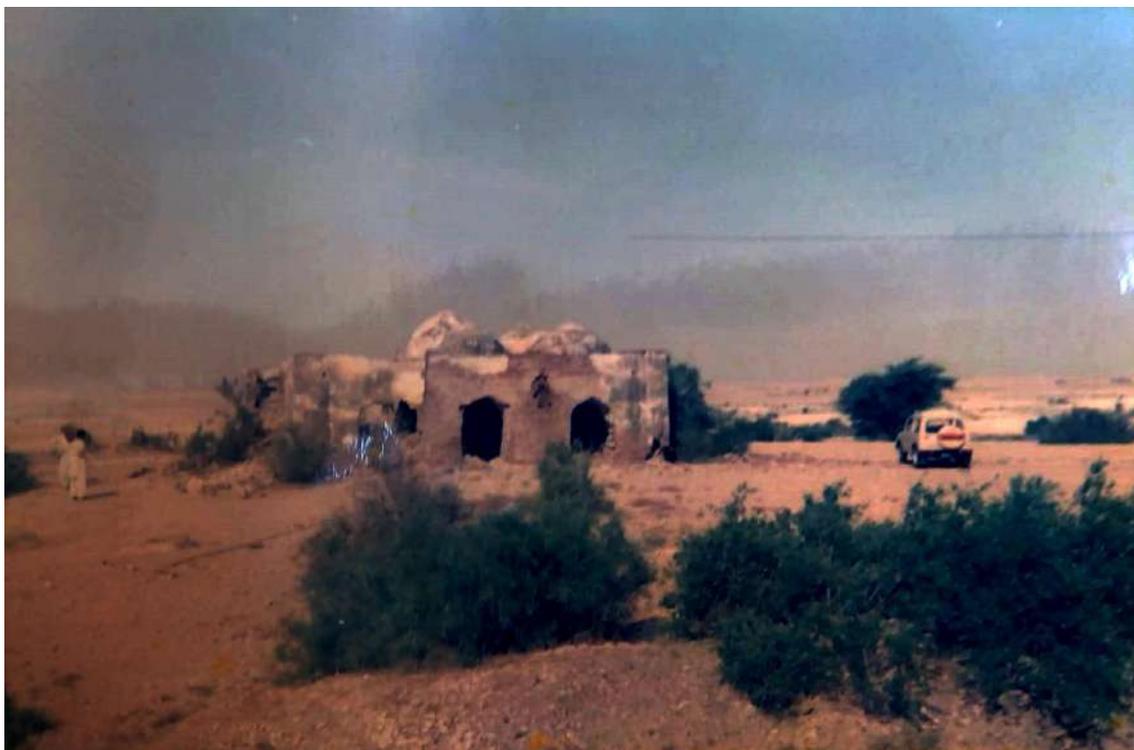
Old photograph of the Southern Side (Courtesy of Syed Hakim Ali Shah and Mr. Badar Abro)

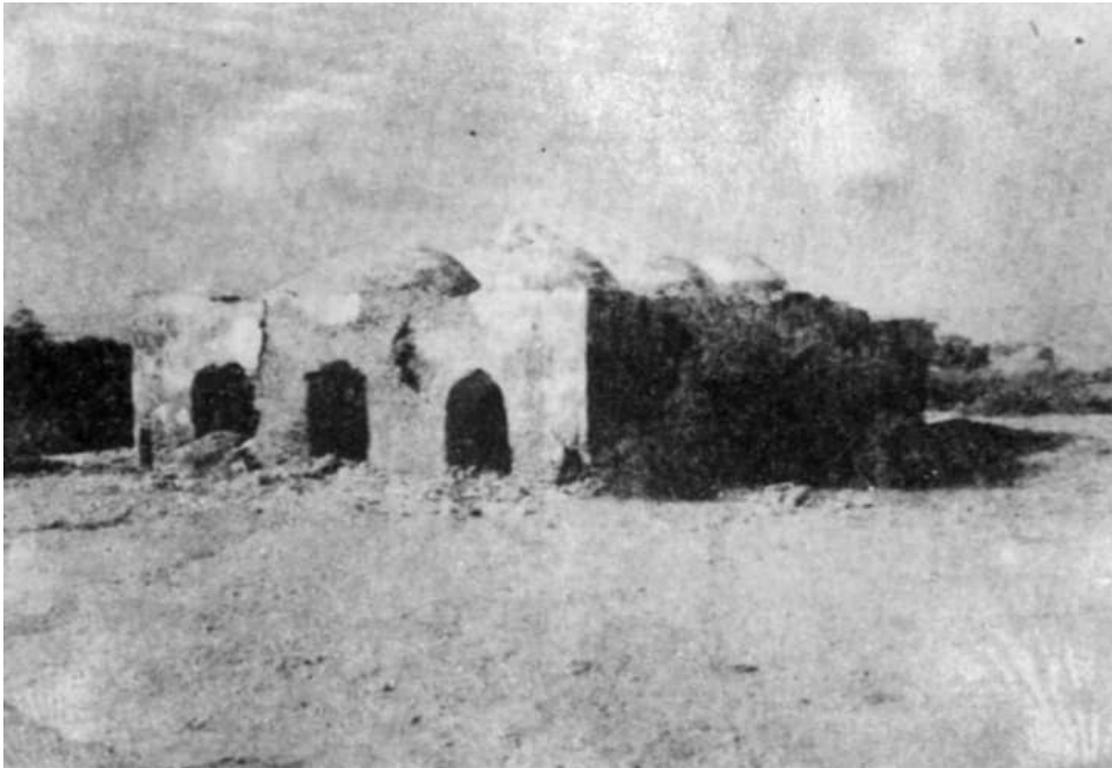
Old Photograph of the Otaaq showing the structure intact (Courtesy of Syed Hakim Ali Shah and Mr. Badar Abro)

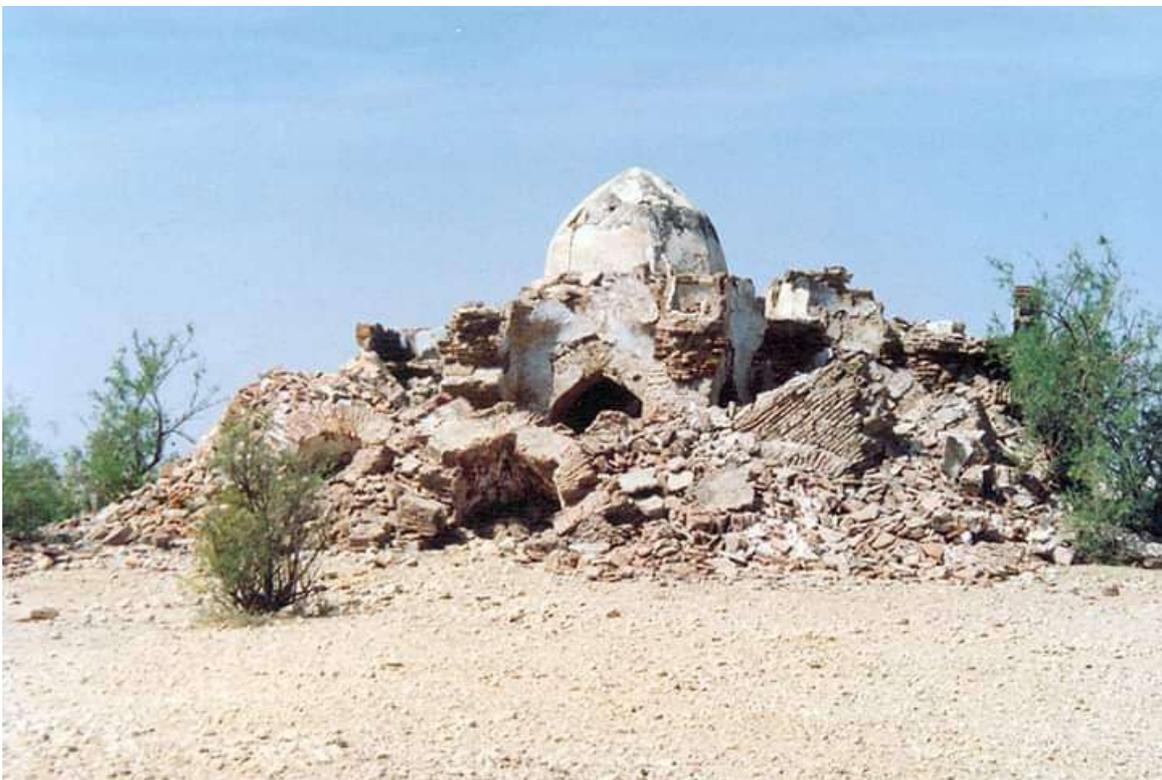
Relatively newer Photograph showing the collapsed structure in 2014

The pictures also suggest the fact that the collapse of the structure came not too long ago. The catalyst was probably heavy rains and flooding.

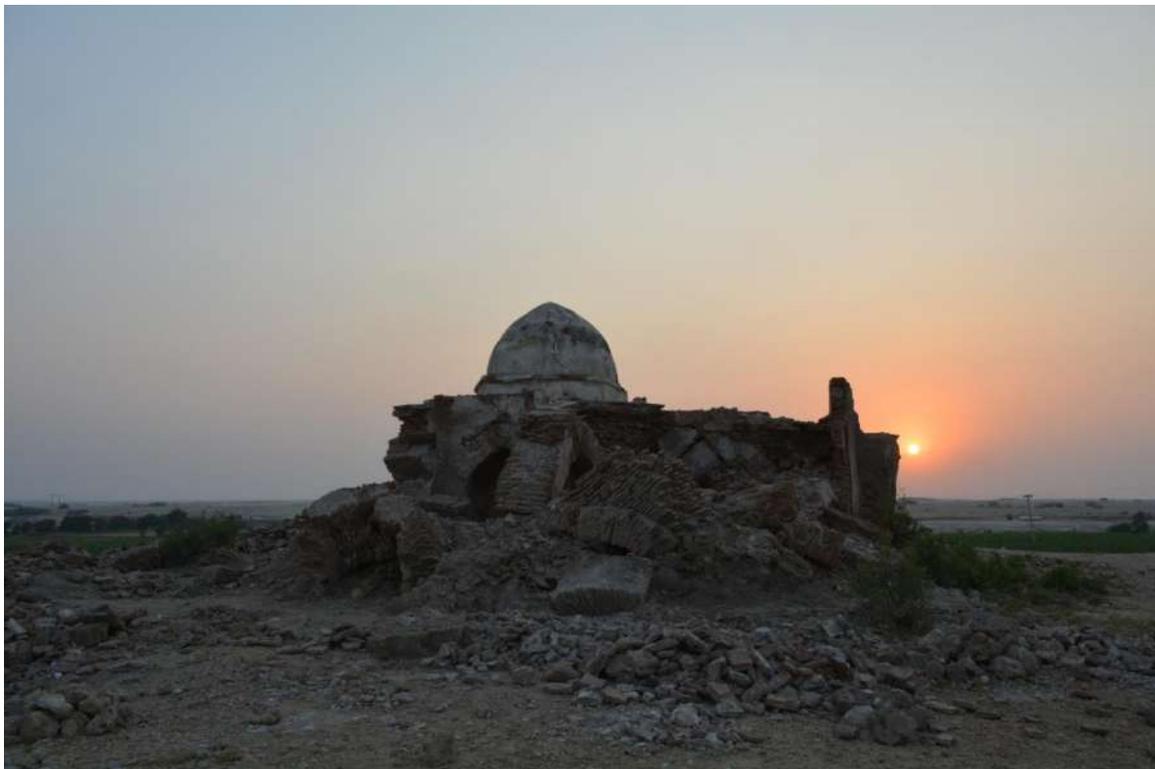
The condition of the structure was found in precarious to say the least. Almost all of it had collapsed and it was difficult to judge the actual plan of the structure, save for the centerpiece. The central dome had managed to weather years of monsoon, high winds and neglect appearing to be barely hanging by a thread. The site was littered by huge amounts of rubble. The arches gave way a long time ago. All walls, except the Western wall had collapsed. No subsidiary domes had survived. The rubble had to be cleared to see the clearer picture of the site and only then measurements could be made.

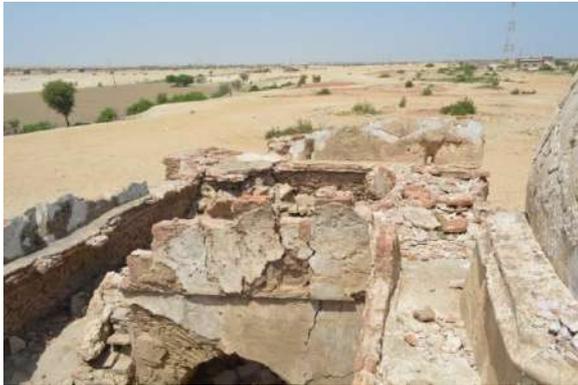
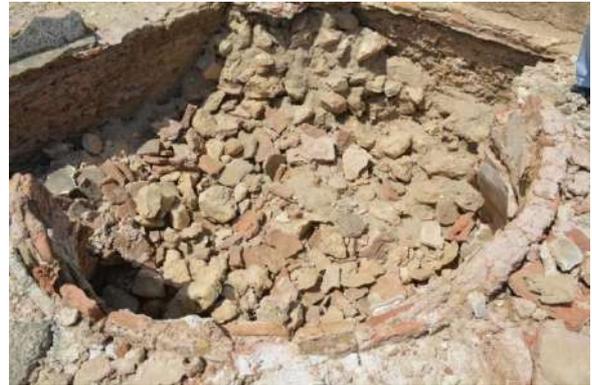
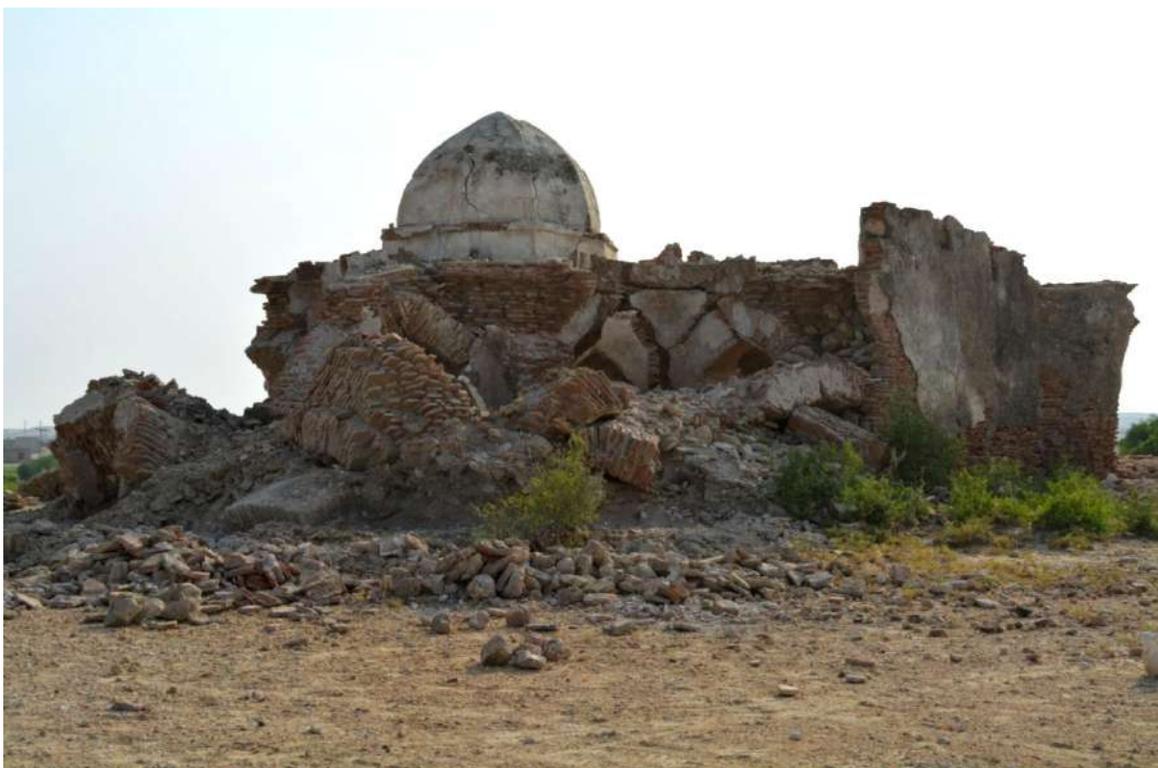
Report Late October ²⁰¹⁹

- Dooleh Daryah Khan Site visited to start the operation.
- It was in a dilapidated condition.
- Debris clearing work initiated.

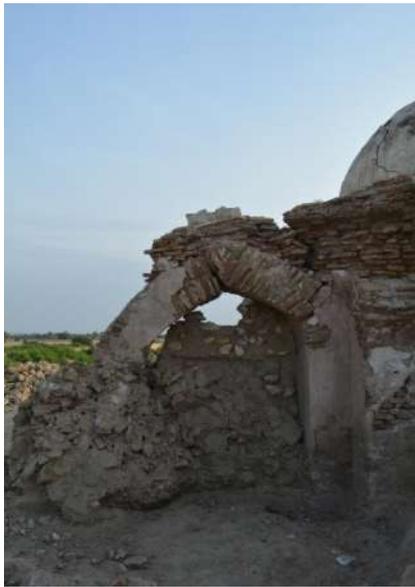
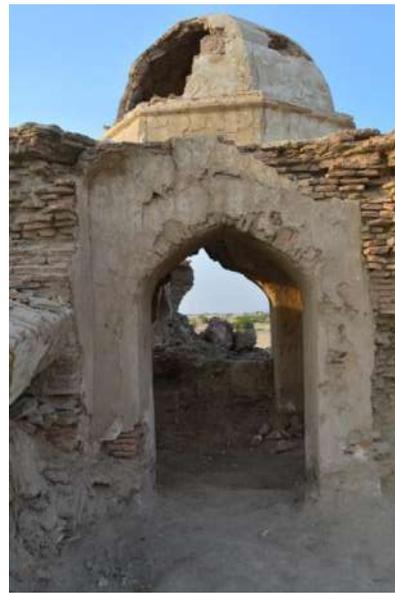
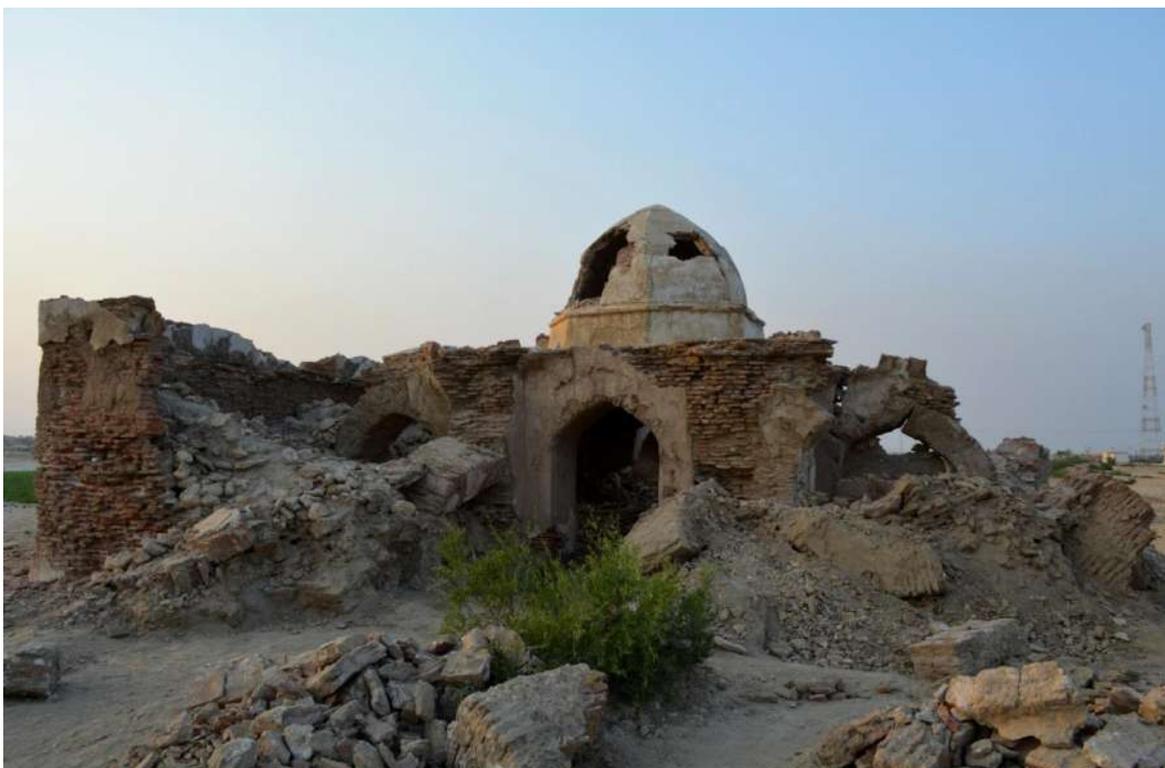
Report November 2019

- Some of the debris had been cleared showing the parts of structure that were still extant.
- Architectural plans and maps made.

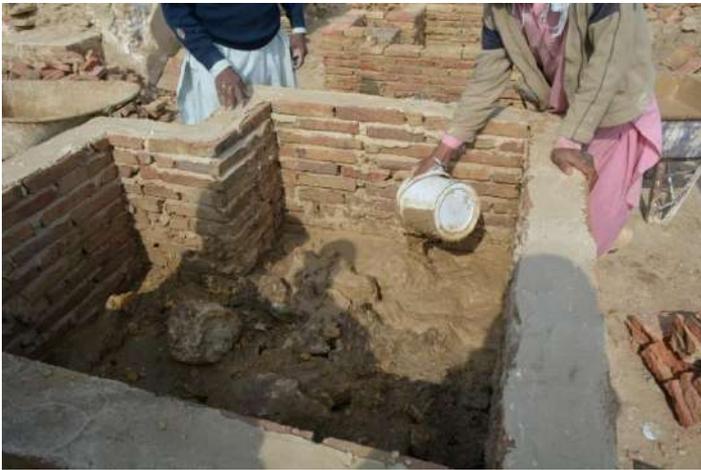
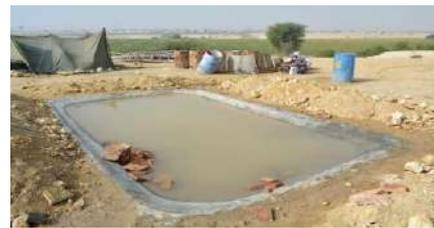
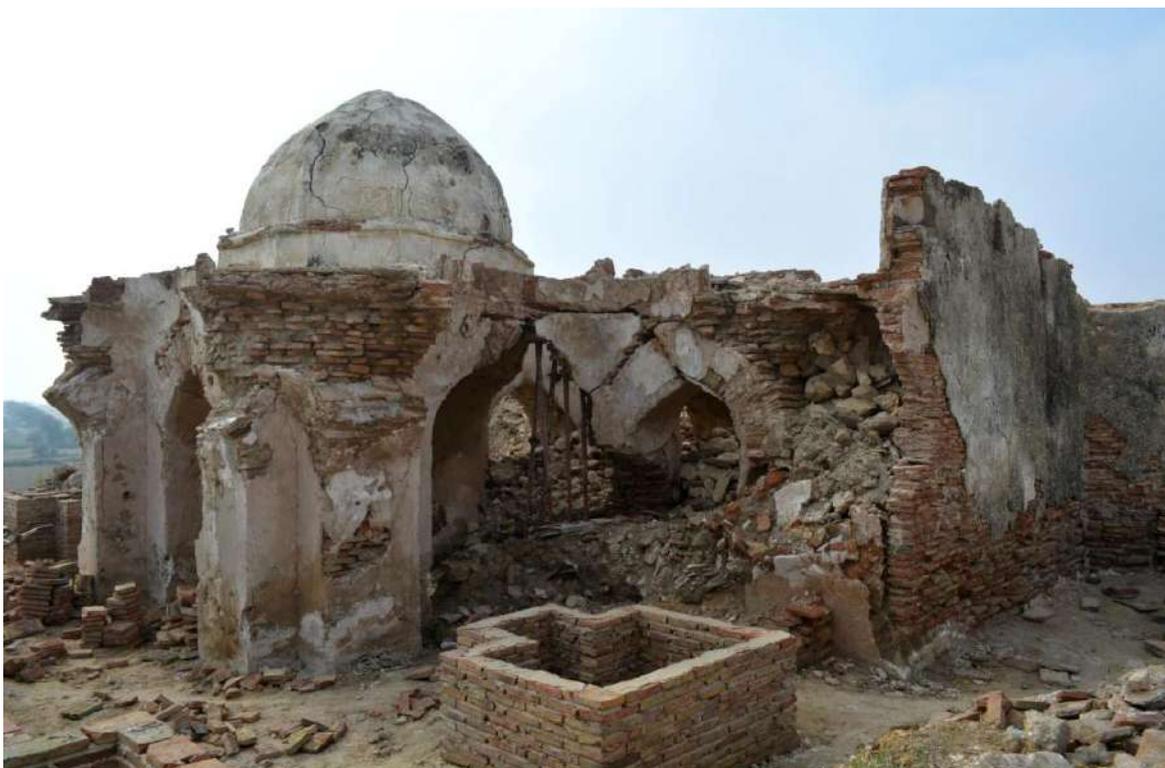
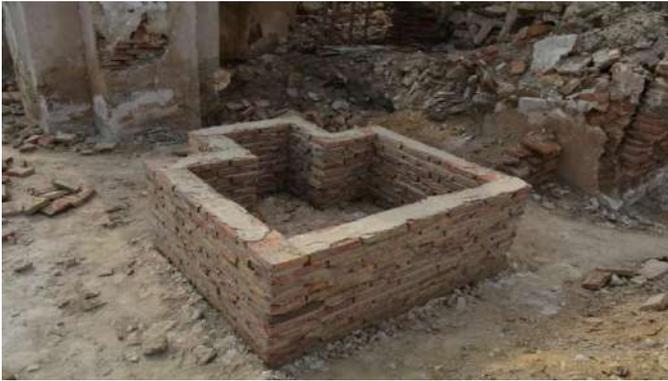
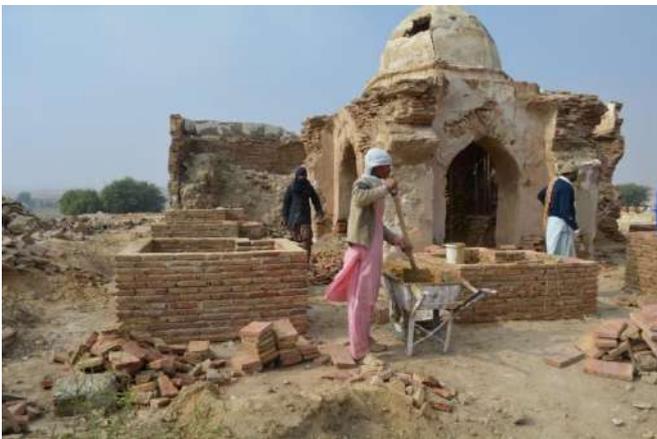
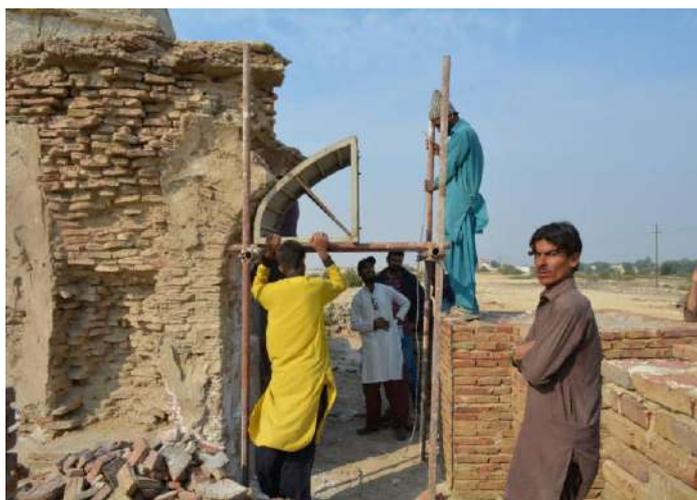
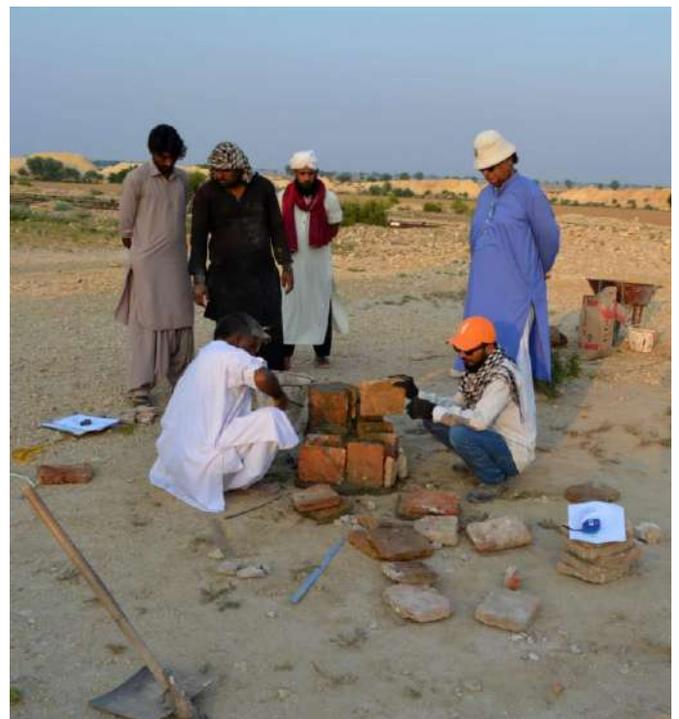
Report December 2019

- Columns unearthed and erected.
- Lime tank excavated.
- Restoration of extant arches started.

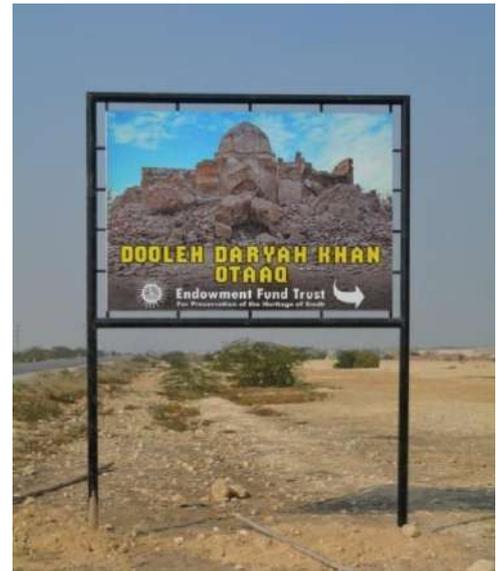
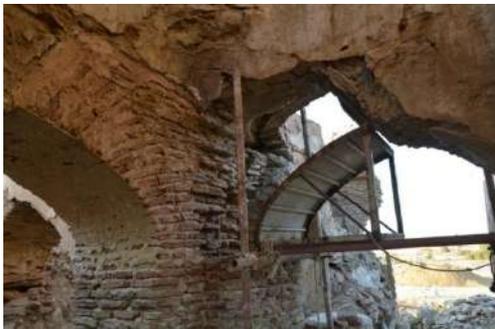
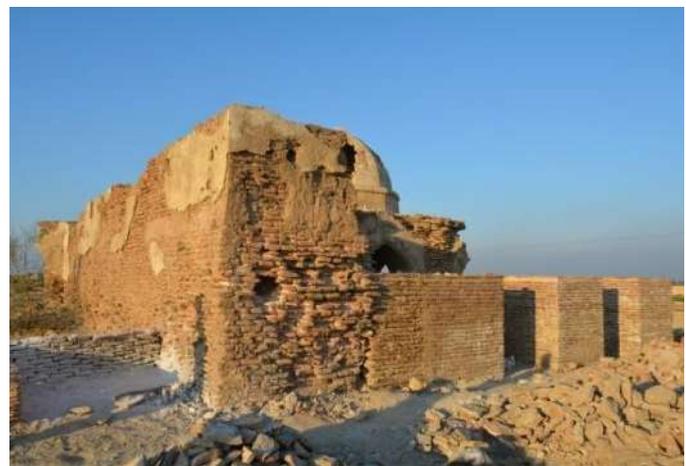
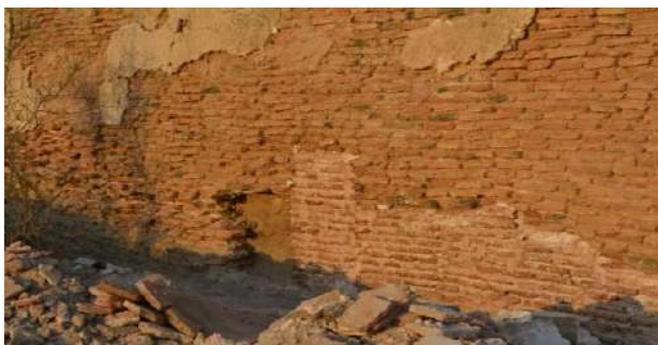
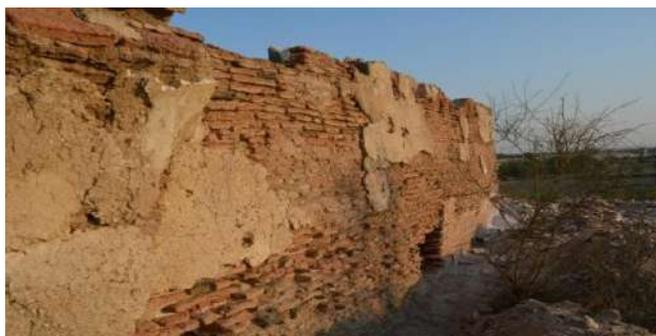
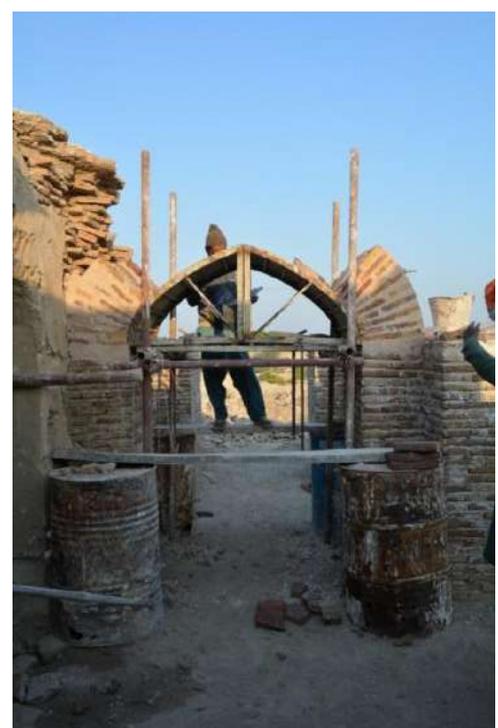
Report January 2020

- Columns raised to the original proposed height.
- Extant arches supported using template and reinforced.
- Dooleh Daryah Khan Otaaq sign board installed.
- Interior Arch-1 work initiated.
- Damages to the central dome fixed.
- Extant Western Otaaq wall restored.

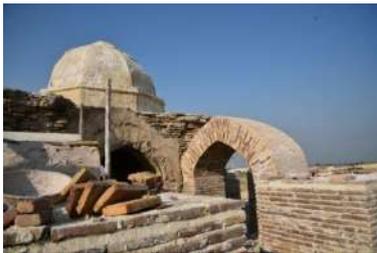
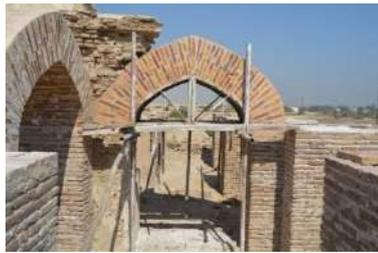
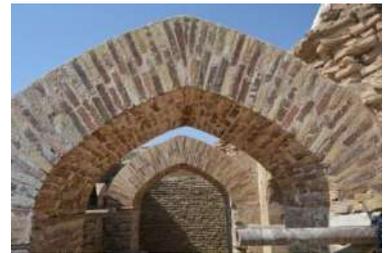
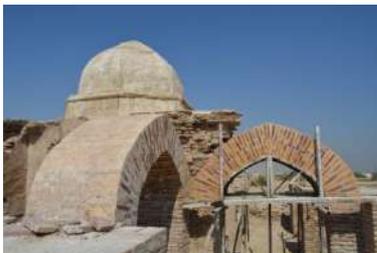
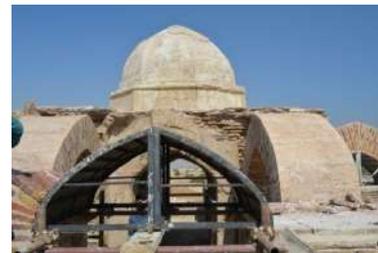
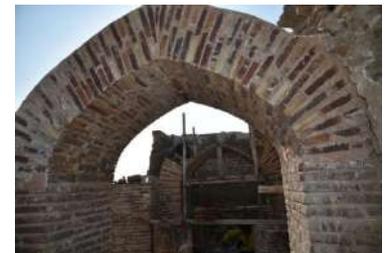
Report February 2020

- Interior Arch-1 completed.
- Interior Arch-2 completed.
- Interior Arch-3 completed.
- Exterior Arch-4 completed.
- Interior Arch-5 completed.
- Exterior Arch-6 completed.
- Interior Arch-7 completed.
- Fort marked.

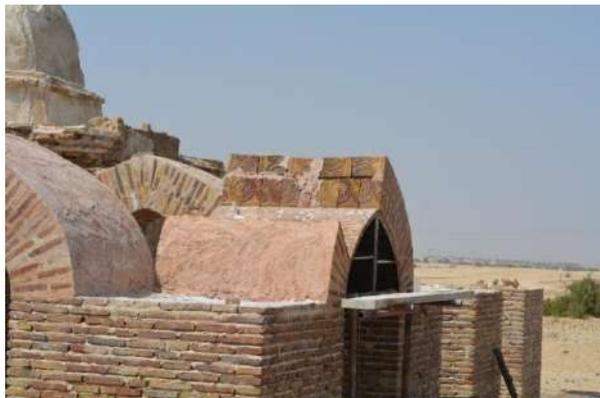
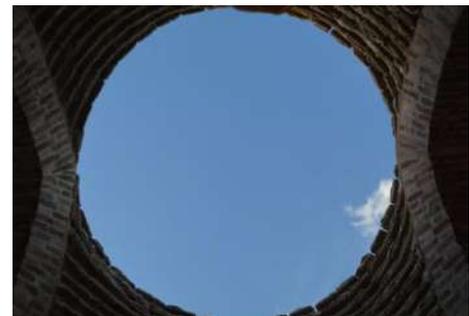
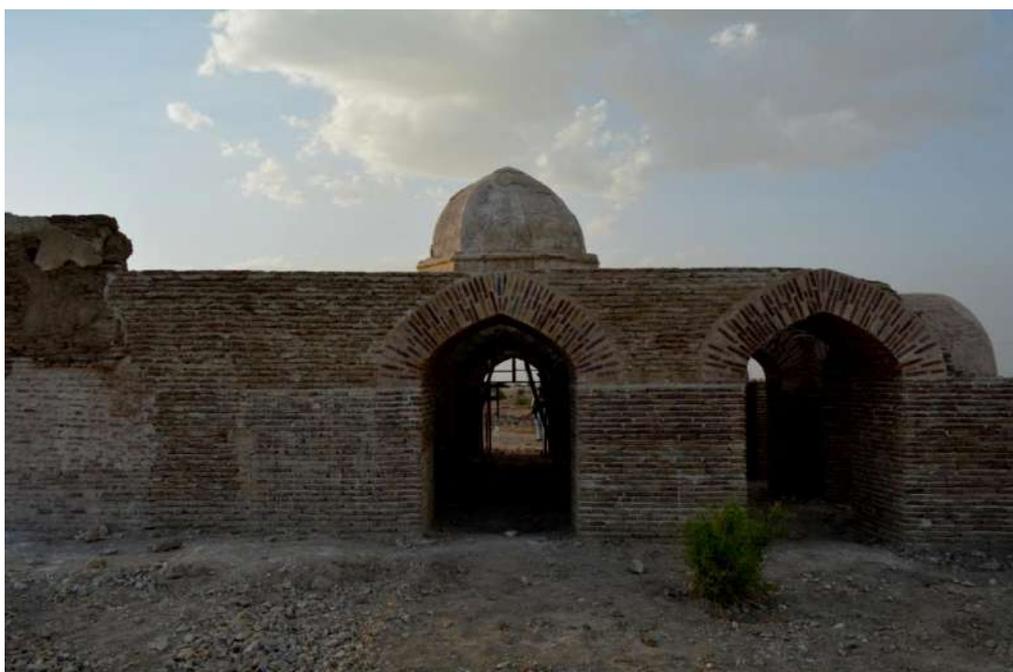
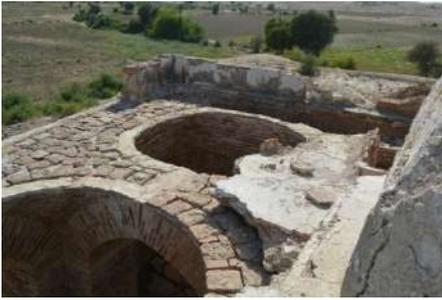
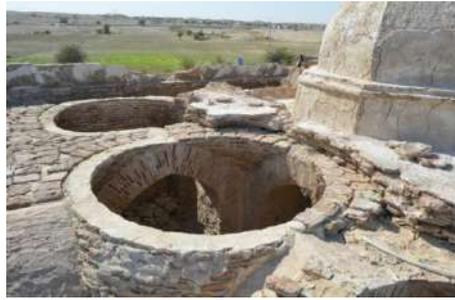
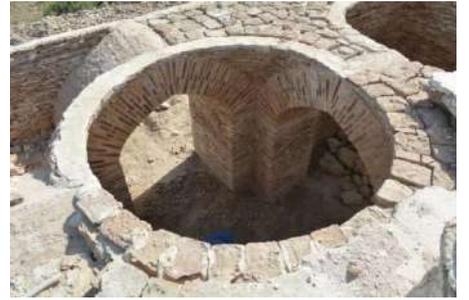
Report March 2020

- Southern Otaaq wall completed.
- Exterior Arch-8 completed.
- Interior Arch-9 completed.
- Exterior Arch-10 completed.
- Exterior Arch-11 completed.
- Exterior Arch-12 completed.
- Exterior Arch-13 completed.
- Eastern Otaaq wall completed.
- Northern Otaaq wall completed.

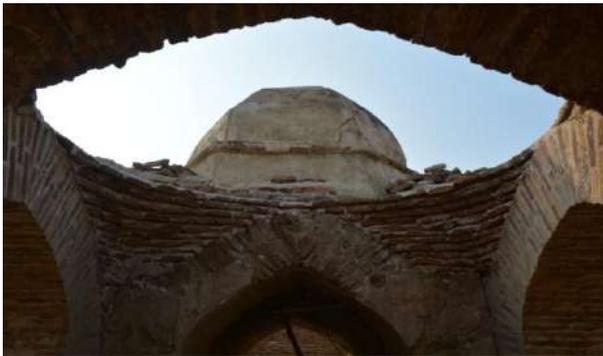
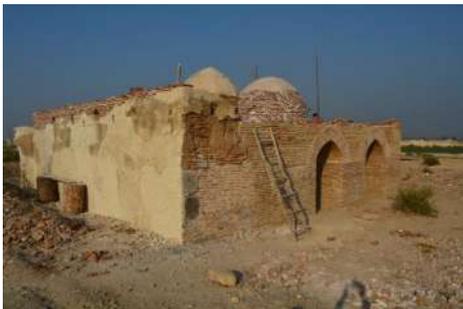
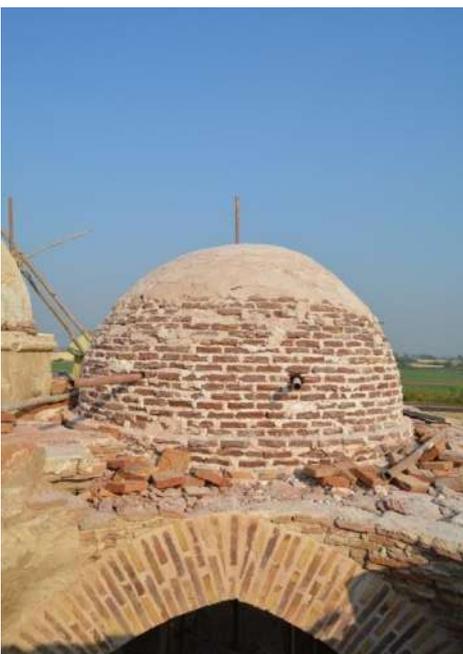
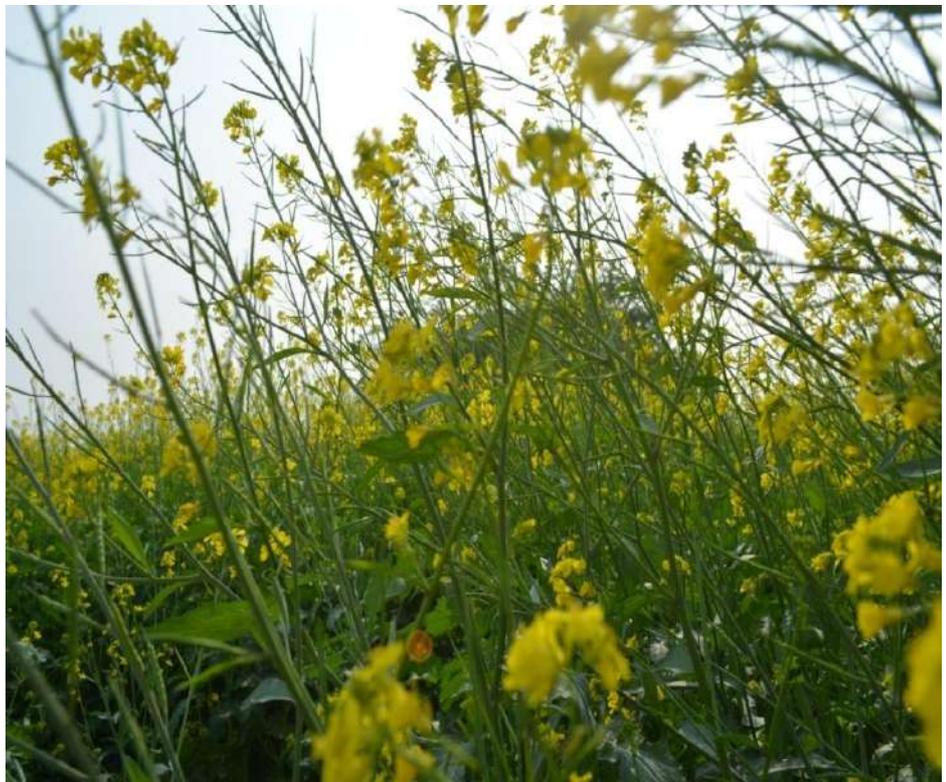
Report Late December 2020

- Dome-A completed.
- Roof restoration started.
- Parapet wall raised.
- All fields around the site are blooming with lush green crops and yellow flowers of mustard (سرهن).

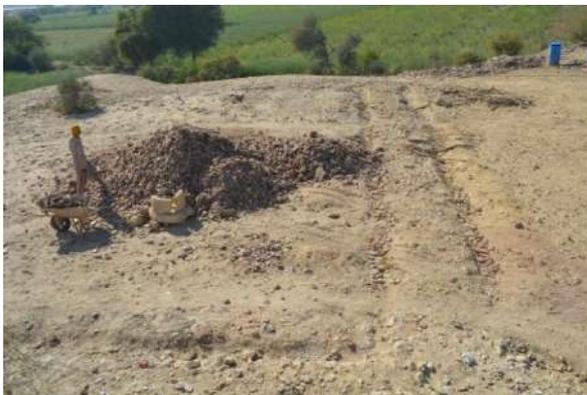
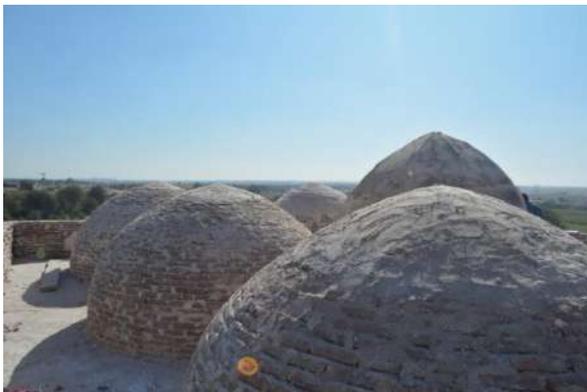
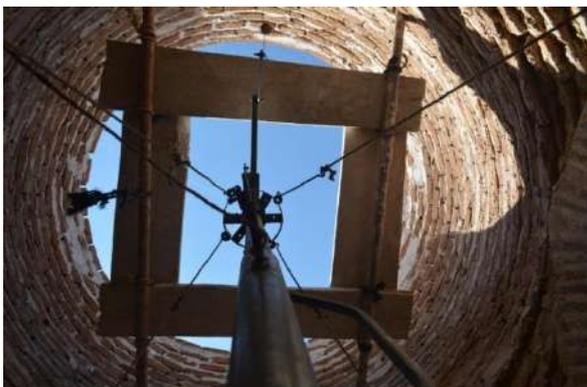
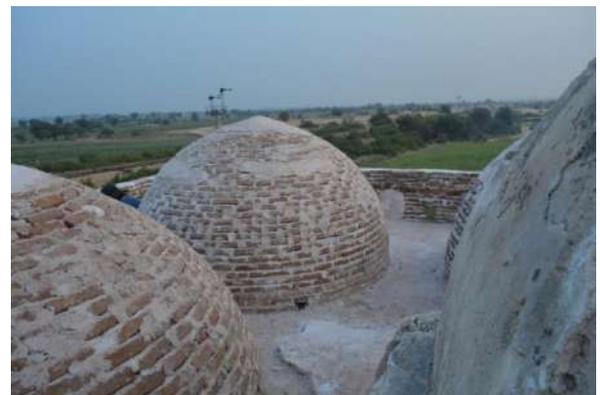
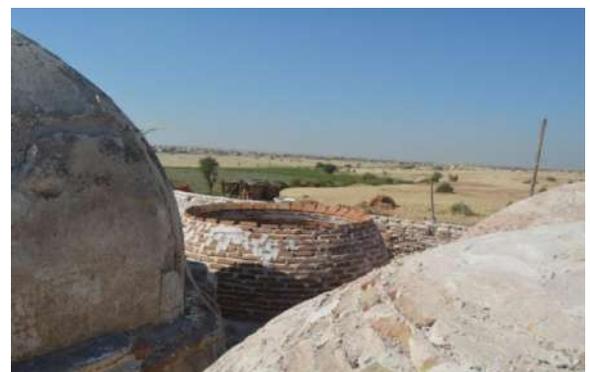
Report January 2021

- All parapets raised.
- Dome-B completed.
- Dome-C completed.
- Dome-D completed.
- Dome-E underway.
- Water supply connected with line from Khasai Village.

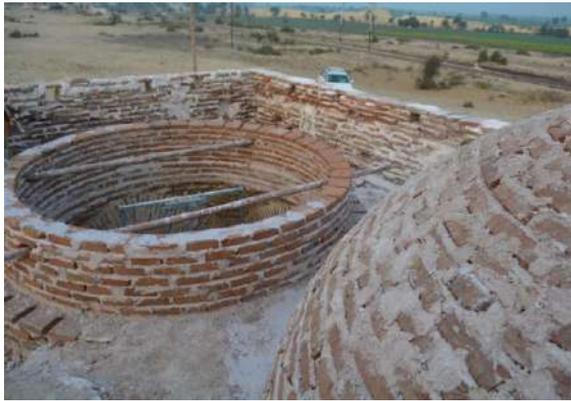
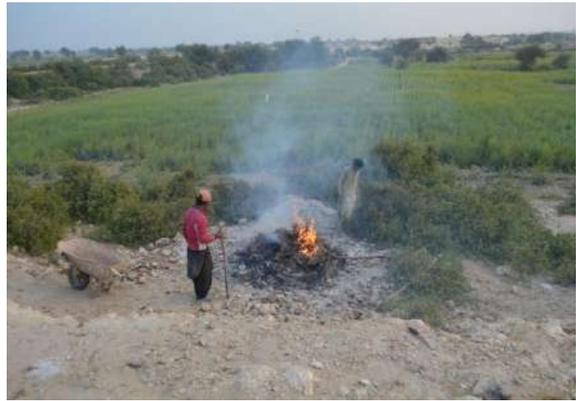
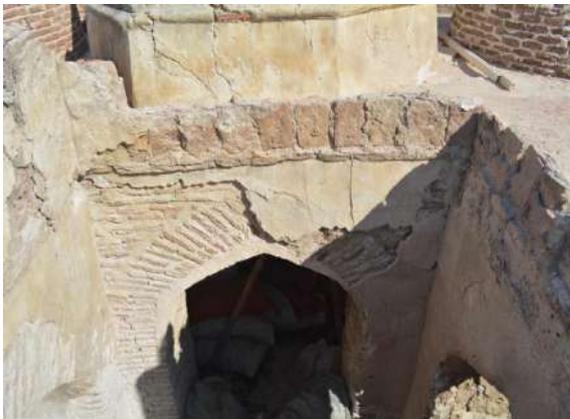
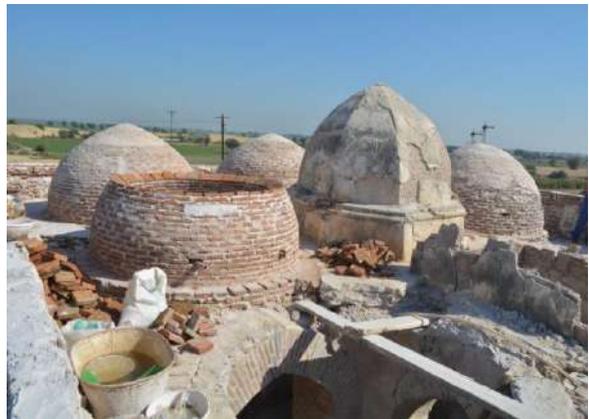
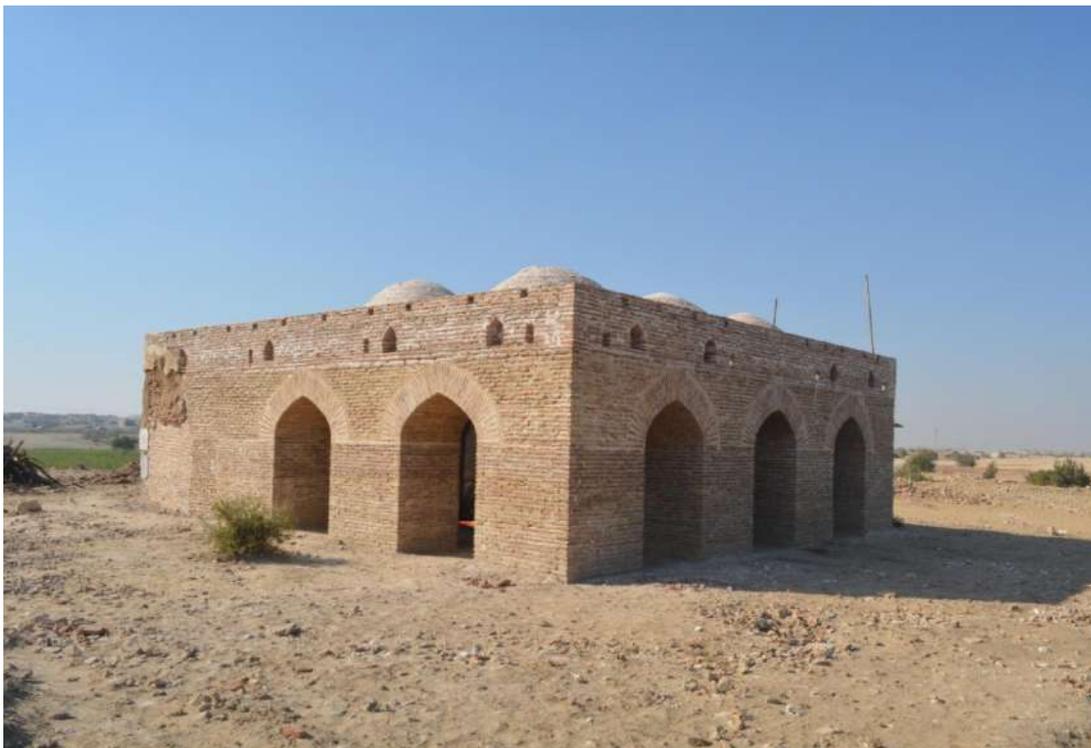
Report February 2021

- Dome-E completed.
- Dome-F completed.
- Dome-H completed.
- Sculpturing of Inverted lotus on domes started.
- Sculptures on Domes A and B completed.

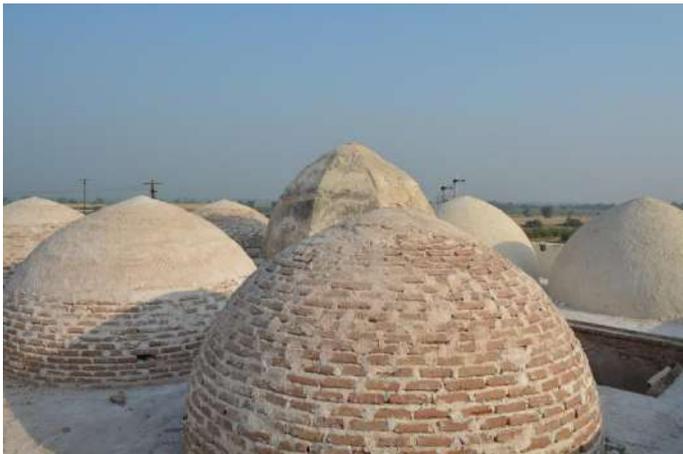
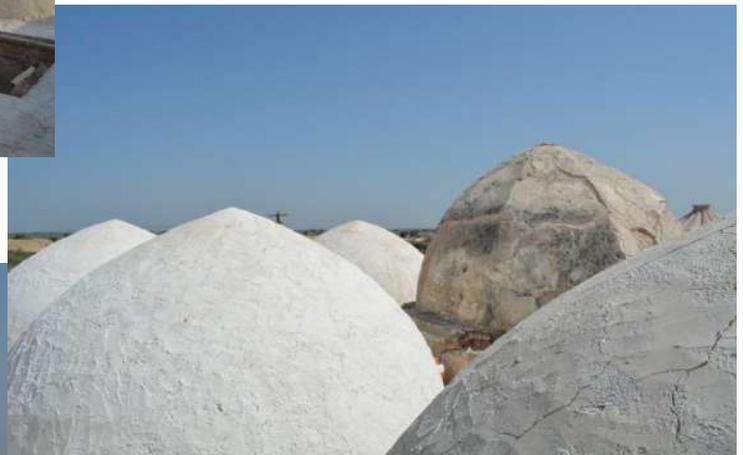
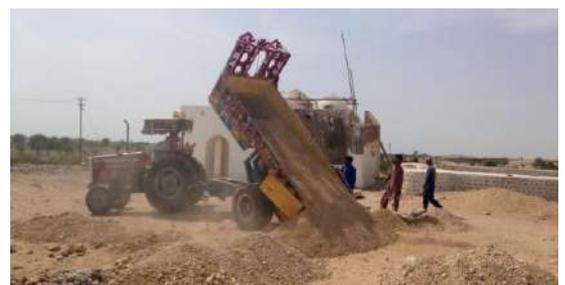
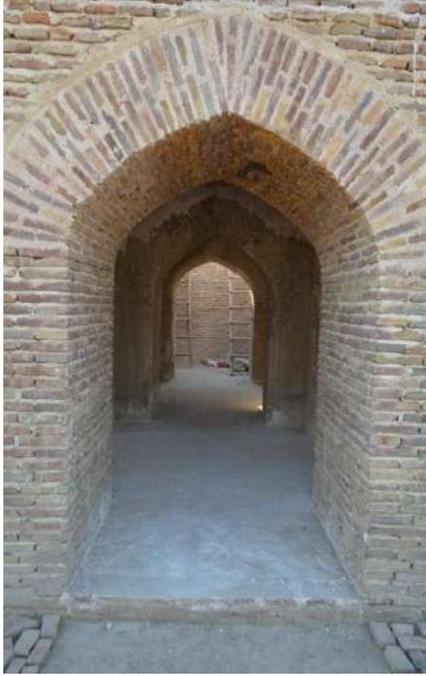
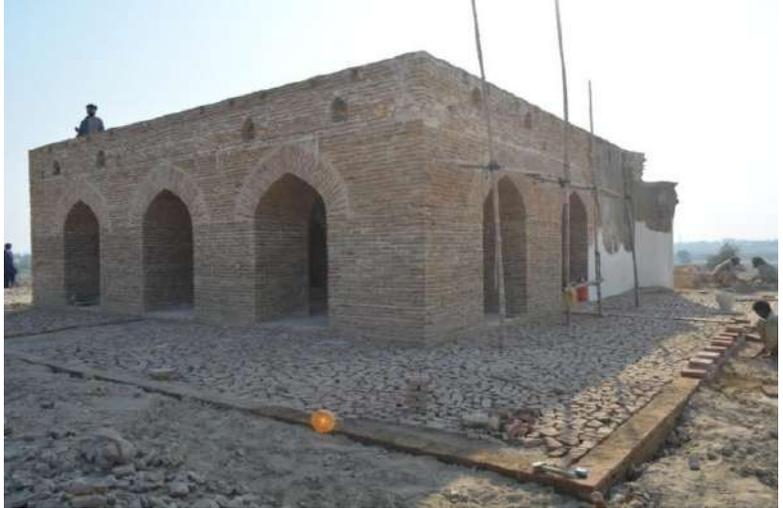
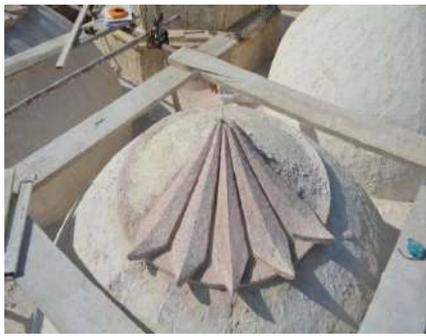
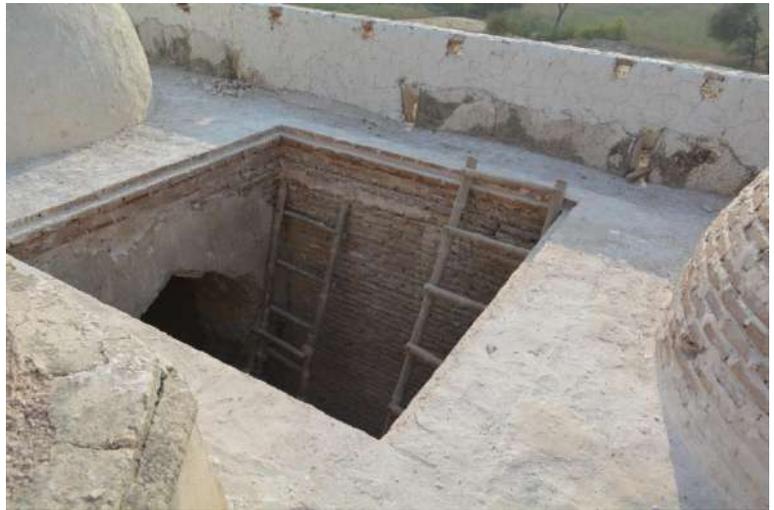
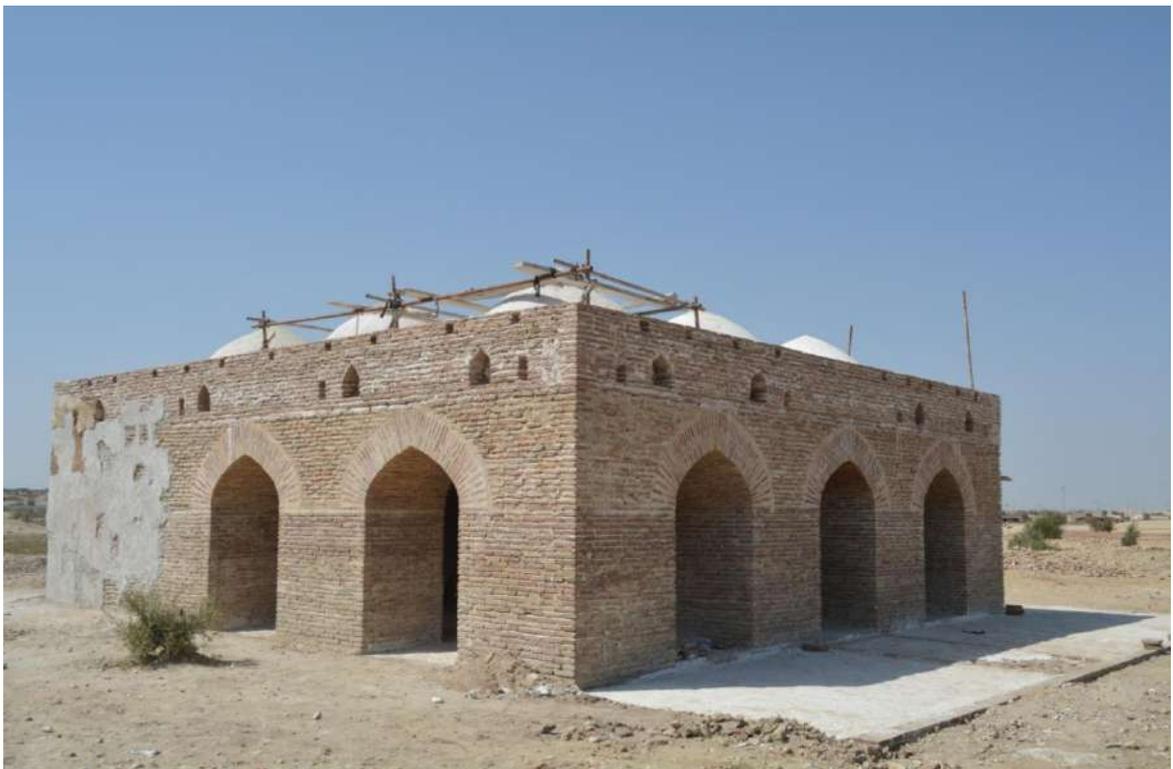
Report March 2021

- Lime work initiated on Otaaq walls.
- Sculptures on domes C and D completed.
- Fort walls on the Eastern, Northern and Southern sides raised.
- Dome-G (Vaulted roof/Tajjar) template installed.
- Lime work puffed with soapstone powder.
