PROJECT COMPLETION REPORT DOOLEH DARYAH KHAN OTAAQ

May, 2021

ENDOWMENT FUND TRUST
FOR PRESERVATION OF THE HERITAGE OF SINDH

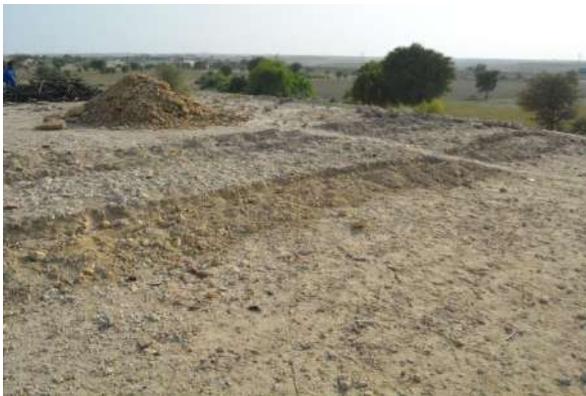
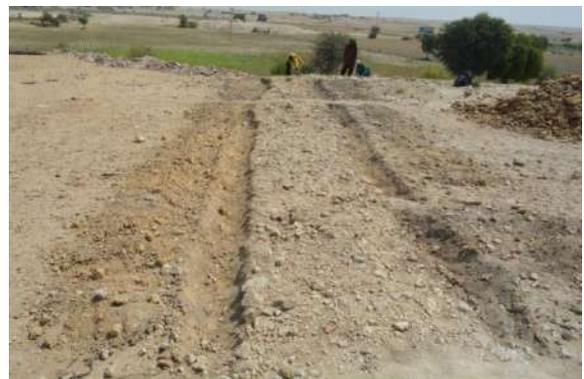
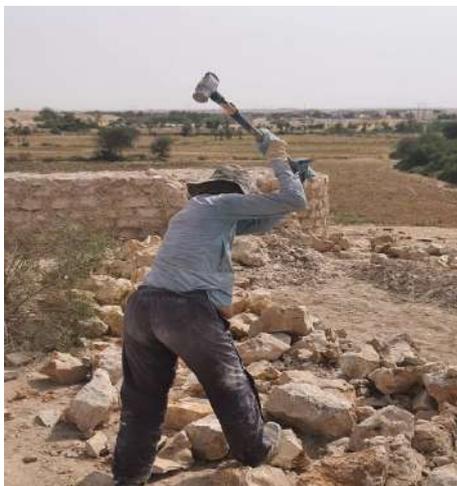
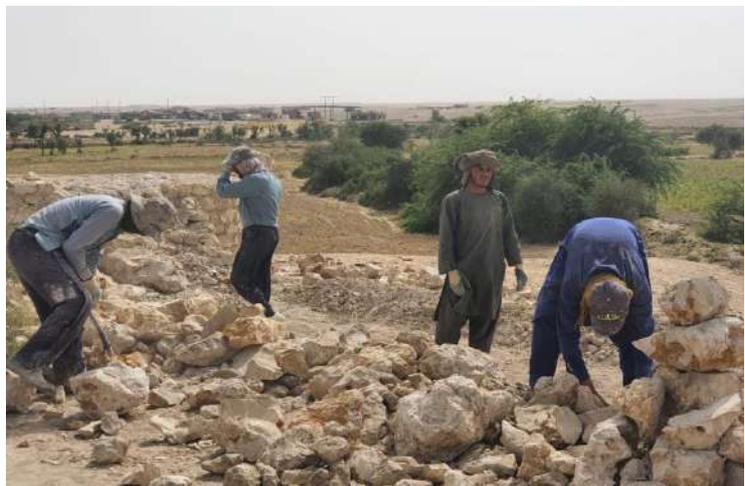
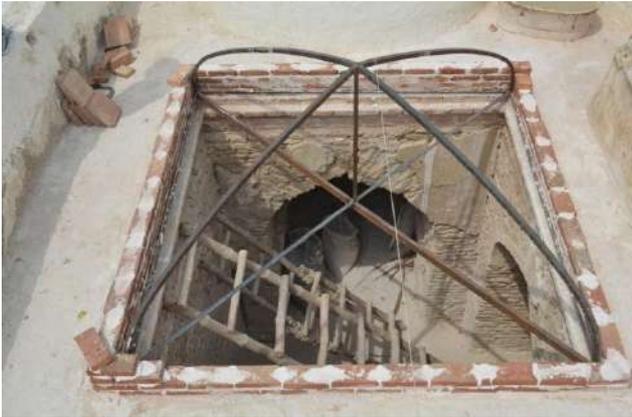
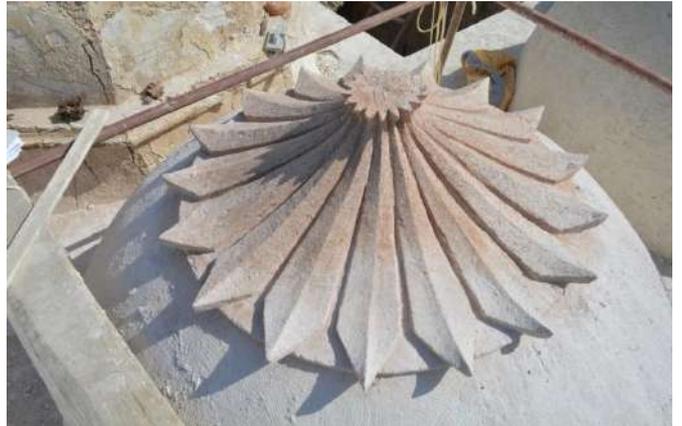
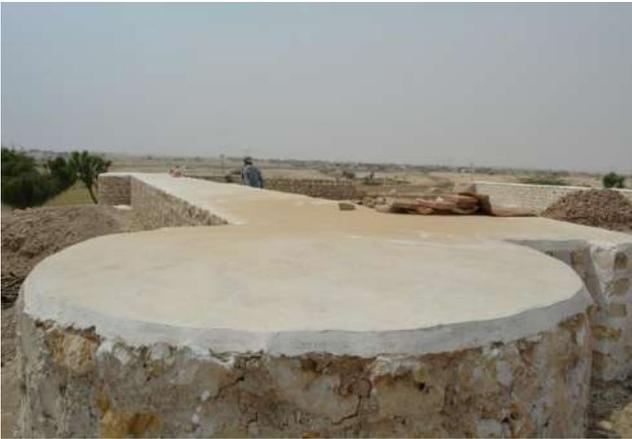
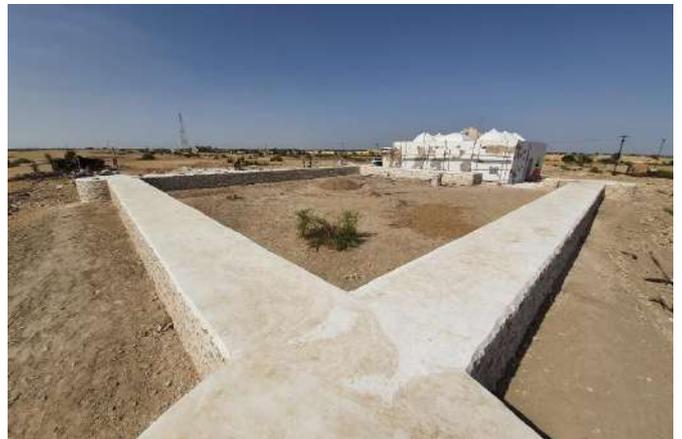
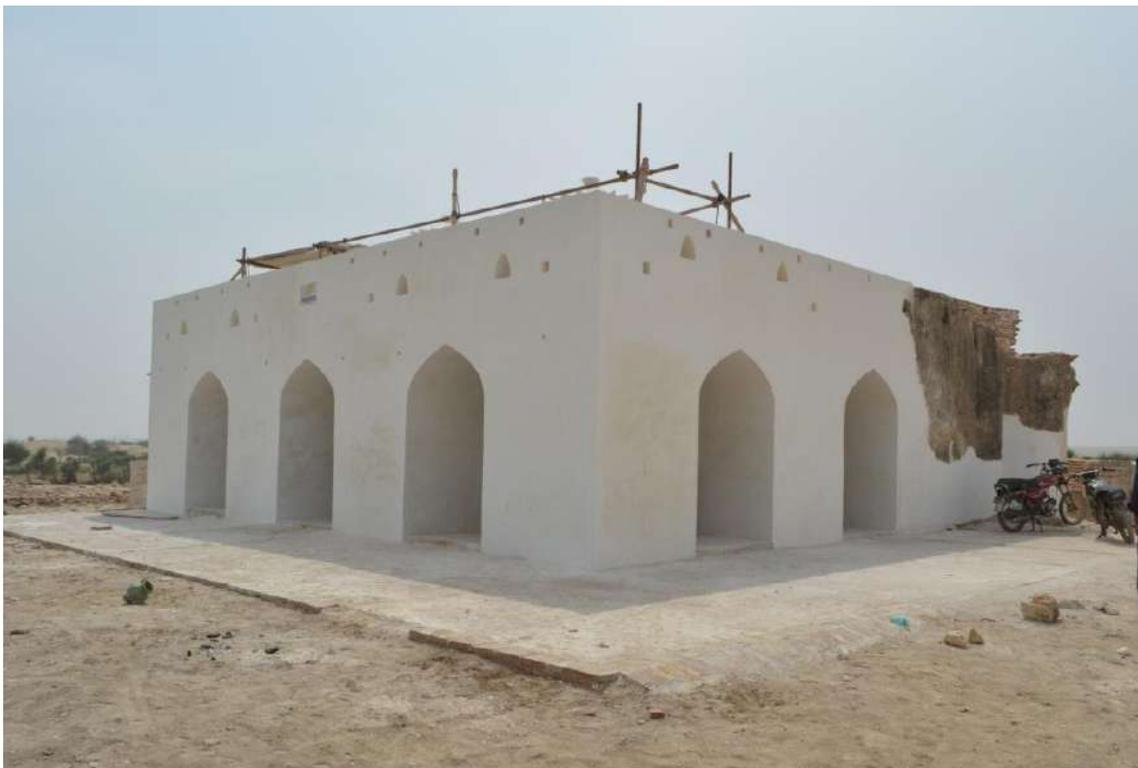
Report April 2021

- All domes completed.
- Tajjar at its completion.
- Pavement belt work at its completion.
- Artifacts found during conservation put on display.

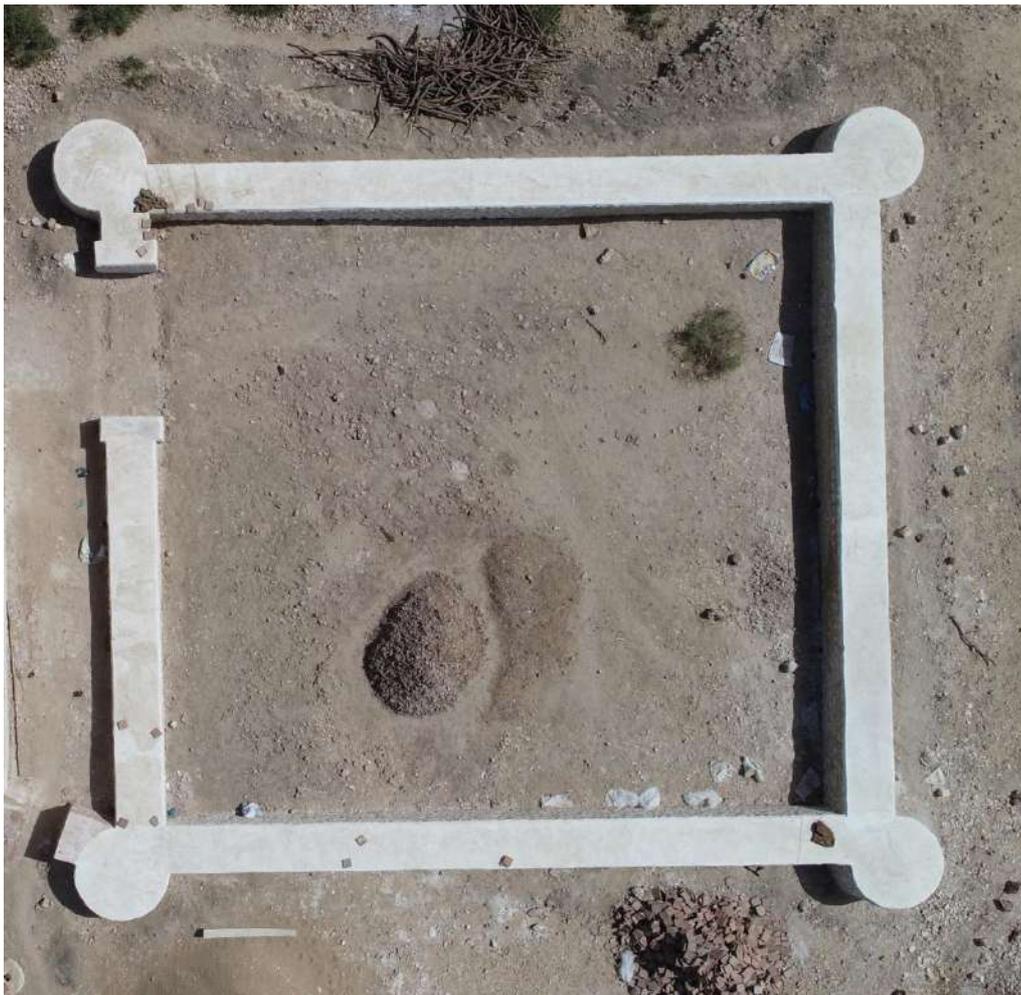
The fortress peculiarly lies adjacent to the Otaaq on its western side. It is a quadrilateral fortress with four bastions. Before restoration, only traces remained of the fort as foundation marks. To make the fortress more prominent and visible from the highway it was raised to a height of four feet. If the height was raised a little more it would have overshadowed the Otaaq. Its awkward placement suggests that the fortress and the Otaaq were constructed in different eras, although no evidence is found as of yet to back this hypothesis. Its small dimensions also suggest that proportionally, the actual walls of the fortress were not that high and it was probably used as a watchtower rather than a defensive fortress.

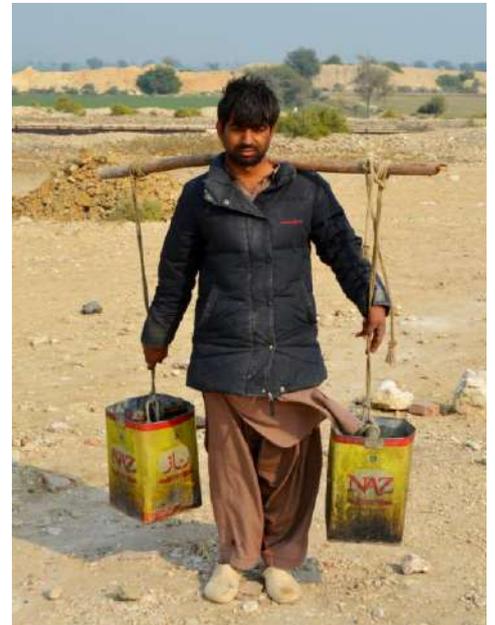
As it is known that for any restoration/construction process easy accessibility to water is essential. The site of Dooleh Daryah Khan proved a challenge as it was built on a rocky hill. Furthermore, lime work requires a large supply of water. This predicament was tackled first by the most surefire way i.e. to get a water supply line to the site. This however failed in the longer run due to the higher cost and the unreliability of the supply which eventually led to a fault from the source and supply was cut off indefinitely. A storage tank was constructed in situ.

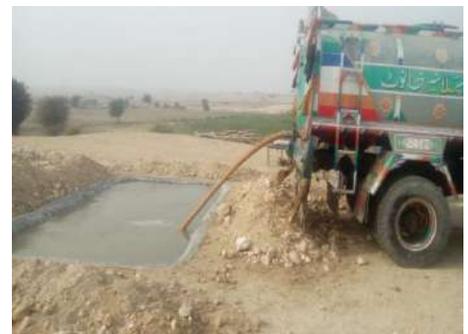
That being said, it was decided to use water tankers instead. This also proved costly and unreliable as the supply was limited and periodical. During the periods where the supply was delayed another way had to be thought of to maintain the steady supply.

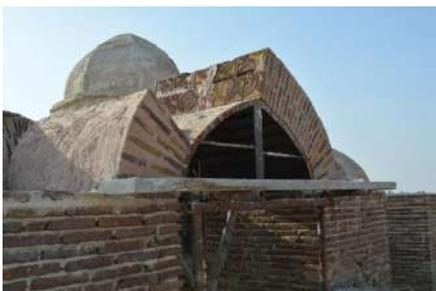
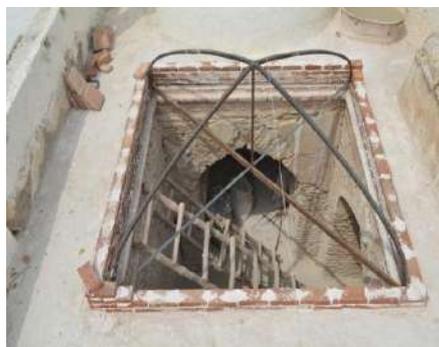
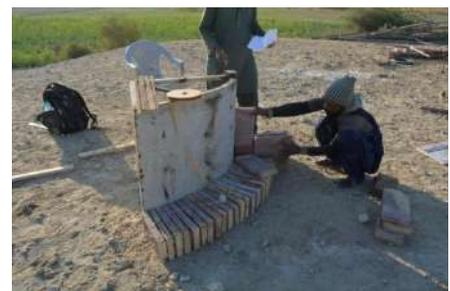
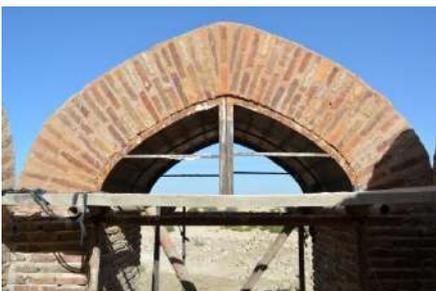
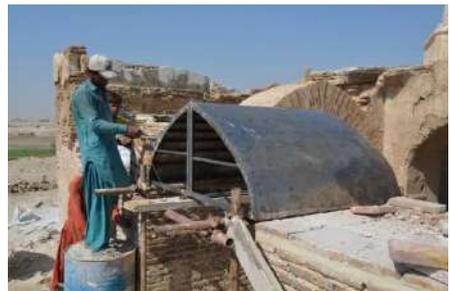
Templates

As mentioned earlier in this completion report, the usage of templates proved indispensable in the conservation process to maintain dimensional uniformity wherever it was needed. The site proved a challenge as each structural component varied a little in dimension. The templates however, helped in shaping the arches and domes to a near uniform form and the dimensional deviations were later dealt with manually so the structure stayed true to the original proposed plan.

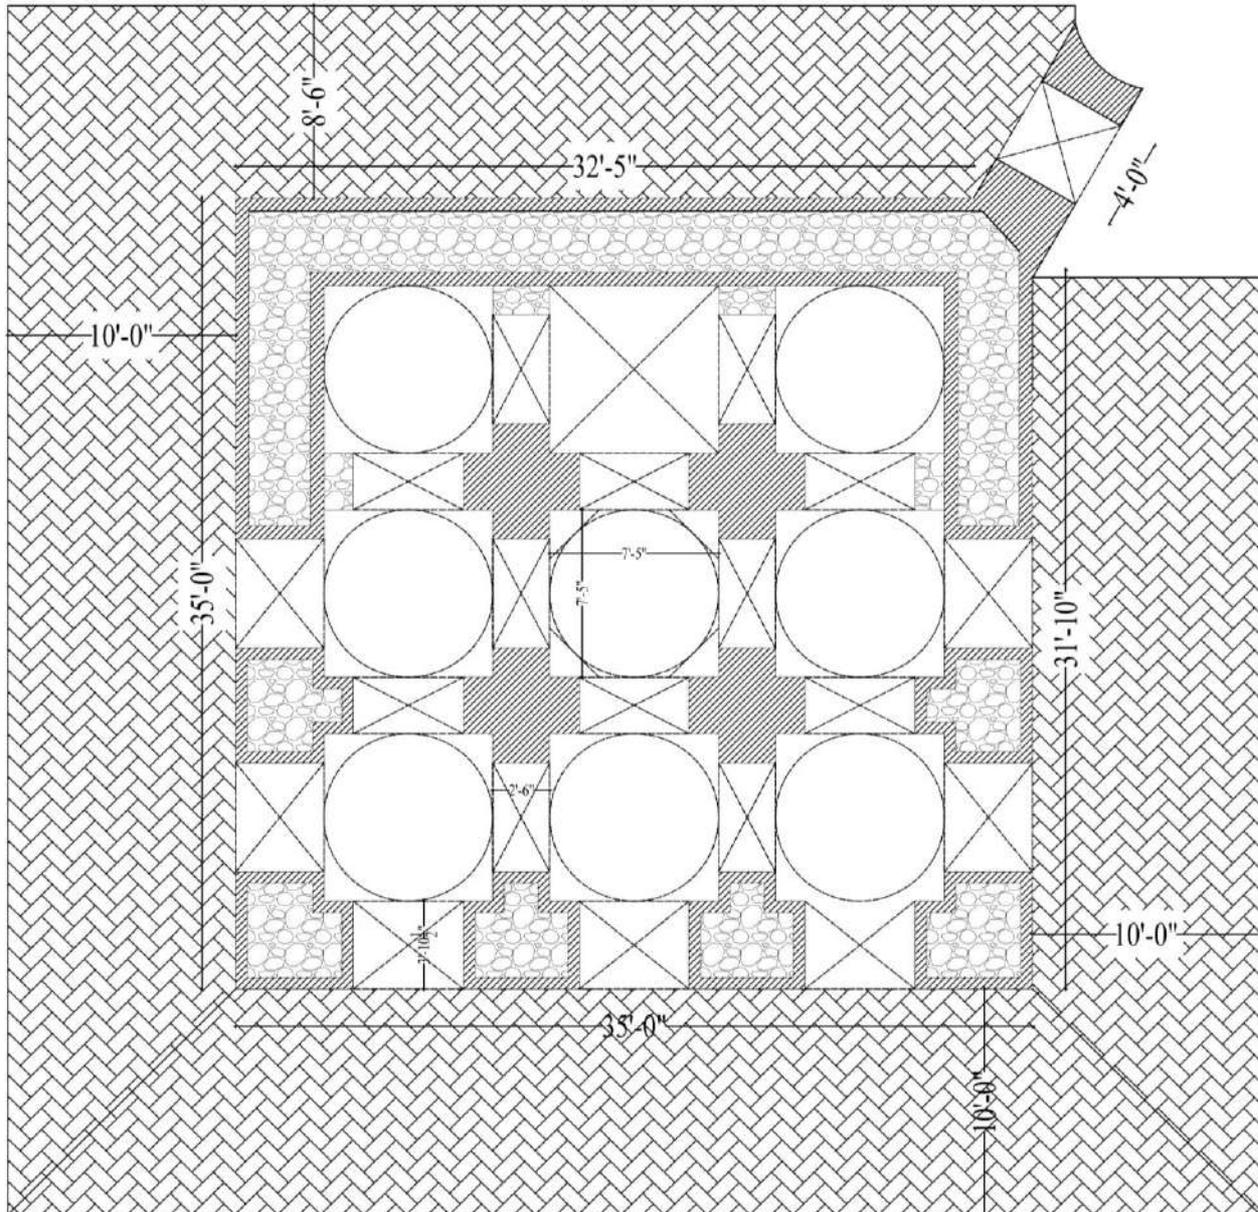
PLAN OF DOOLEH DARYAH KHAN OTAAQ

- 1 central pointed-fringed dome.
- 7 three-centre domes
- 1 cubical dome locally called a Tajjar.
- 12 interior arches
- 4 walls
- 1 outer arch
- Pavement

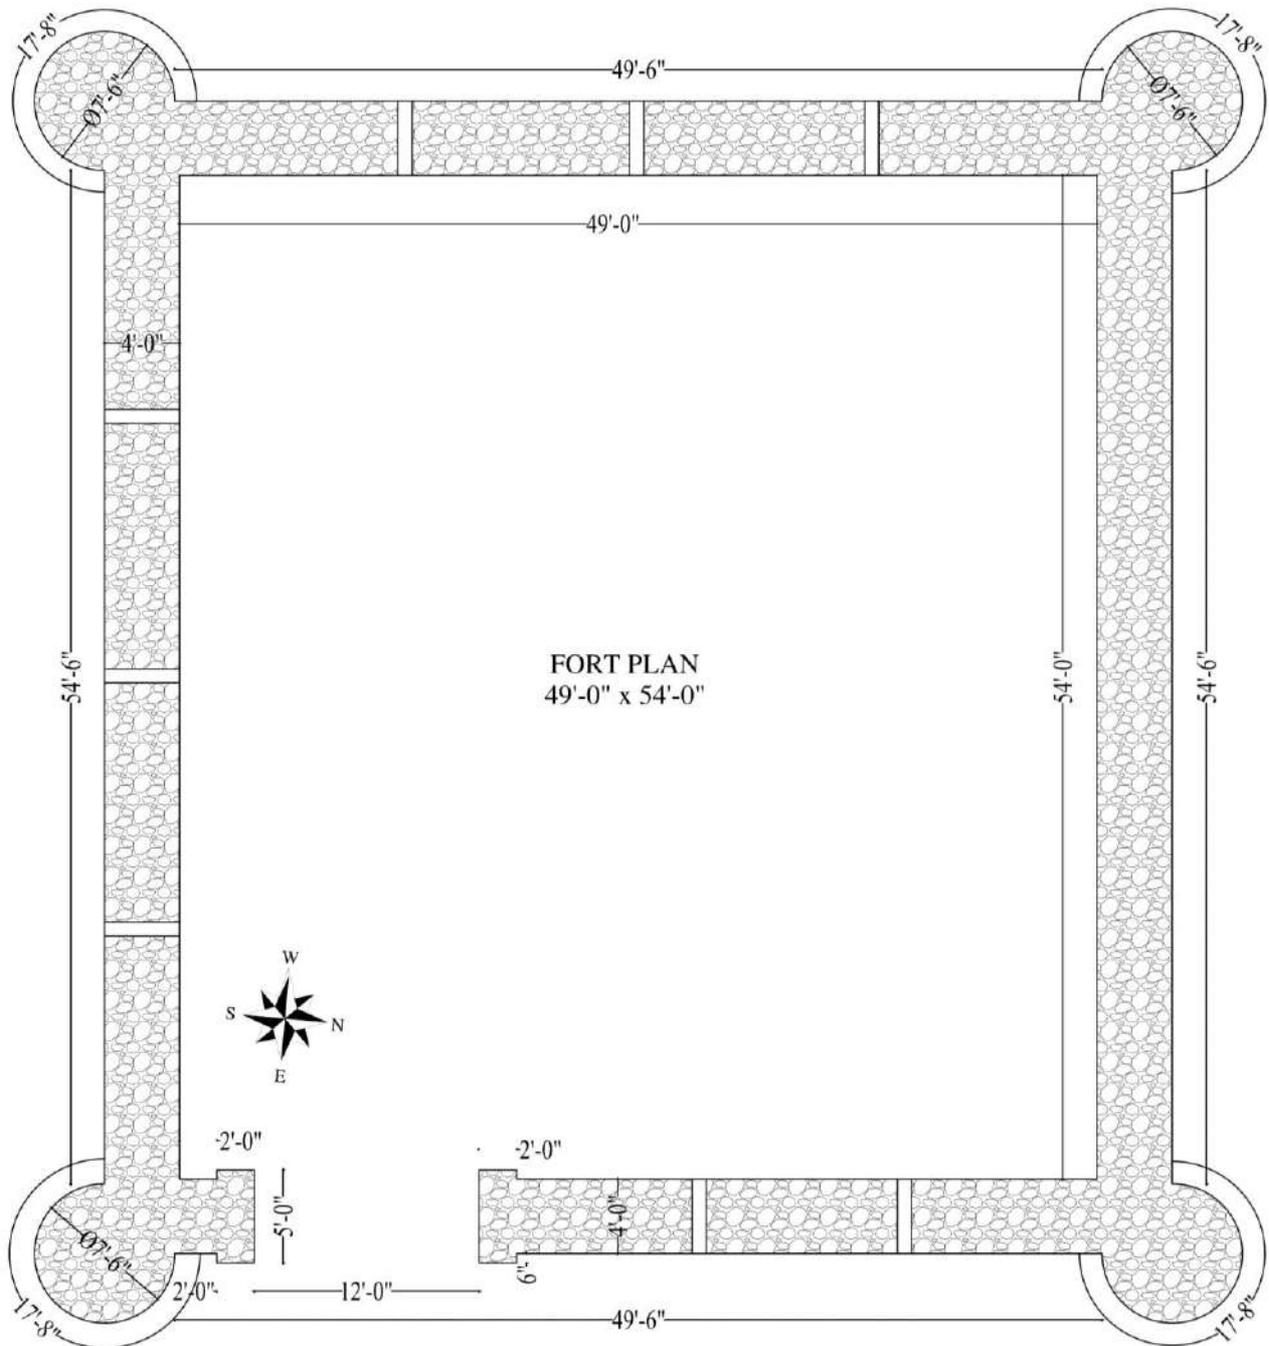
FORT PLAN OF DOOLEH DARYAH KHAN OTAAQ

- 4 bastions
- 4 walls
