**Project
Completion
Report**

Bastion of Mud Fort

***Tando
Allahyar***

ENDOWMENT FUND TRUST
For Preservation of the Heritage of Sindh

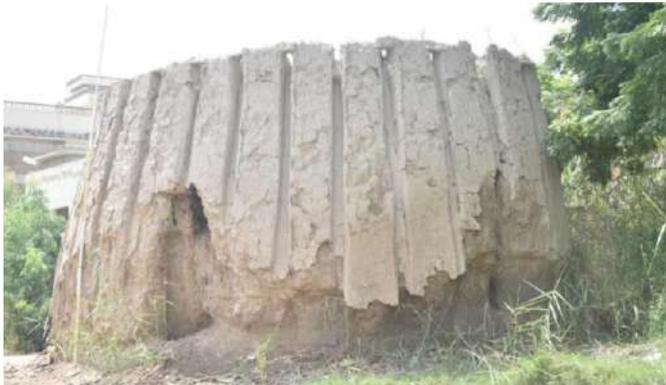
- The surviving bastion was in a very vulnerable condition, and needed to be preserved on priority basis.
- Mud from the base of the bastion had eroded and upper part of the bastion is also eroded due to Efflorescence, harsh environmental conditions.

Eroded Portion of Bastion

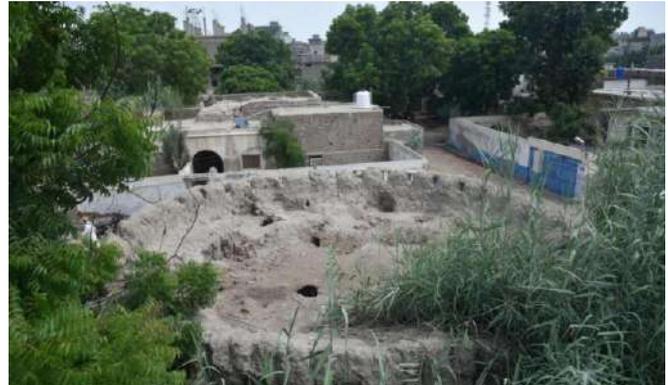
Damage Top of the Bastion

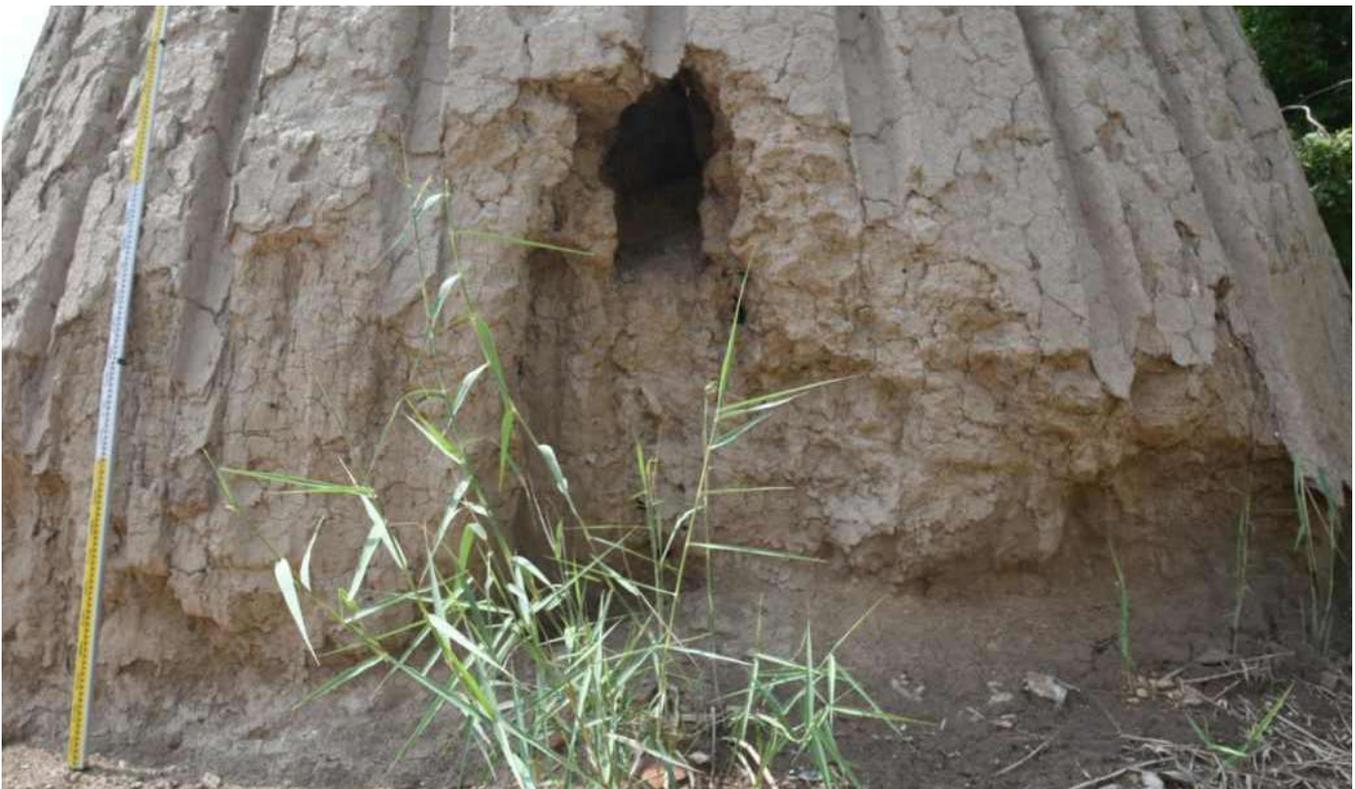
Coved Portion of Bastion

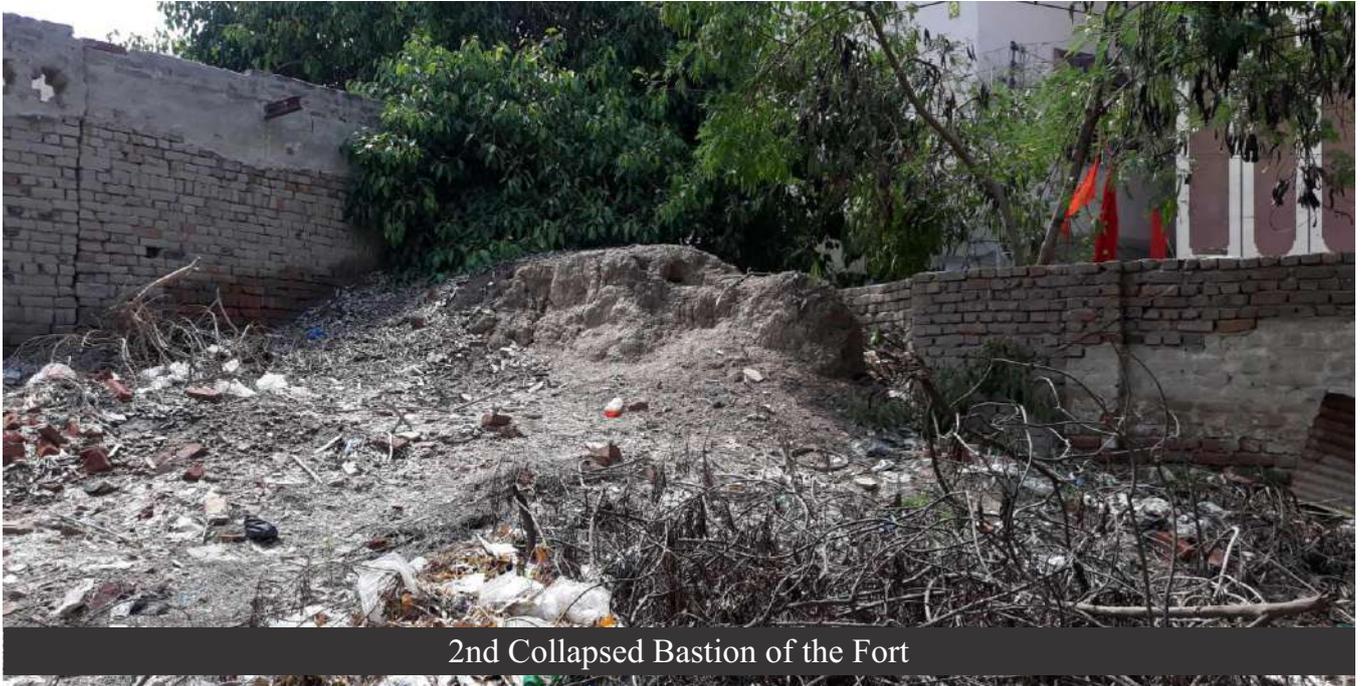
2nd Collapsed Bastion of the Fort

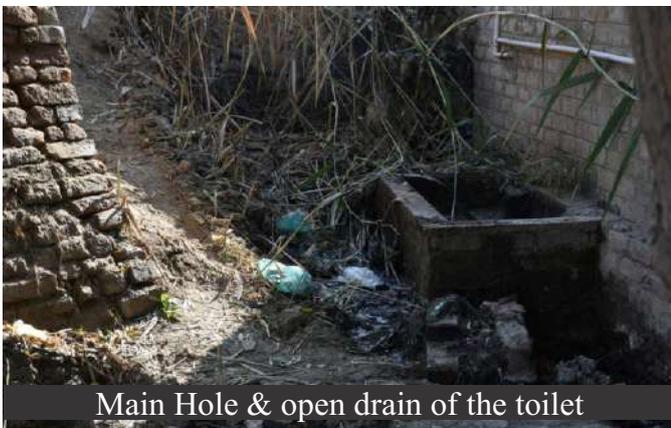
Main Hole & open drain of the toilet

Main Cause of the deterioration of the bastion is seepage from the open drain constructed along with Bastion

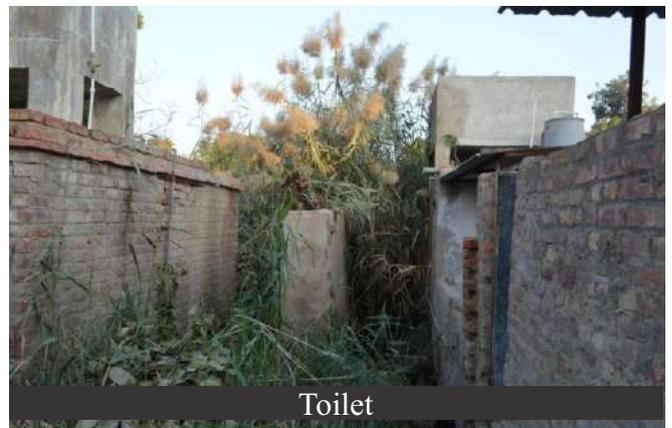
Toilet

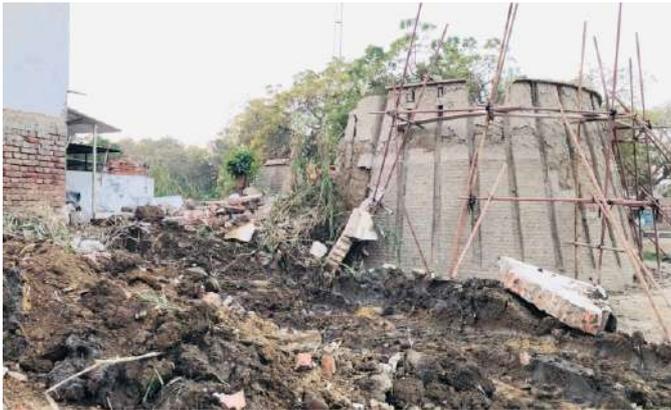
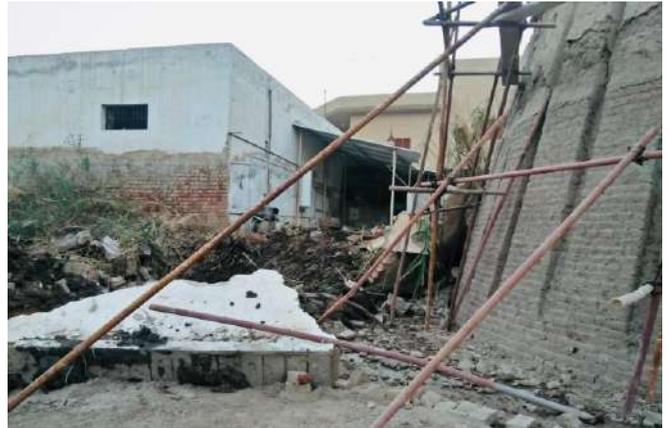
Demolition of encroached Washrooms by Assistant Commissioner Mr. Shabbir Jan Jiskani and team

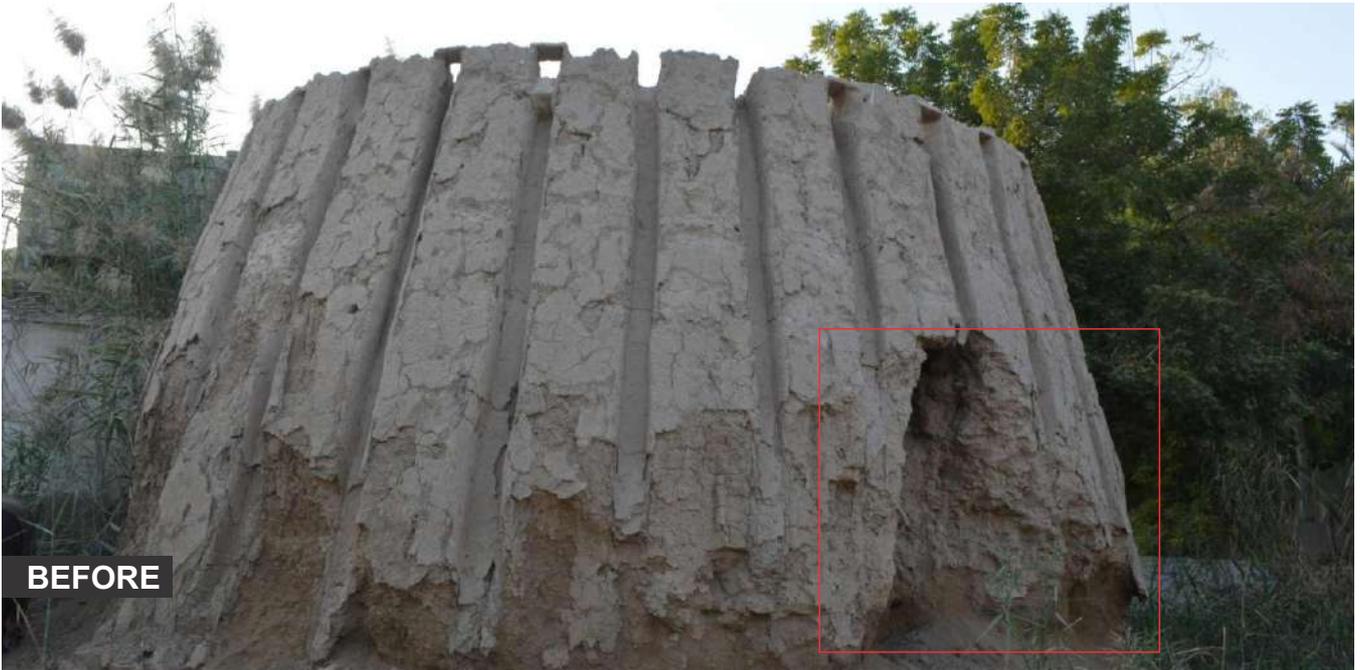
Under pinning and mud brick masonry of the coved and eroded portion of the Bastion & Jungle clearance was carried out

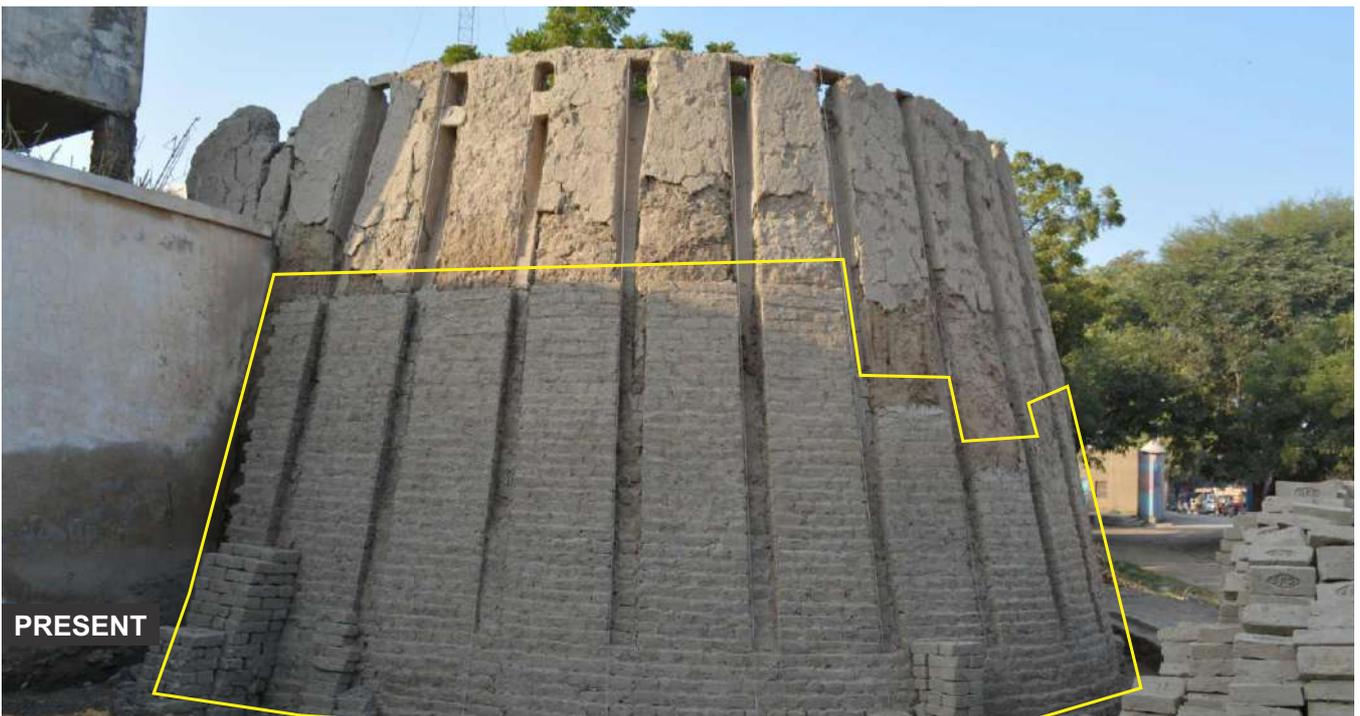
Debris were cleared surrounding the Bastion

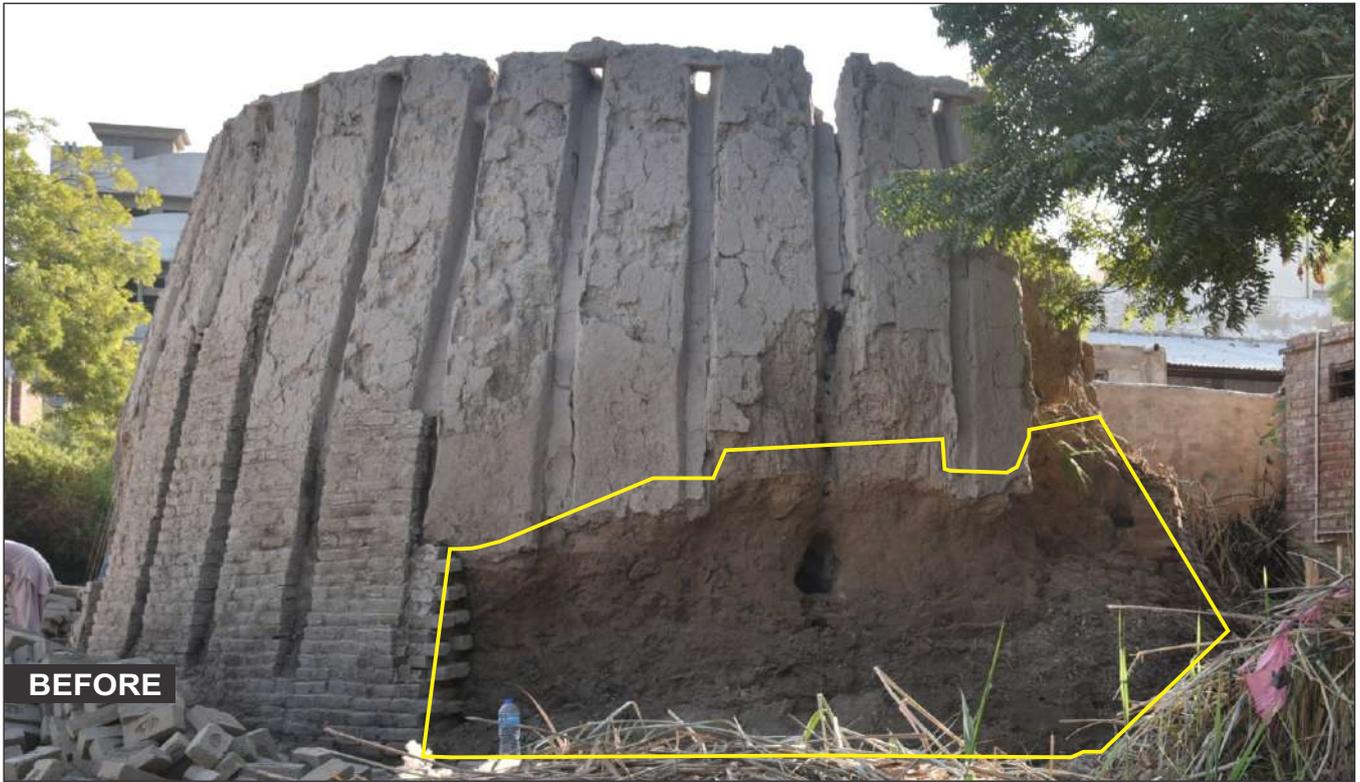
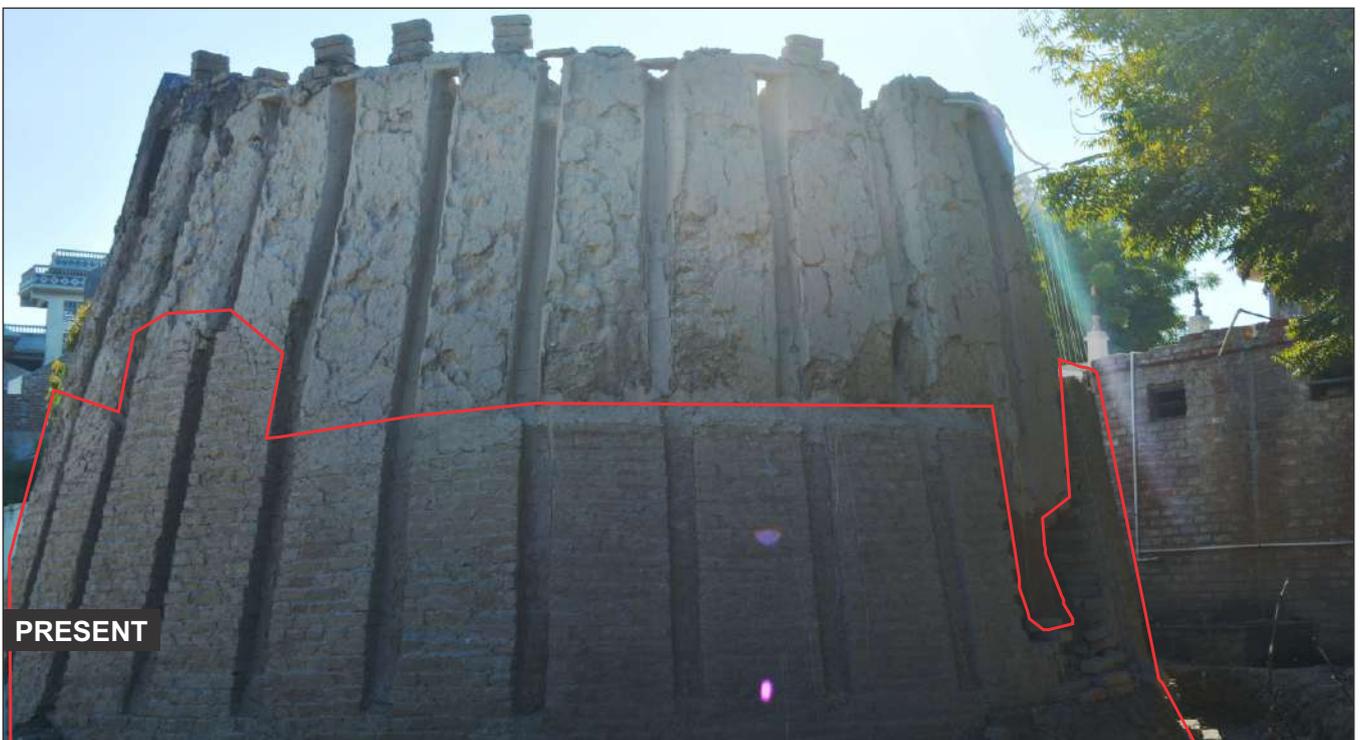
Underpinning have done and Masonry work in progress

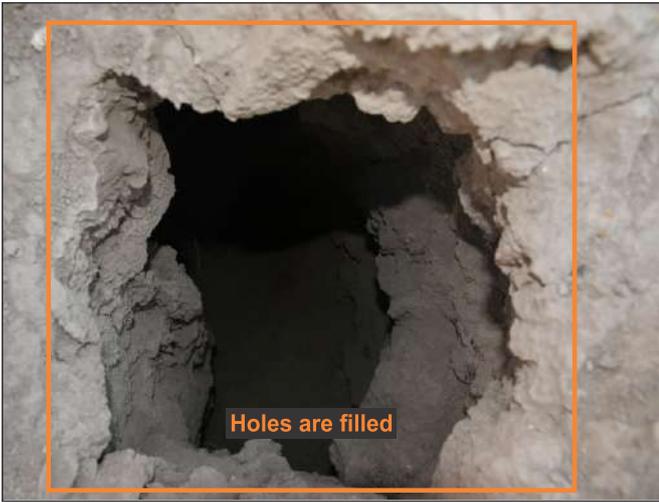
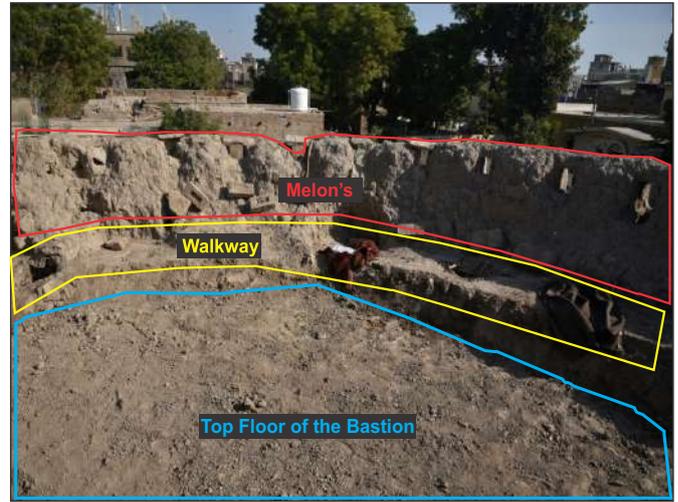
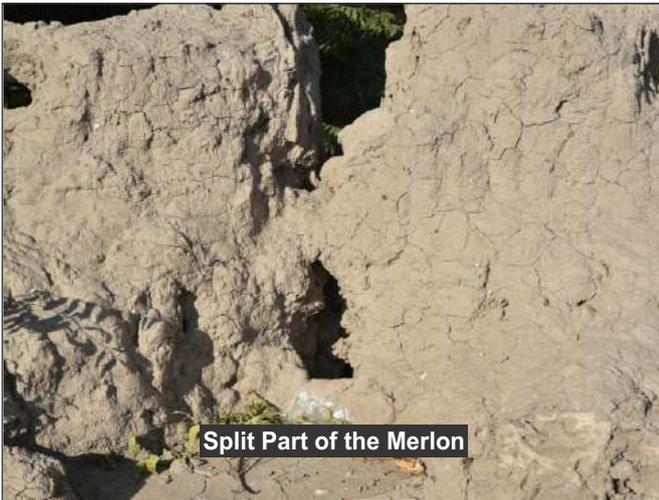
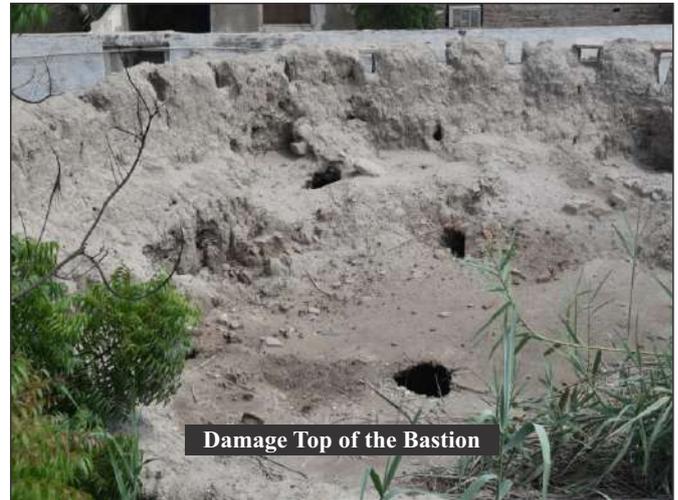
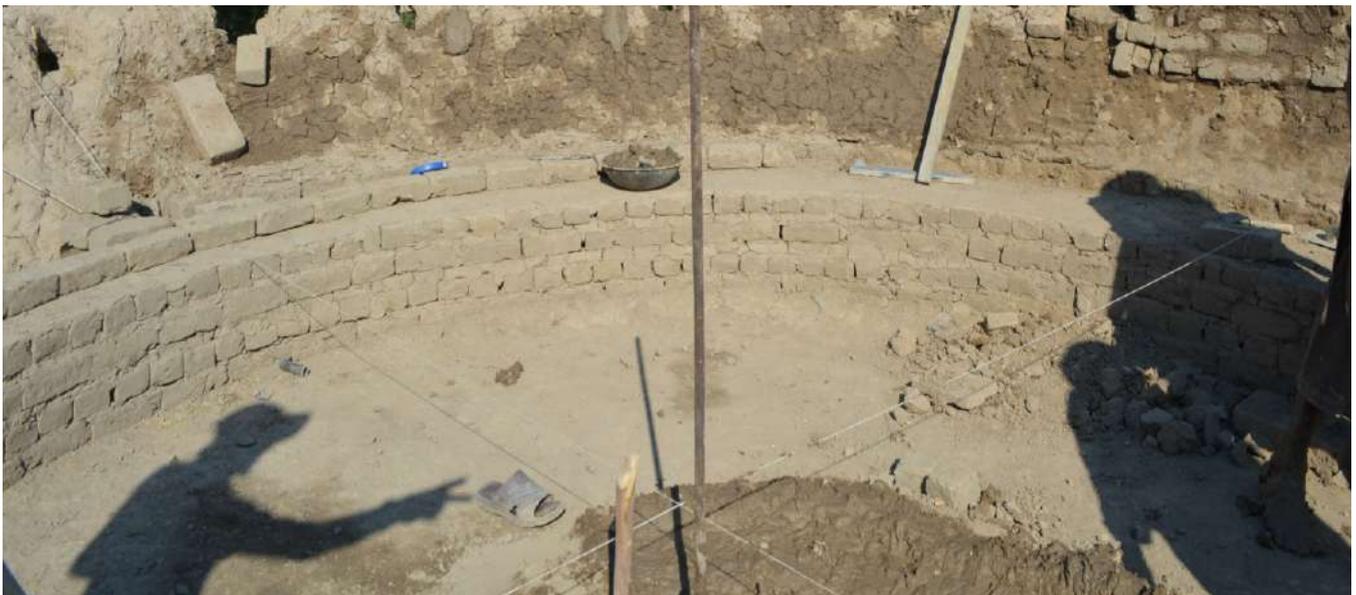
Restored the Top surface of the bastion

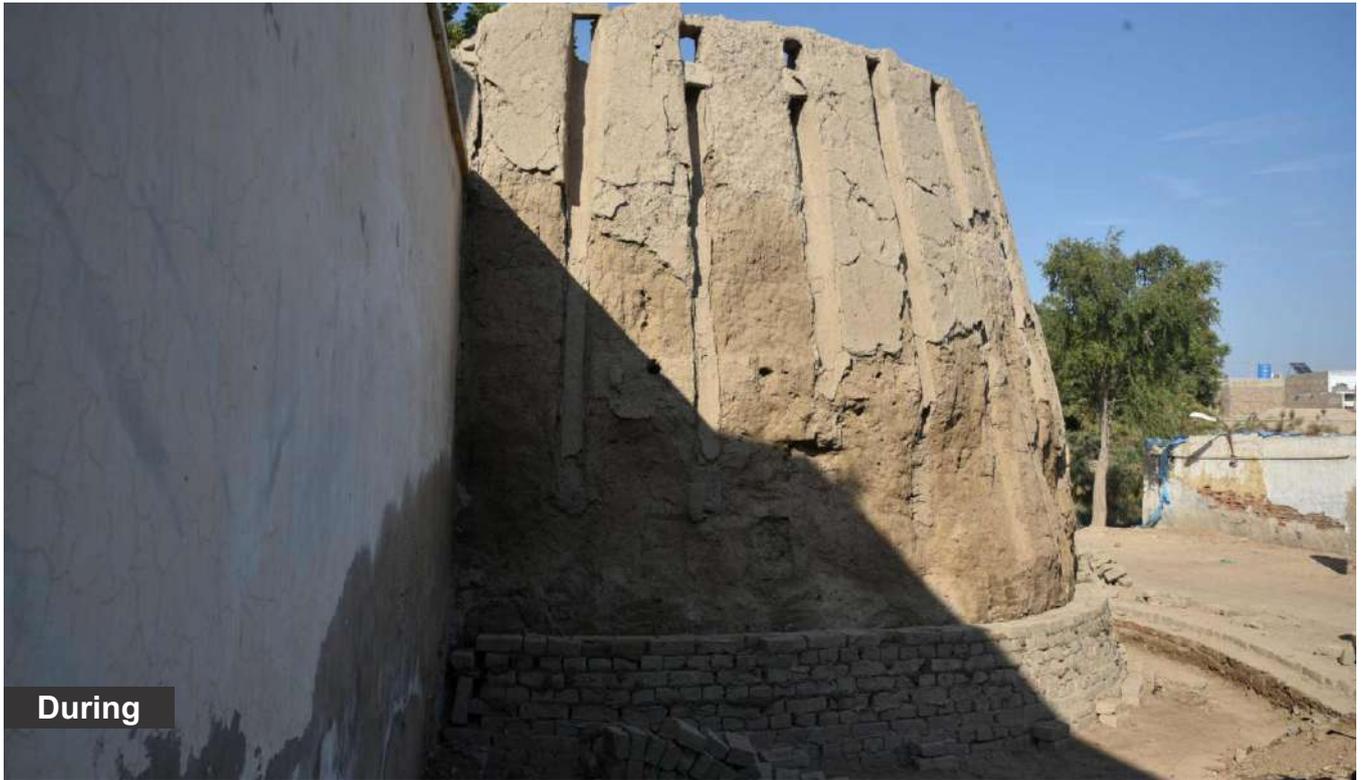
During

Exterior Wall Masonry in progress.
Scaffolding has fixed for doing elevated restoration work,
Scaffolding are shifted from the Ghulam Shah Kalhoro Hyderabad & Sabzwari tombs Sehwan.

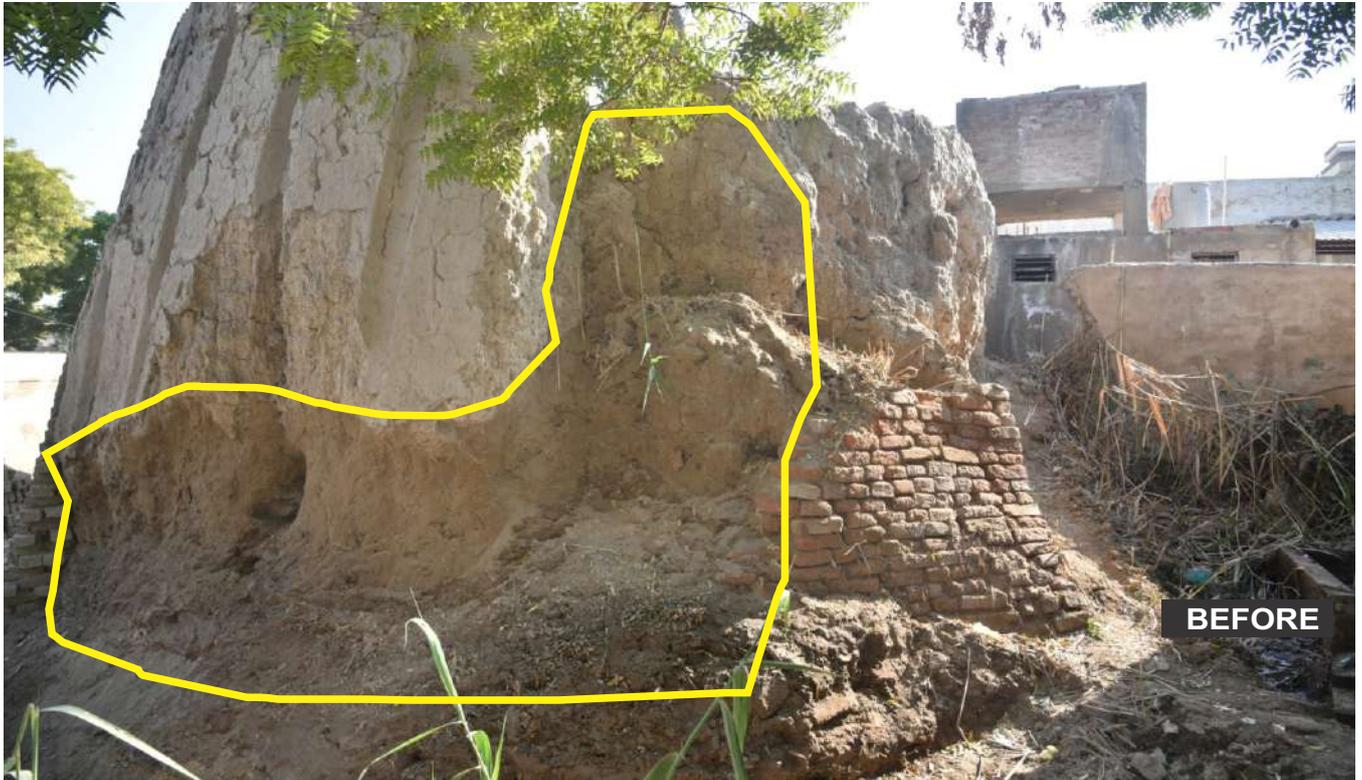
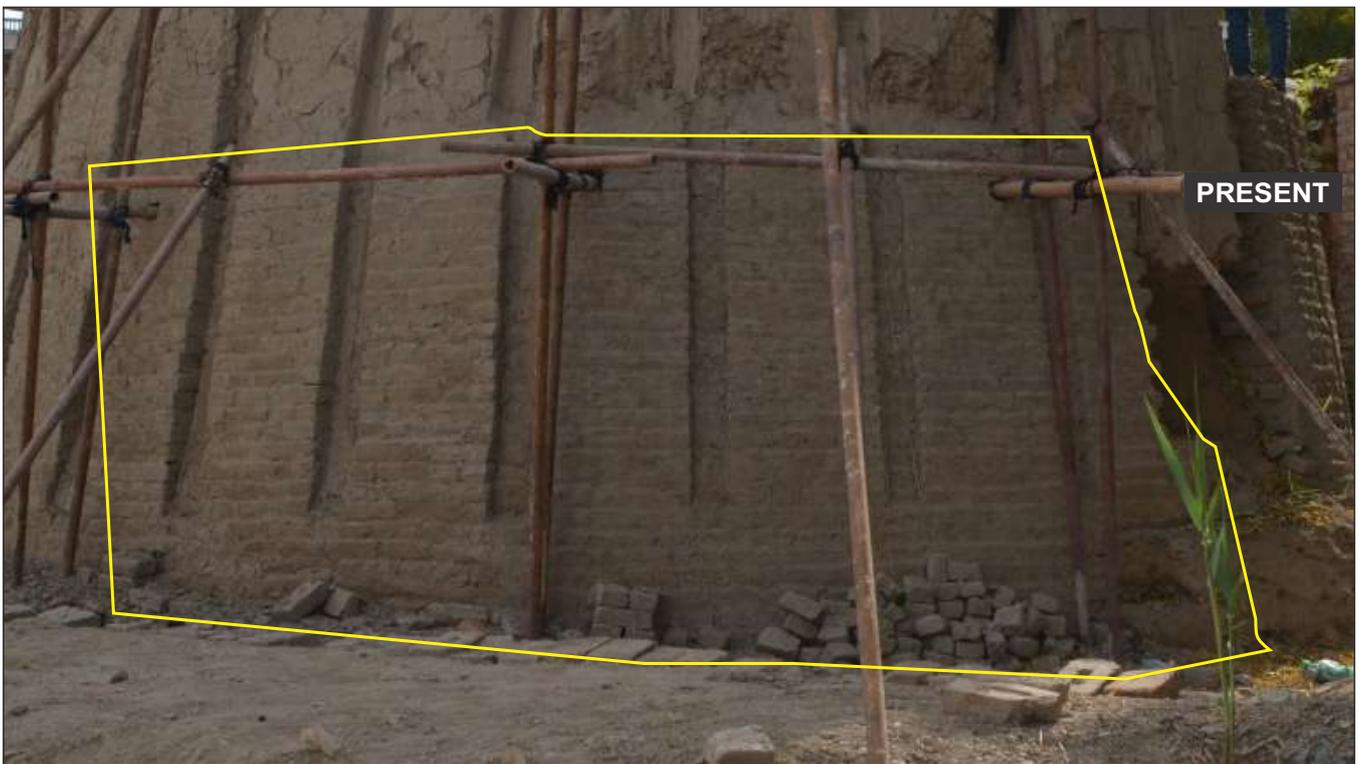
The Coved base of the Bastion has underpinned

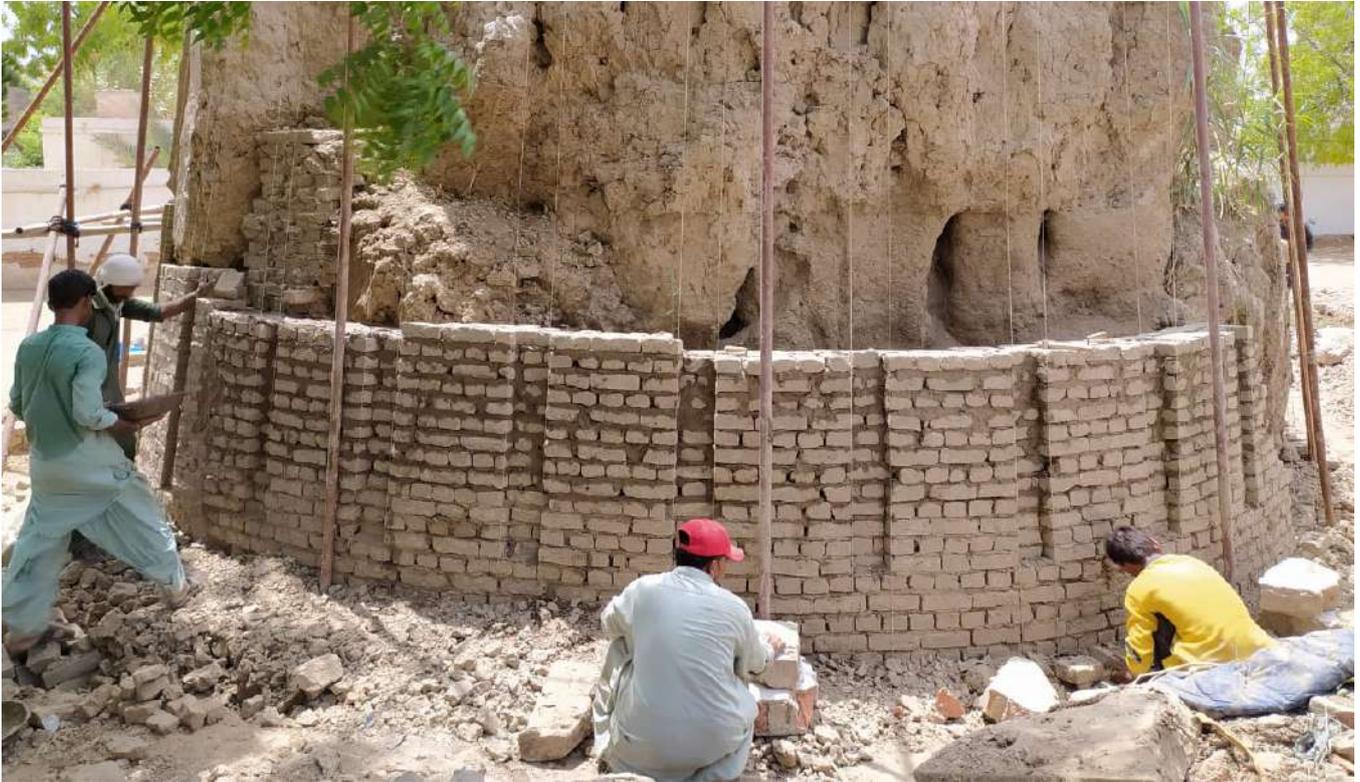
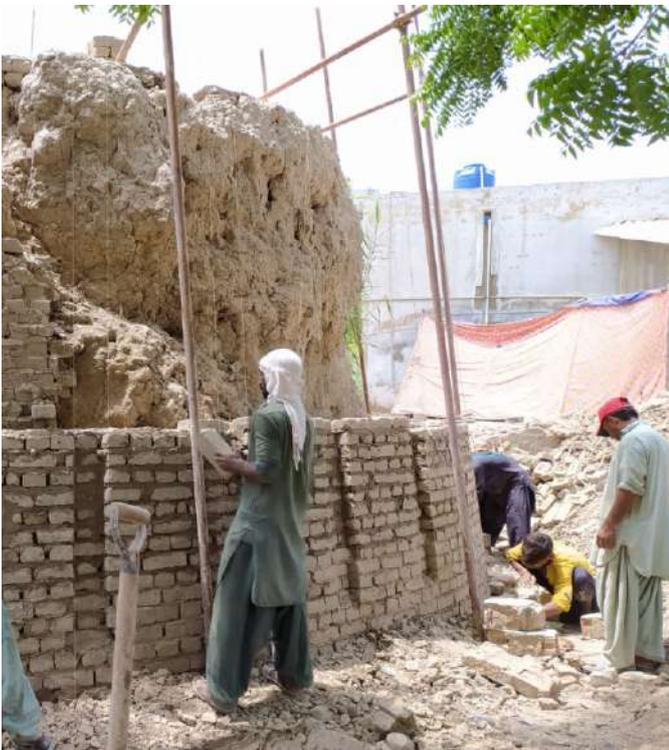
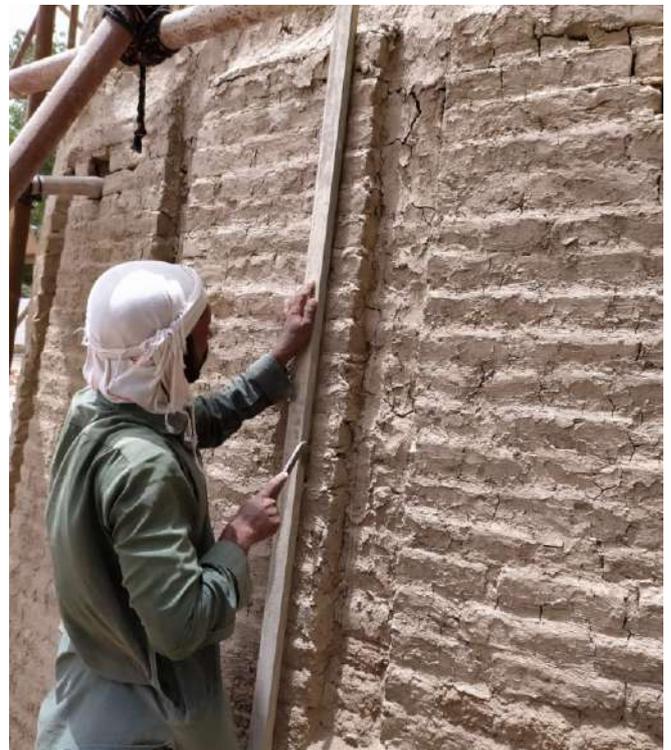
Masonry Work

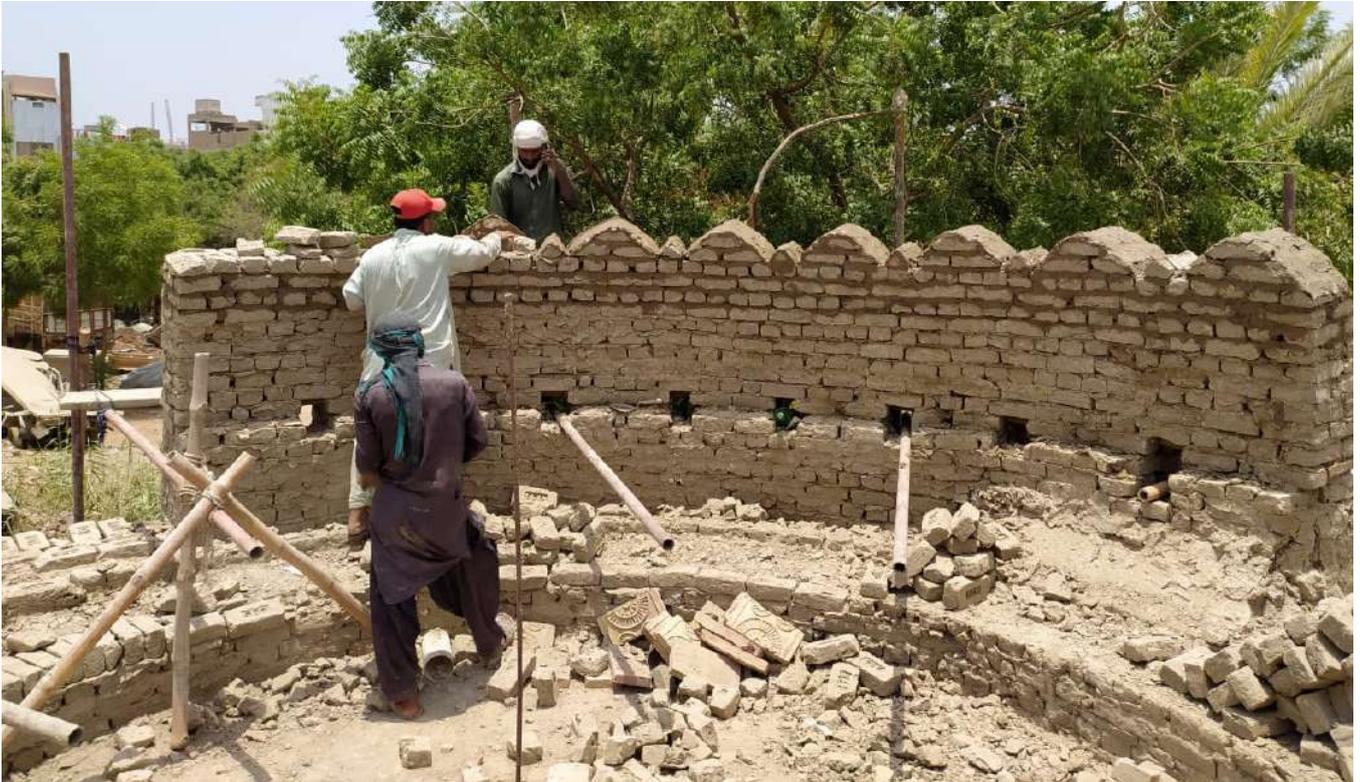
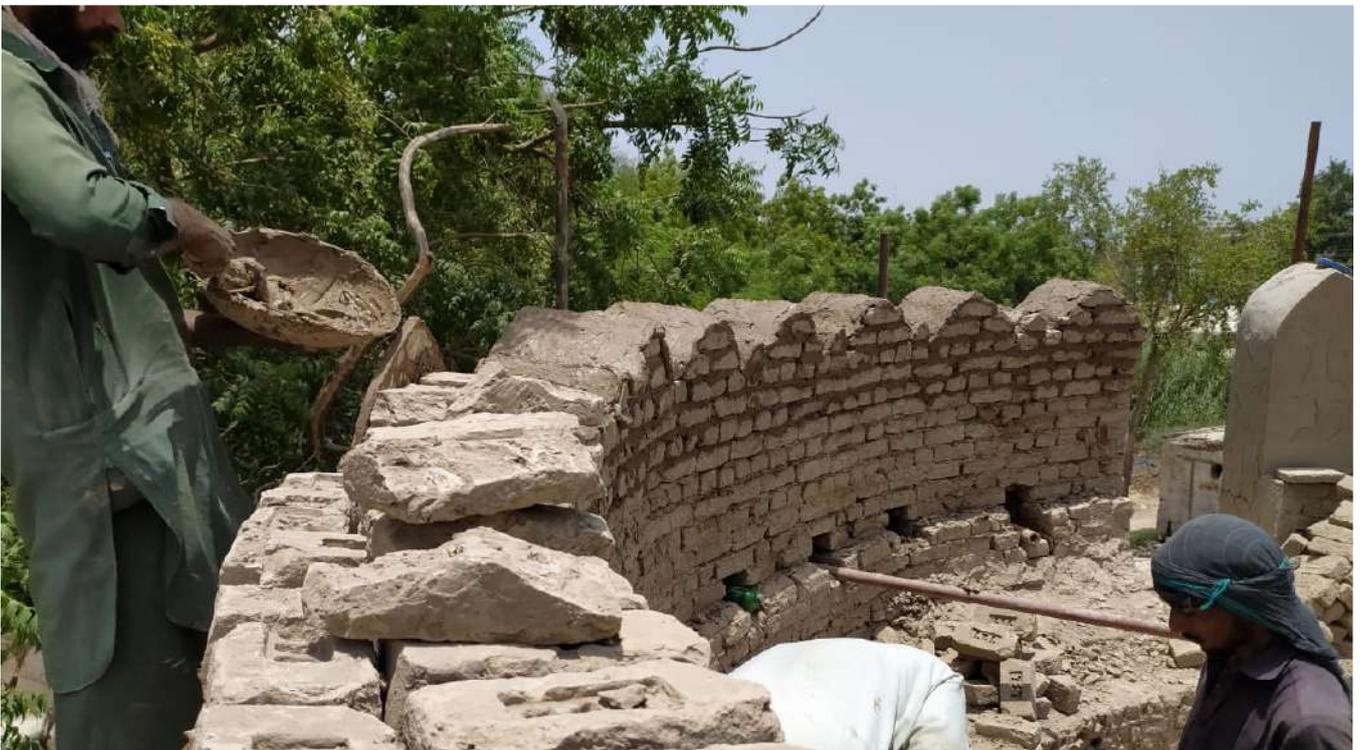
Mud Plaster on Merlons top surface

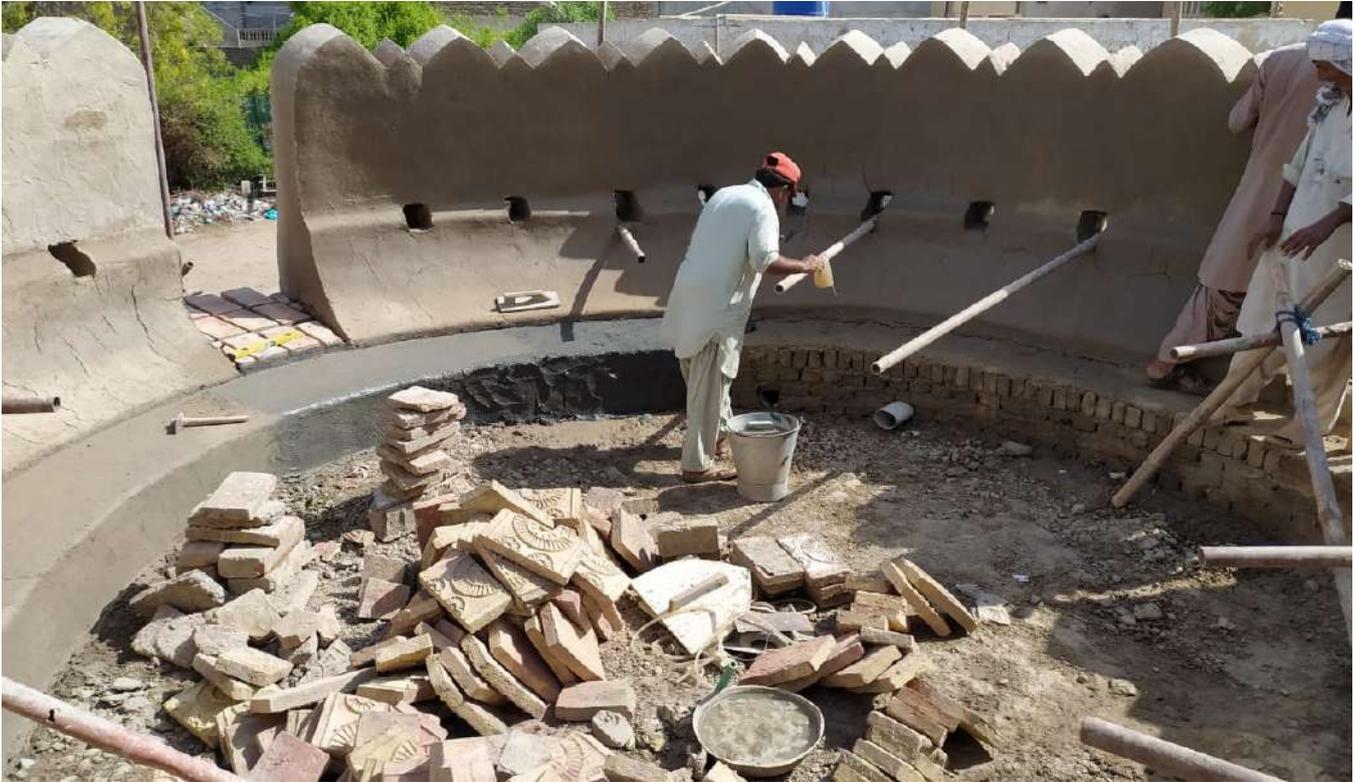
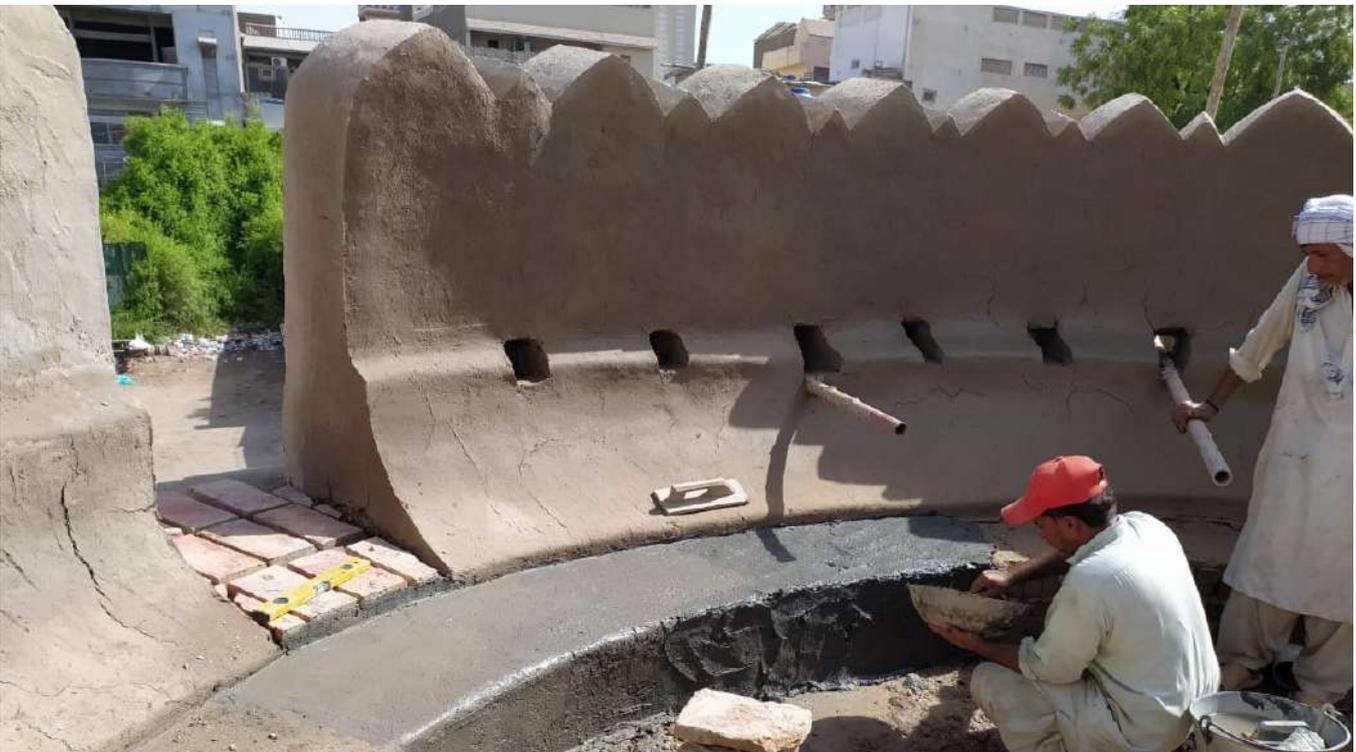
Merlons mud plaster work in process

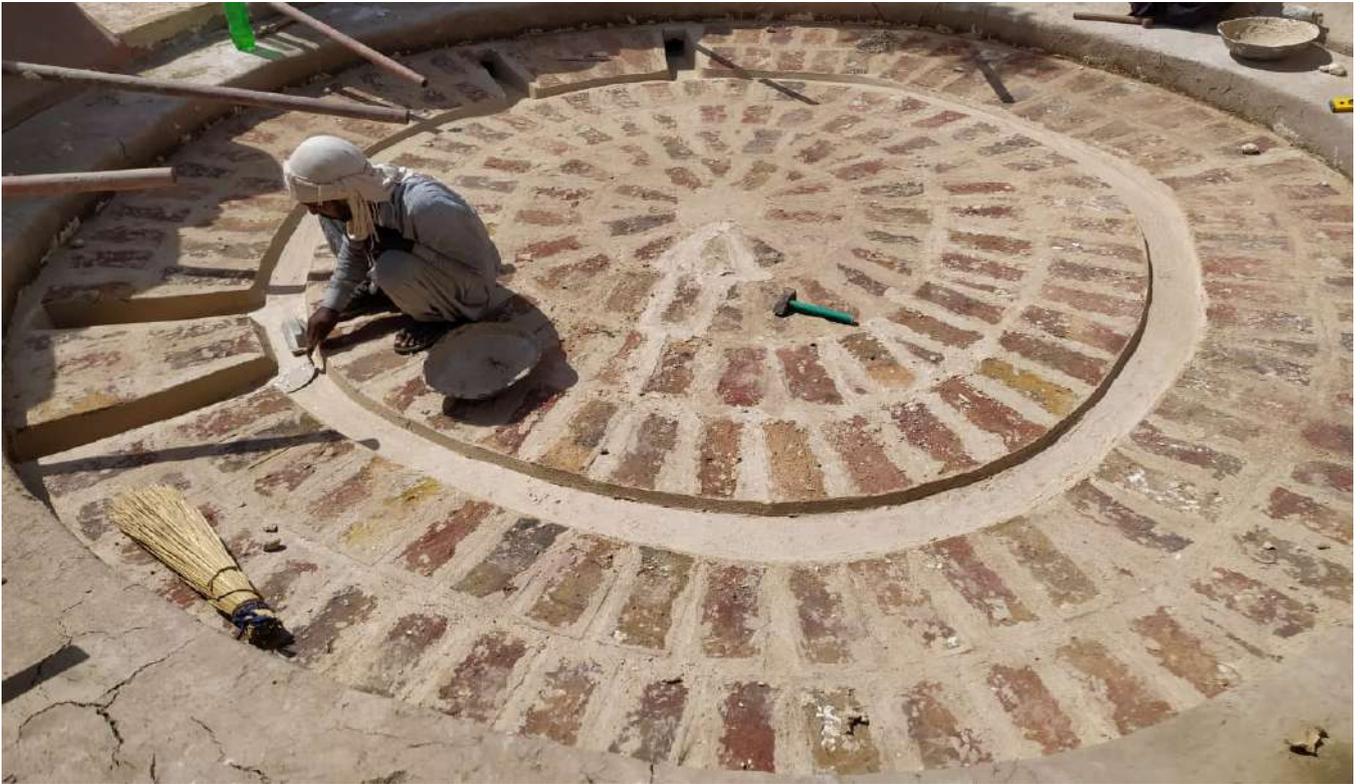
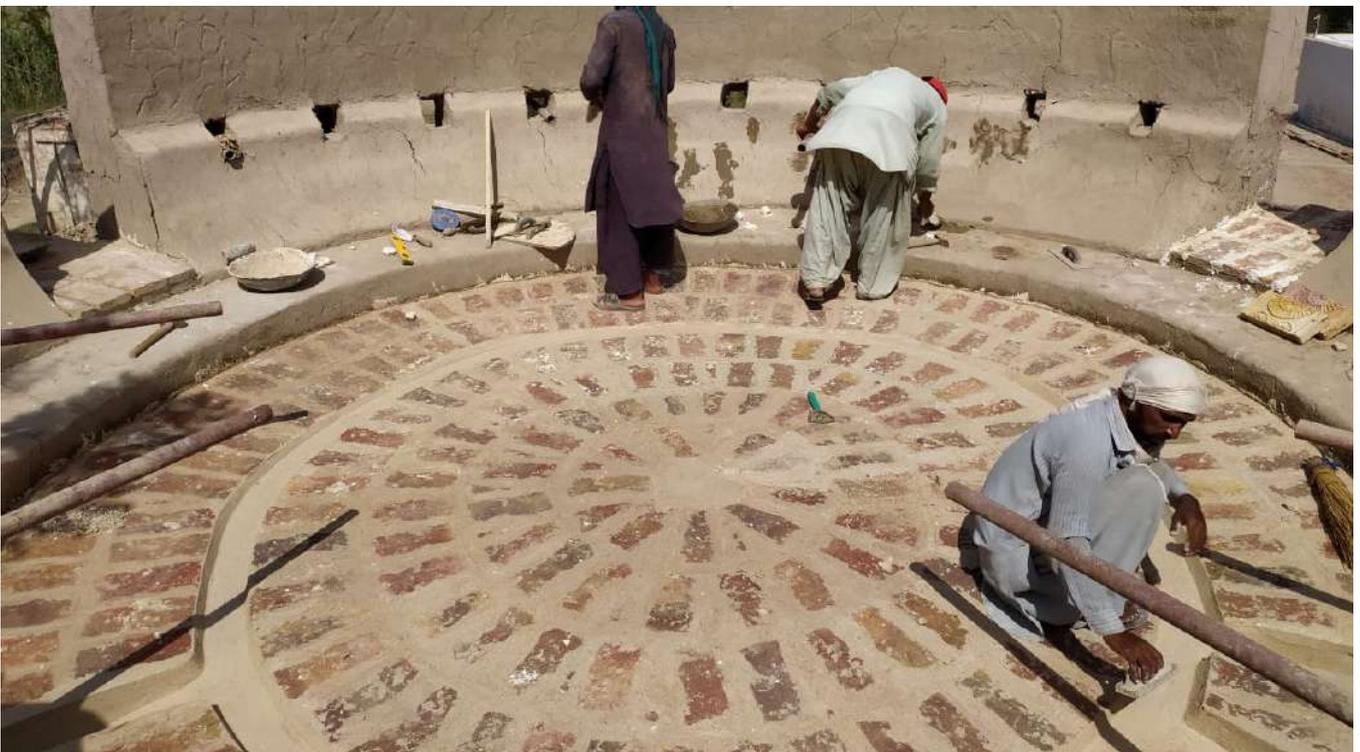
After flooring of Bastion top level
