**Project
Completion
Report**

Bastion of Mud Fort

***Tando
Allahyar***

ENDOWMENT FUND TRUST
For Preservation of the Heritage of Sindh

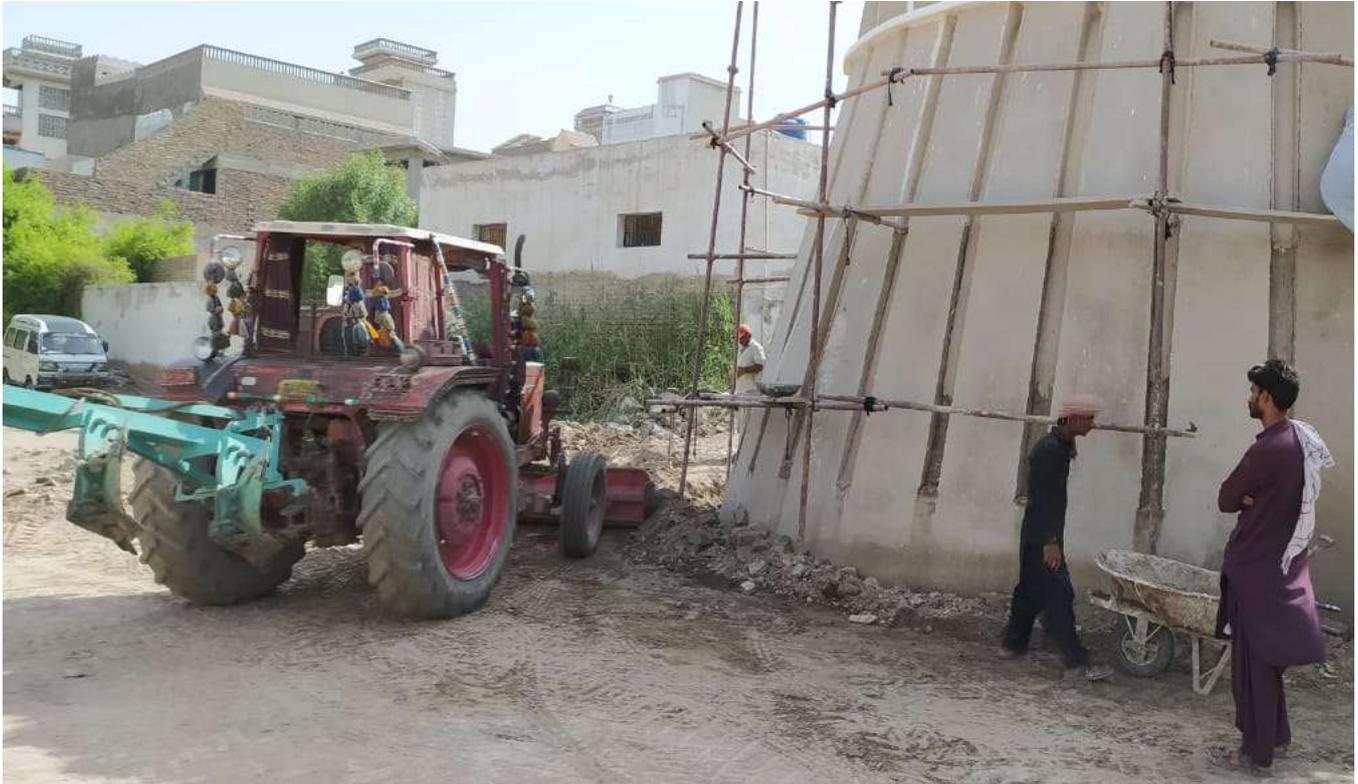
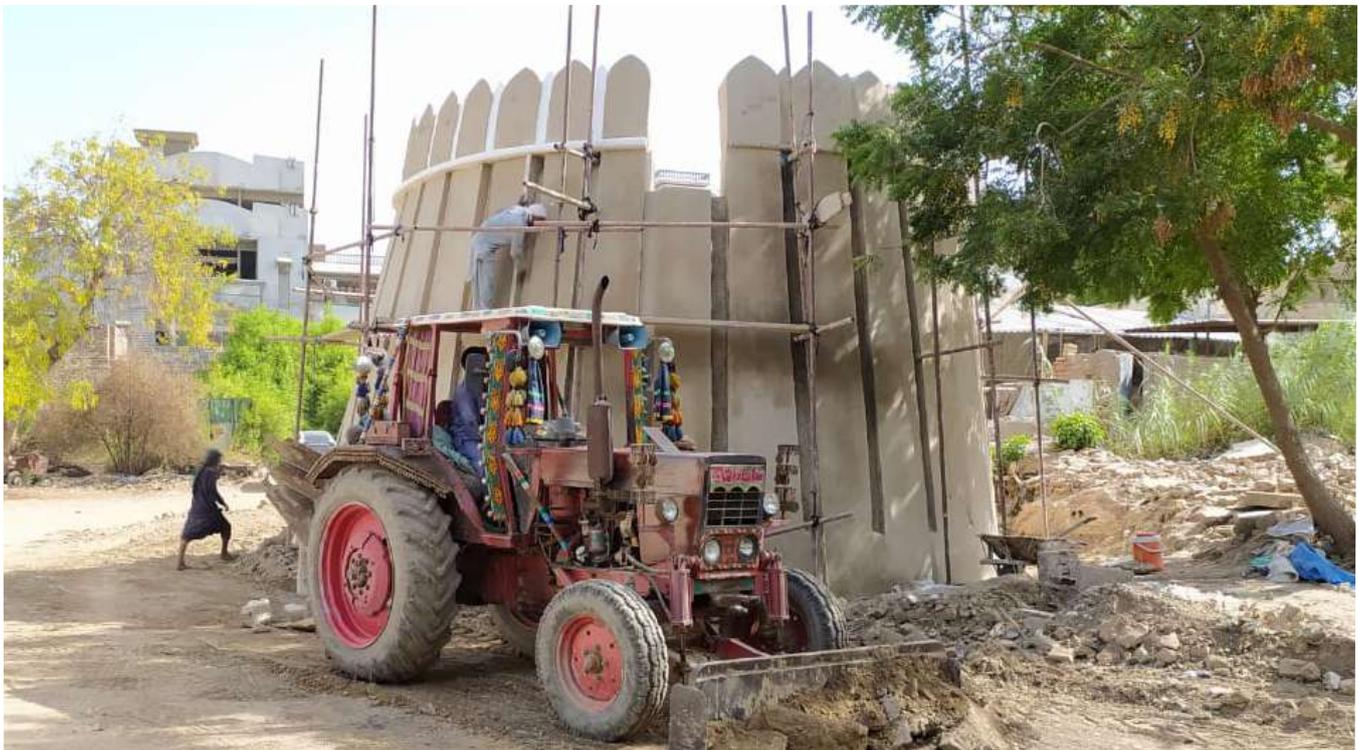
Cleaning of surroundings debris for flooring purpose

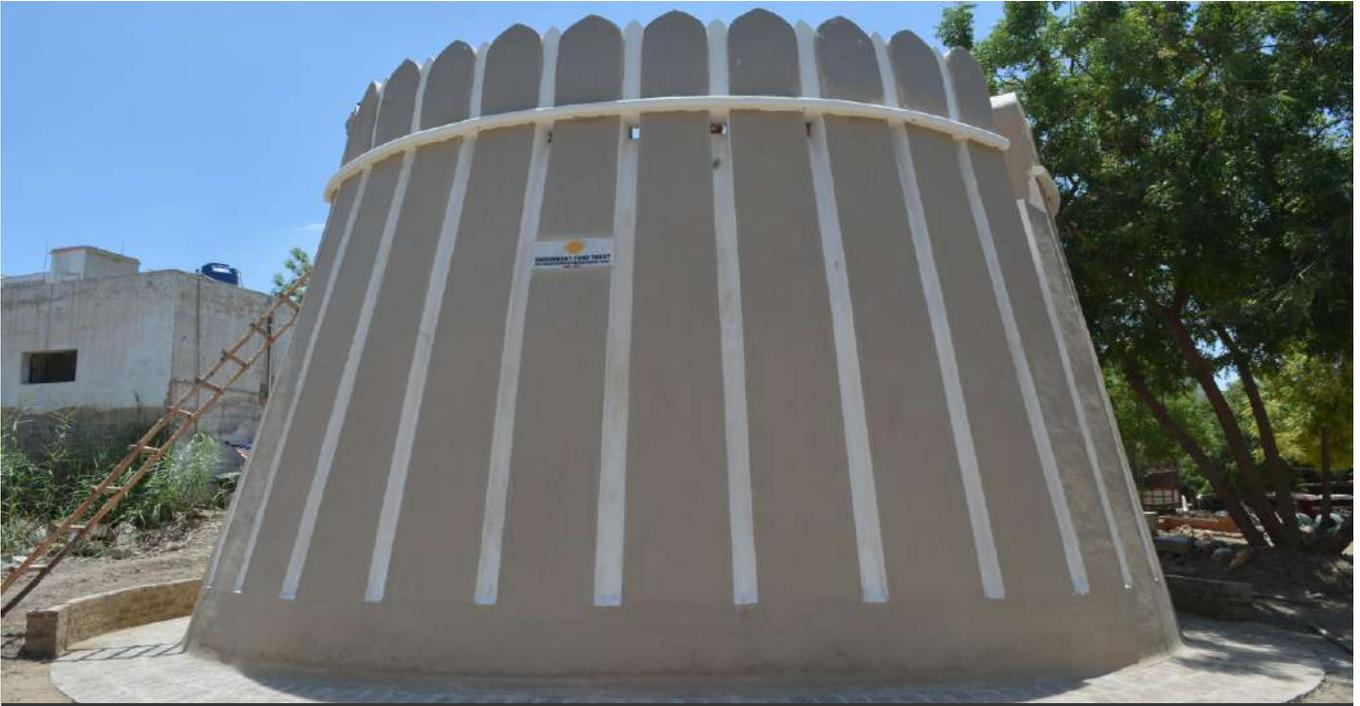
Eastern side view after Restoration of Bastion

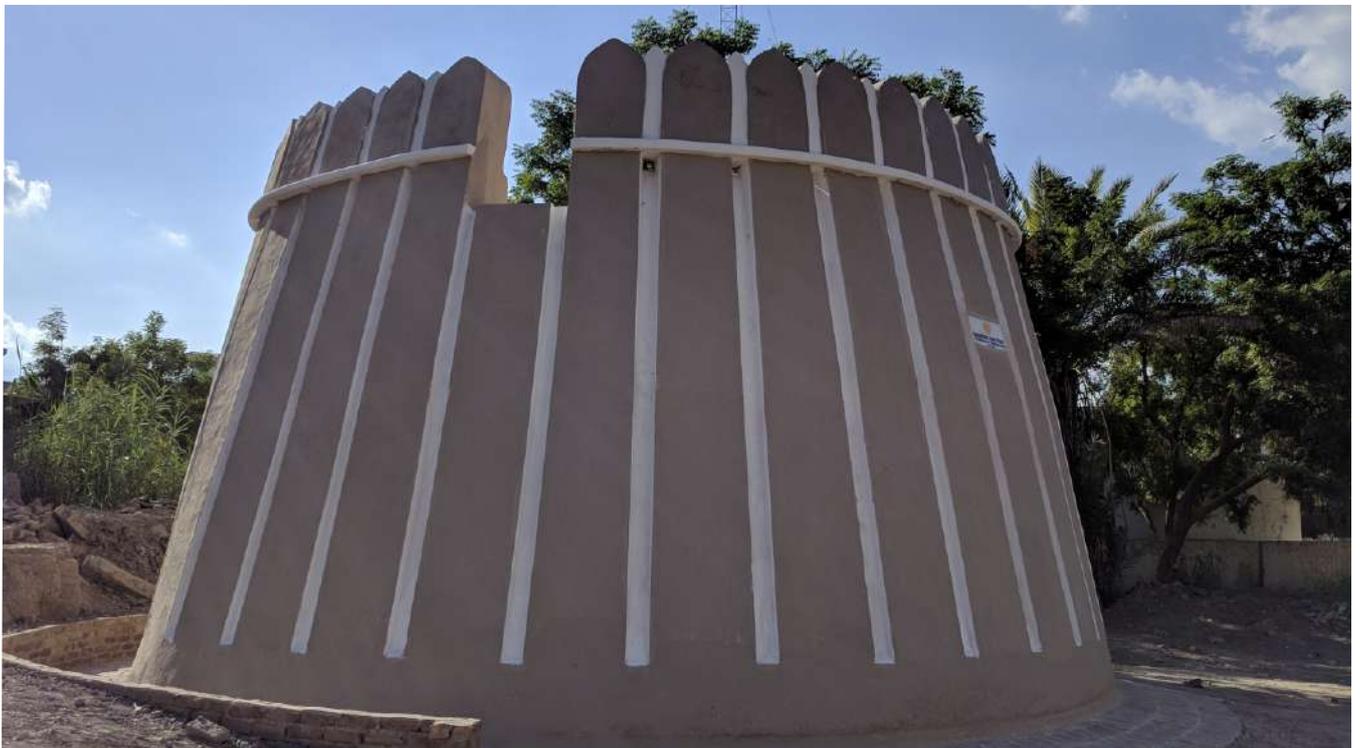
Southern side view after Restoration of Bastion

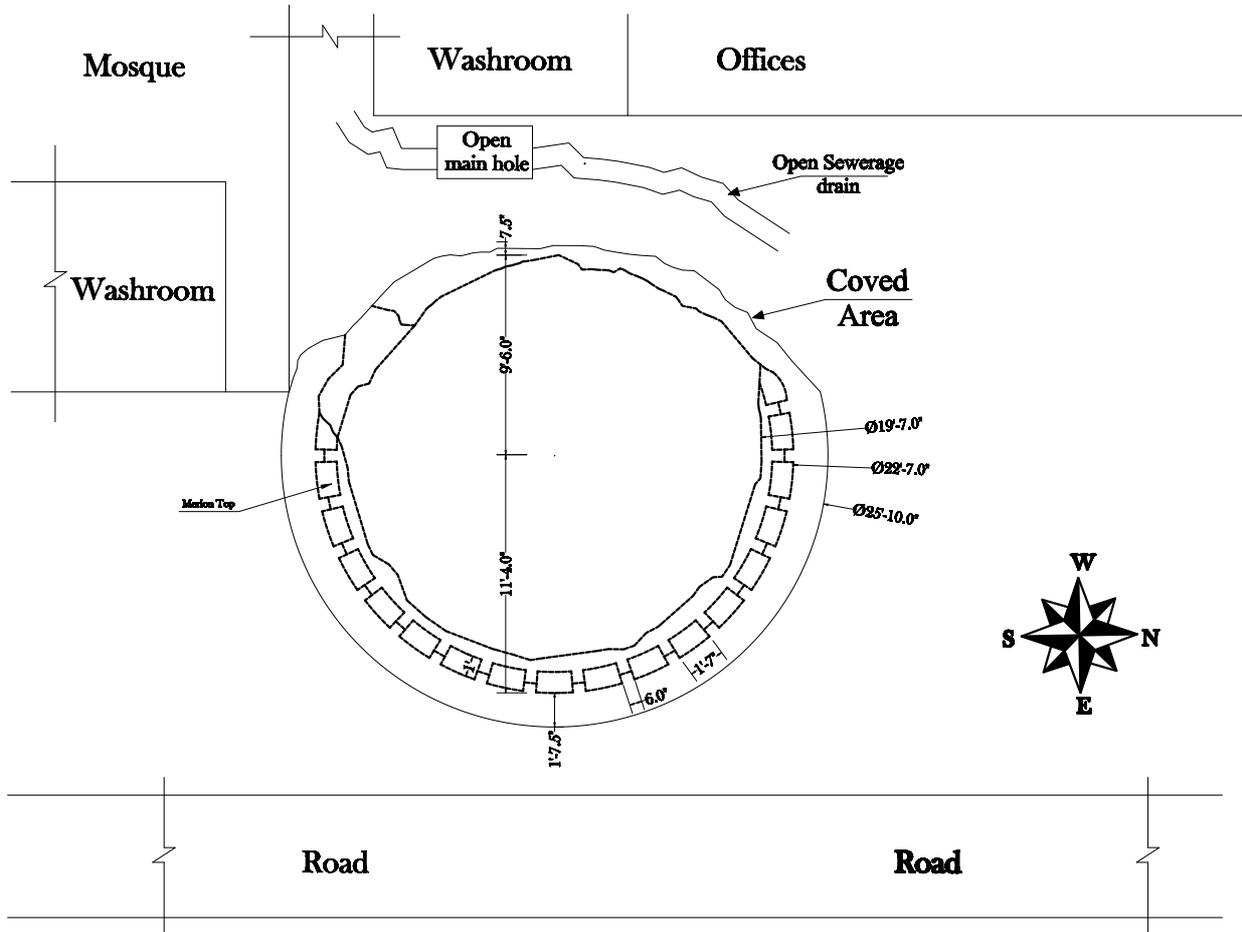
Existing Plan of Mir Allahyar Fort Mud Bastion

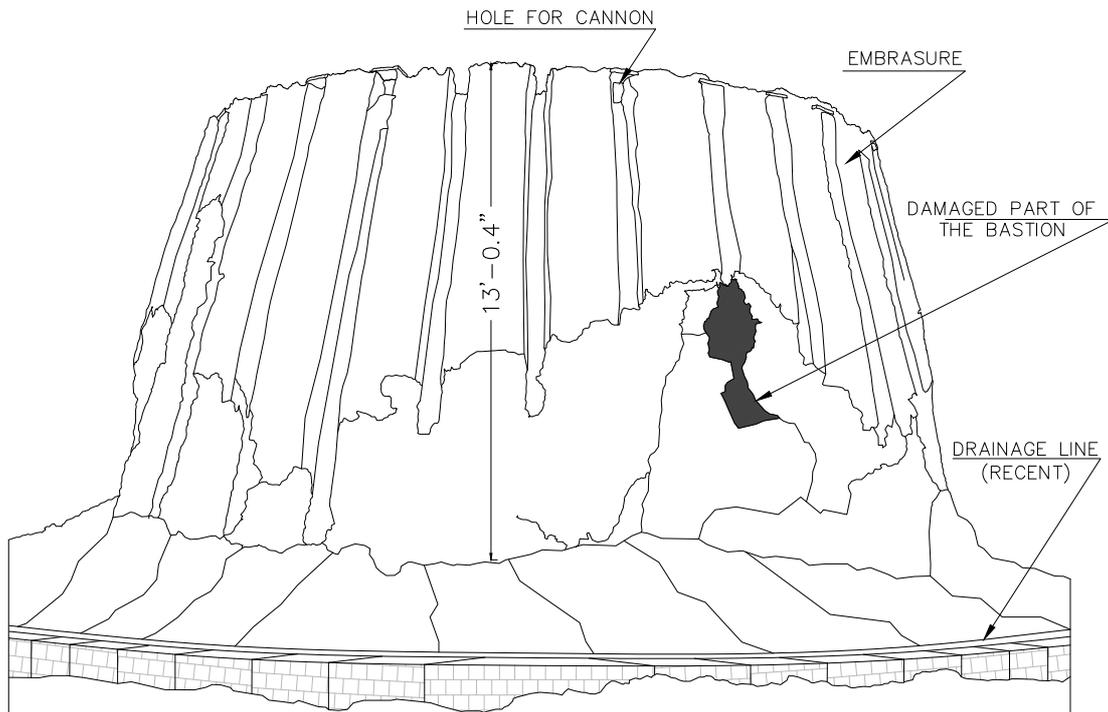
Existing Elevation of Mir Allahyar Fort Mud Bastion

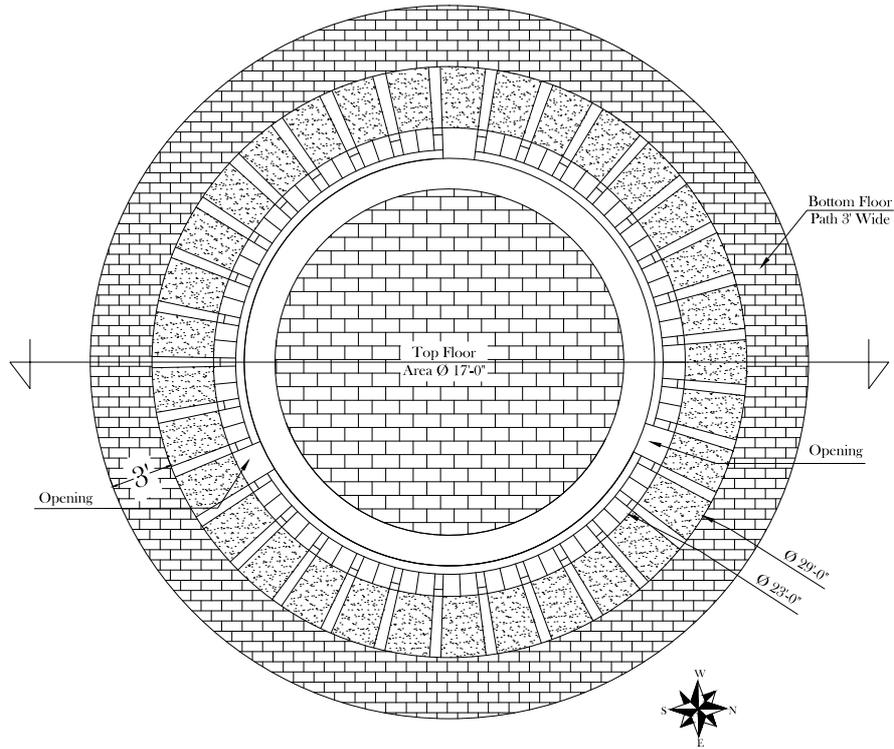
Proposed Plan of Mir Allahyar Fort Mud Bastion

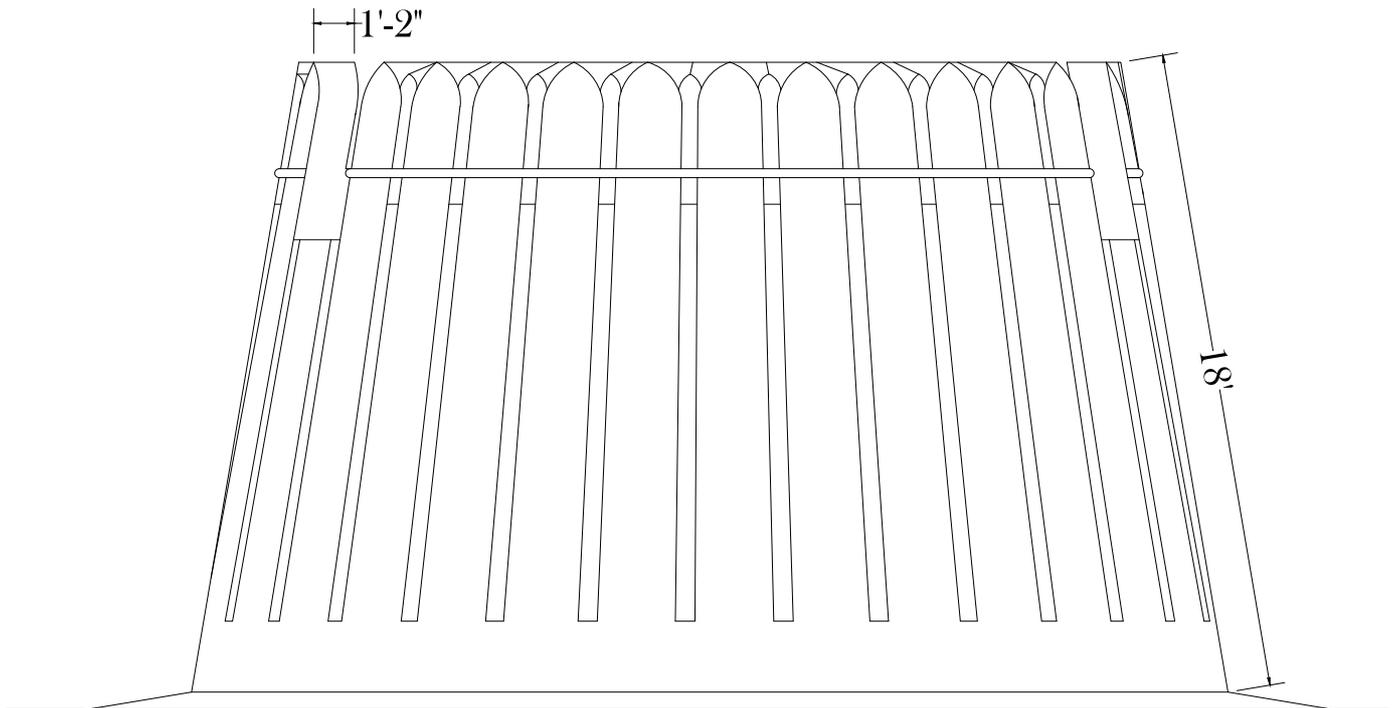
Proposed Elevation of Mir Allahyar Fort Mud Bastion
