**PROJECT COMPLETION REPORT**  
**MAI JAMAN**  
**MOSQUE**  
**December | 2024**

**Endowment Fund Trust**  
**for Preservation of the Heritage of Sindh**

## COMPLETION REPORT: MAI JAMAN MOSQUE

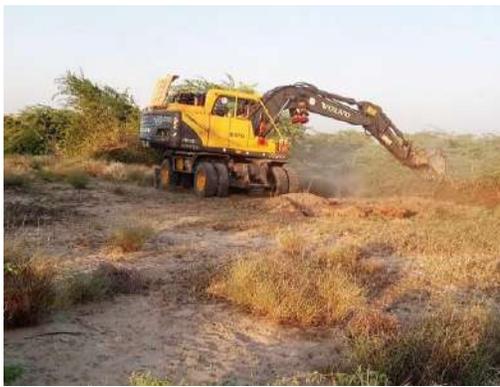
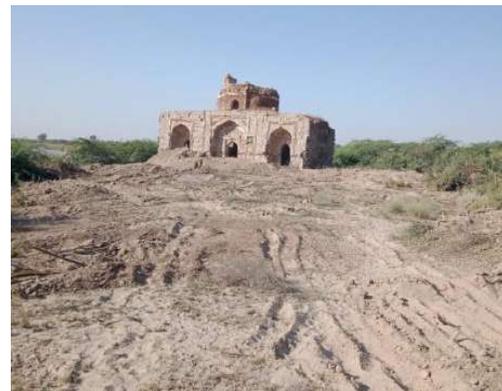
**The Mosque after jungle clearance in 2021**

The mosque was in a completely dilapidated state when the EFT survey team arrived to document the structure. Eventually, it was agreed that it is one of the few heritage structures extant in the region and conservation is imperative. As the mosque was to be rehabilitated and would be a living

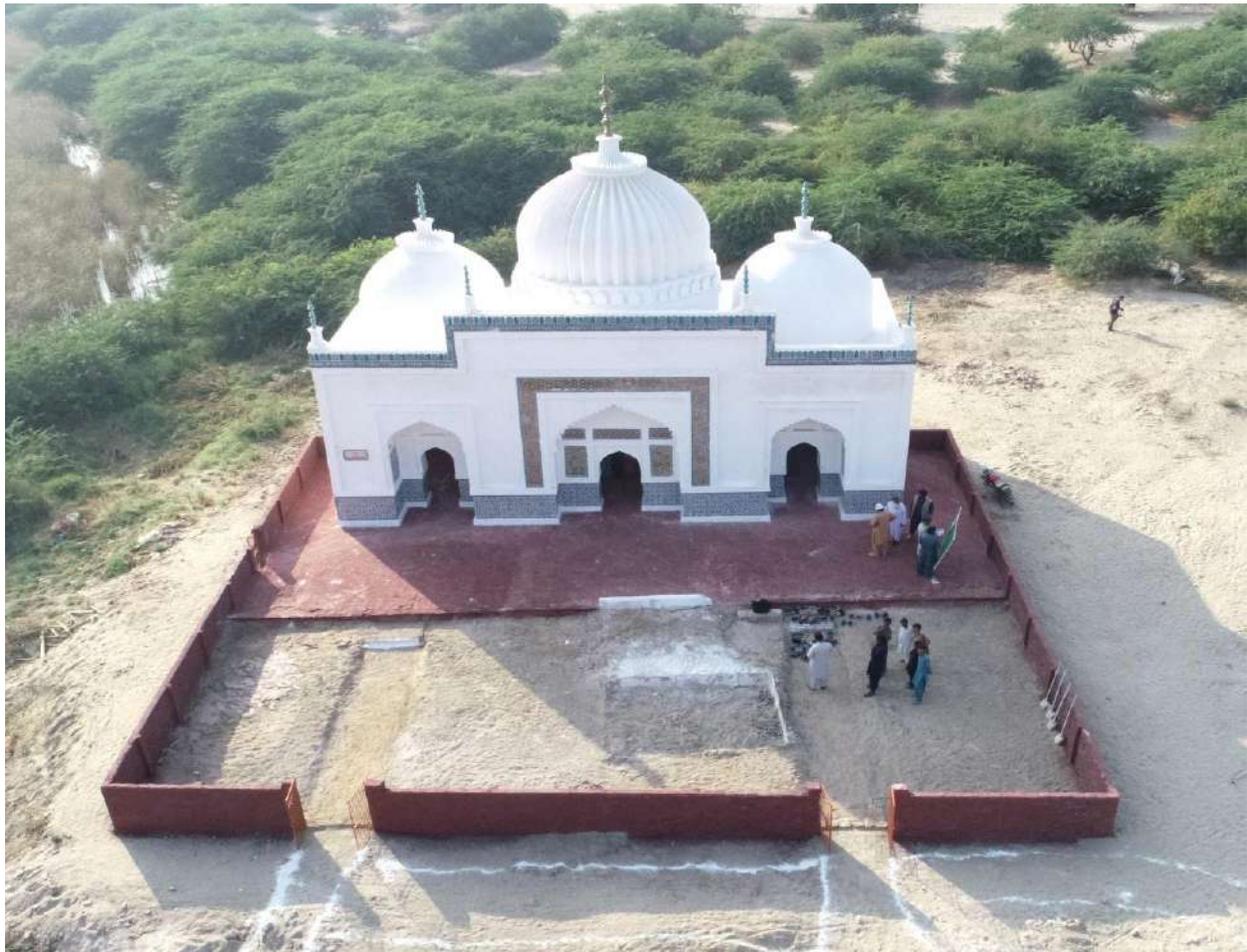
**Drone image of mosque after conservation**

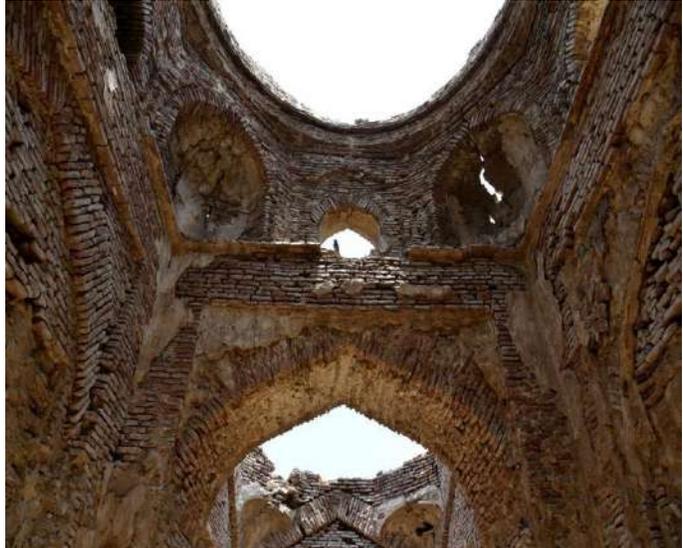
- The exterior side of the mosque shows the black staining of bricks; shear cracks due to tensile stress caused by settlement; detachment of spalled bricks at places and displacement.

- The interior sides show severe spalling; bulging; and displacement of the masonry work. The arches appear intact although keystone damage is observable and might need replacement. The majority of plaster has fallen off. The tile work is barely evident anymore.
- The floor appears to be uprooted. This might be due to the work of greedy desecraters. Many of the rubble appear to be missing from site including the bricks from the collapsed domes and kashi from the panels.
- Underpinning is advisable although the foundation still appears sturdy.
- The structure is surrounded by overgrowth which would need to be cleared as plant roots play a role in foundational failures. This will also allow more accurate measurement of the structure and improve accessibility.

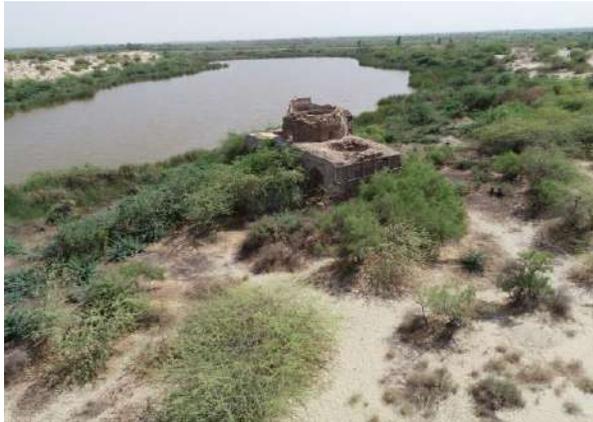
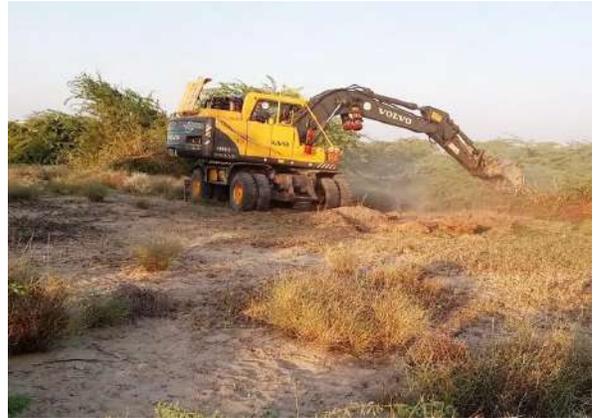
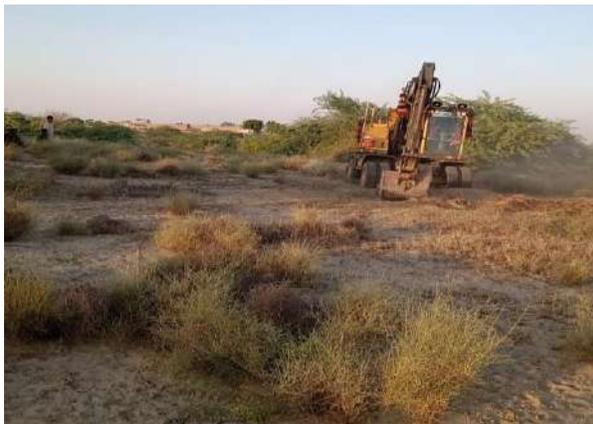
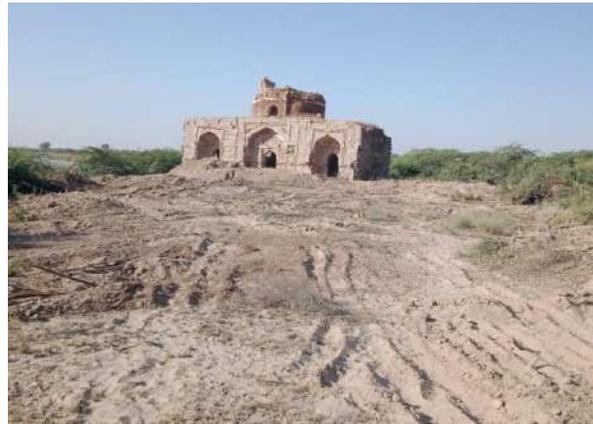
The Mosque is located about 4 kilometers away from the town of Chotiari. It is constructed on top of sand dunes known as "Joghi Bhit." On its northern side lies a small village, while to the south, there is a beautiful natural lake. For centuries, this abandoned mosque remained hidden amidst bushes and dense jungle.

With the help of heavy machinery such as excavators and tractors, the thick jungle was cleared, and the sand dunes were leveled. Skilled masons were brought in from the Drigh Balla site in Johi, Dadu. Various construction materials were transported from different locations: bricks from Shahdadpur and Chirol, lime from Thatta, and sand from Bholahari.

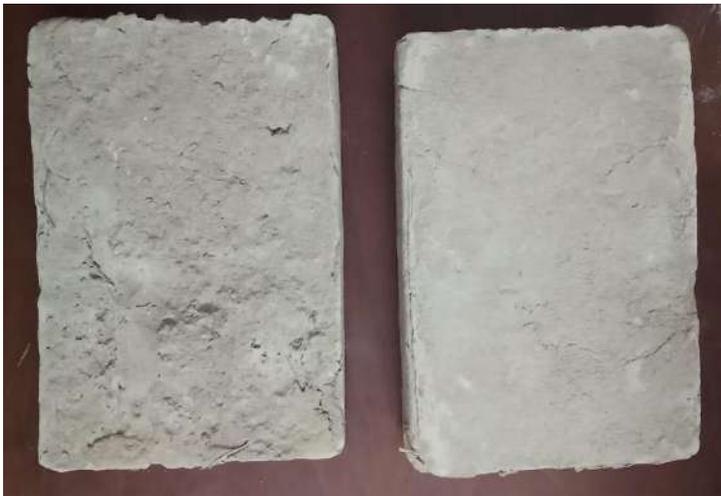
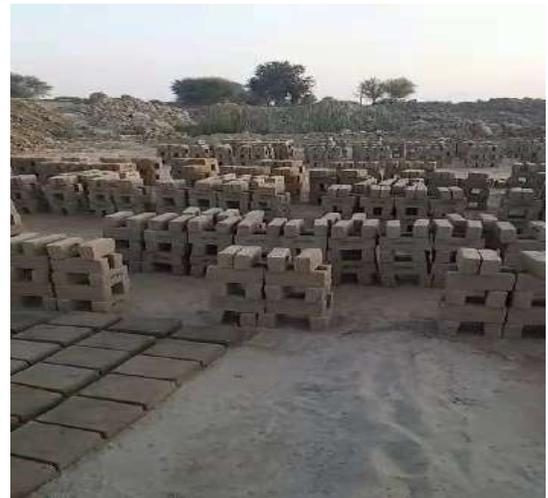
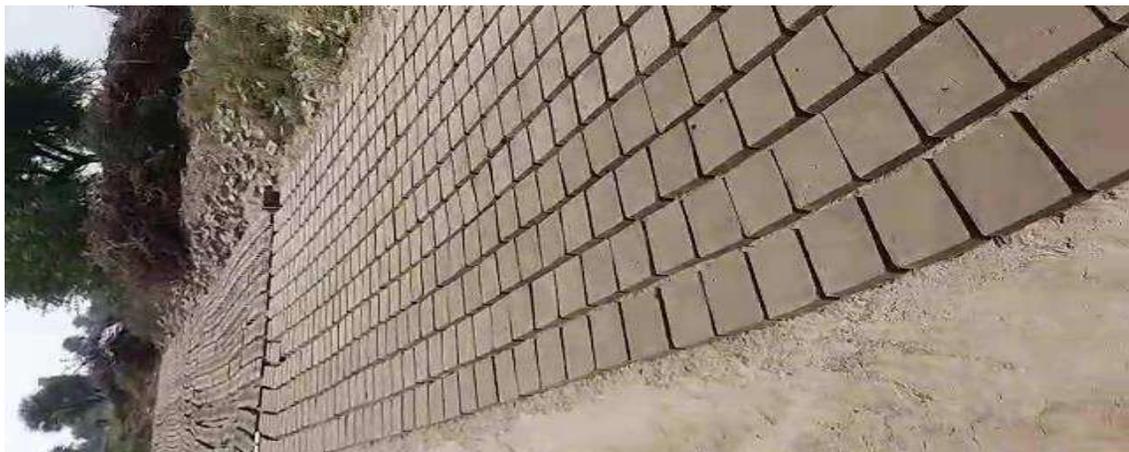
The bricks used in the old structure from the Kalhora period measured 9×6×1.5 inches. This size of brick was not available in the market. To produce these bricks, suitable mud and a kiln were selected in Shahdadpur, located about 40 kilometers away from the site. Approximately 35,000 bricks were required to restore the old structure.

**Kalhora period bricks size were not available in the market to produce these bricks the kiln was selected in Shahdadpur.**

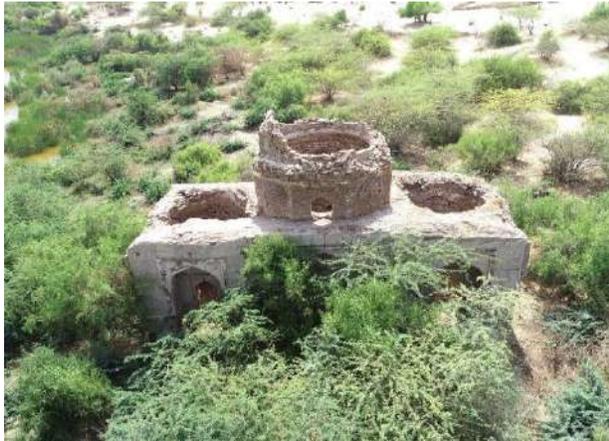
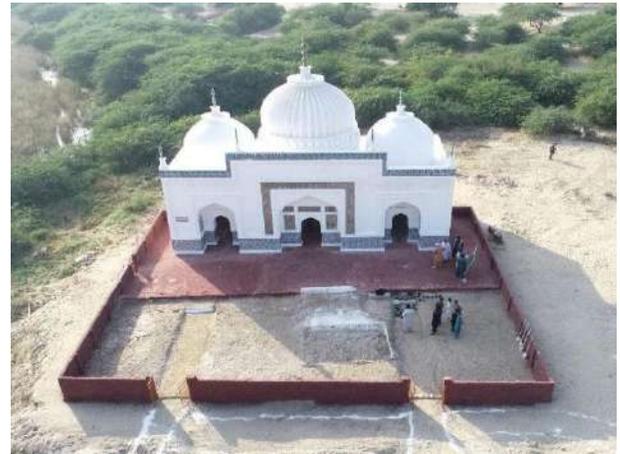
**Before**

**After**

The EFT technical team restored various issues, including spalling, bulging, displacement of masonry, black staining, and plaster deterioration of exterior walls. The restoration process of walls involved applying a first coat of Chirolly, followed by two coats of lime covered with lime cream mixed with soapstone.

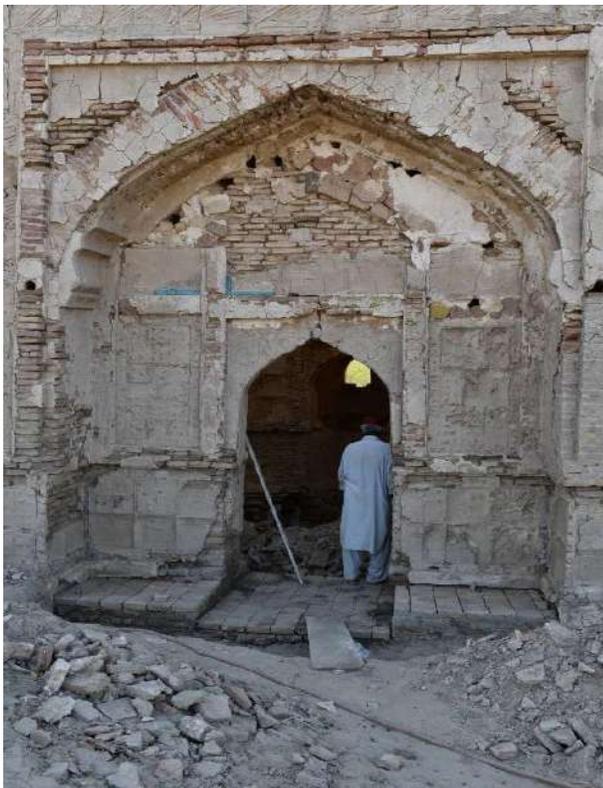
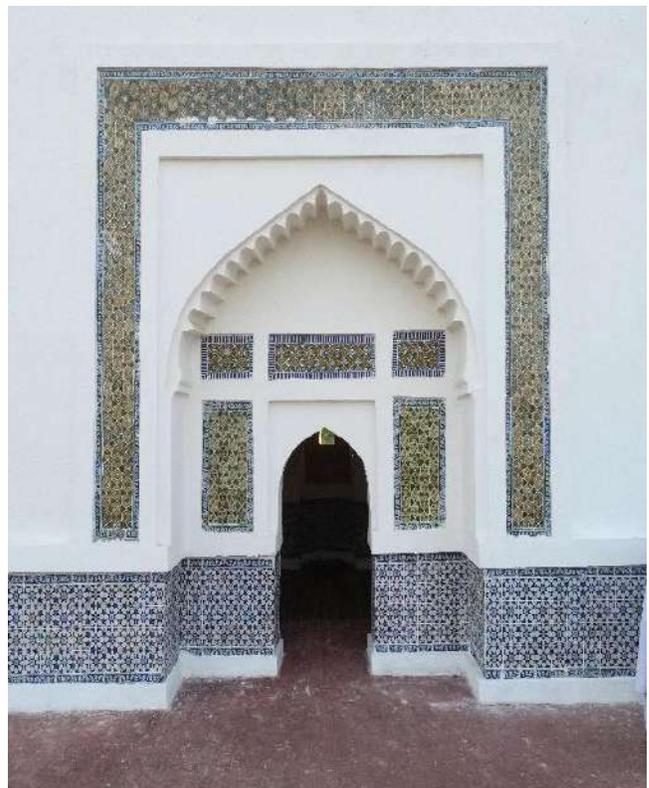
**Facade Before**

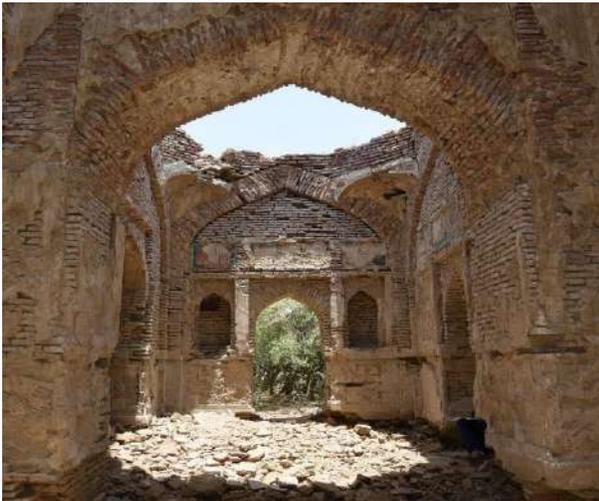
The interior walls show severe spalling, bulging, and displacement of the masonry work. The floor appears to have been uprooted, likely due to the actions of desecrators. Many pieces of rubble, including bricks from the collapsed domes, are missing from the site. Underpinning is advisable, although the foundation appears to be weak. Additionally, the structure is surrounded by overgrowth, which needs to be cleared, as plant roots contribute to foundational failures.

**Before**

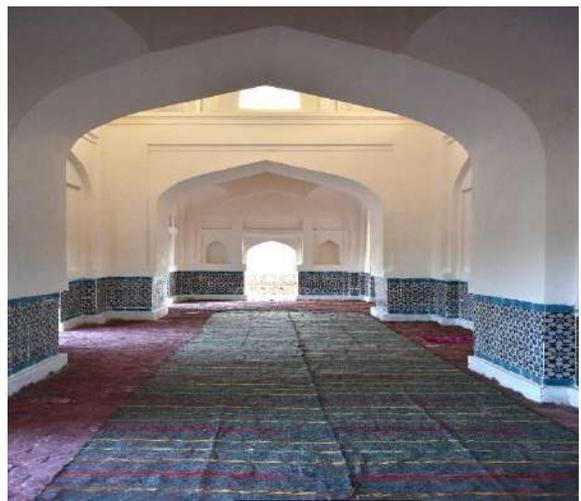
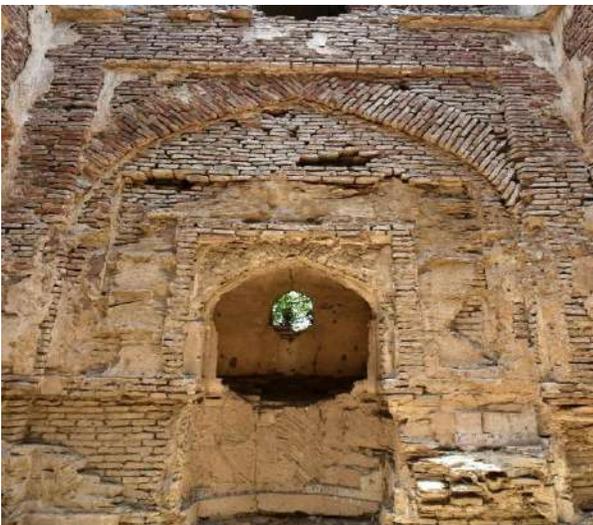
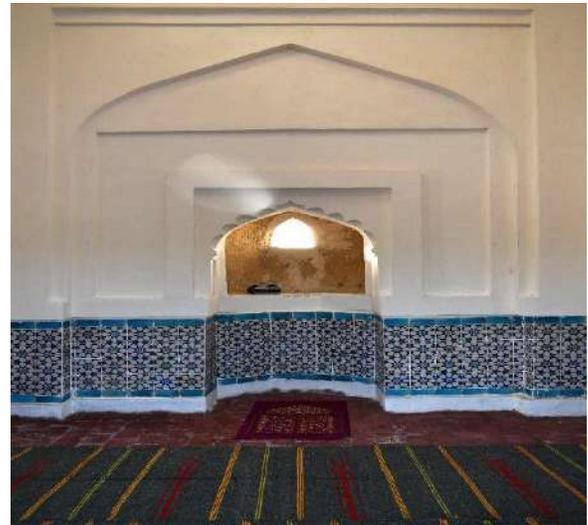
View of interior Arch showing the exposed, weathered and missing bricks. New homogenous bricks were incorporated into the structure to ensure stability.

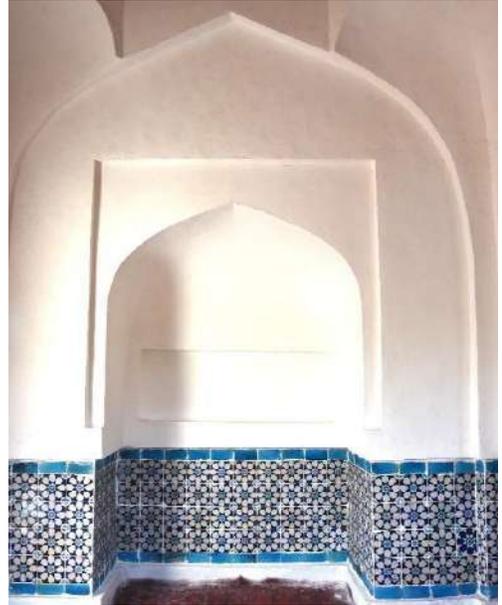
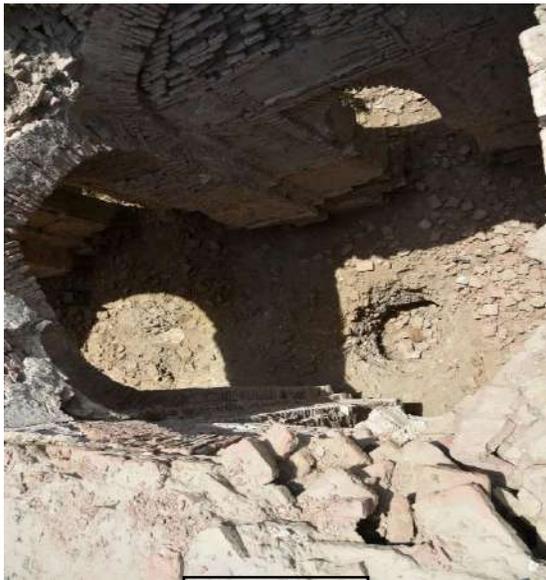
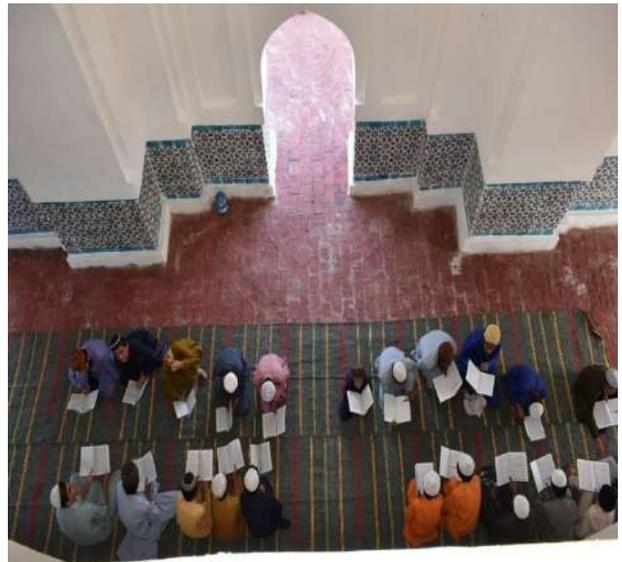
Animals and treasure hunters had dug numerous tranches inside the structure. Additionally local people had taken bricks from the site for their own use.

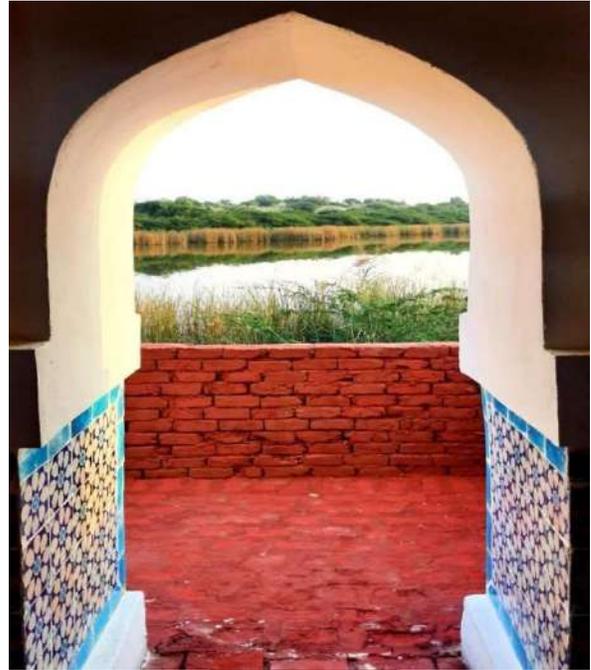
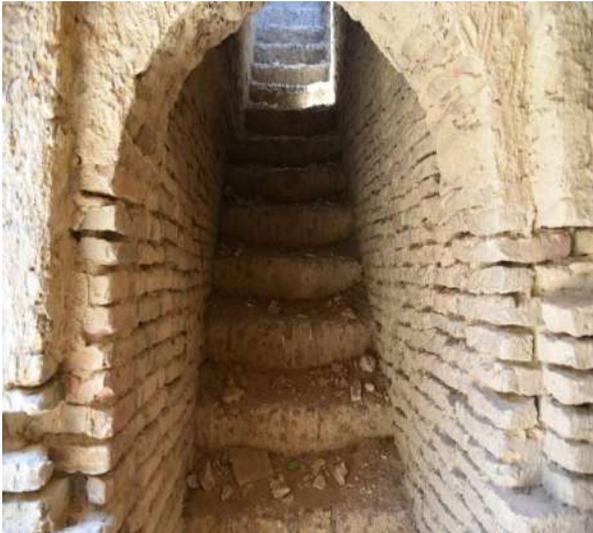
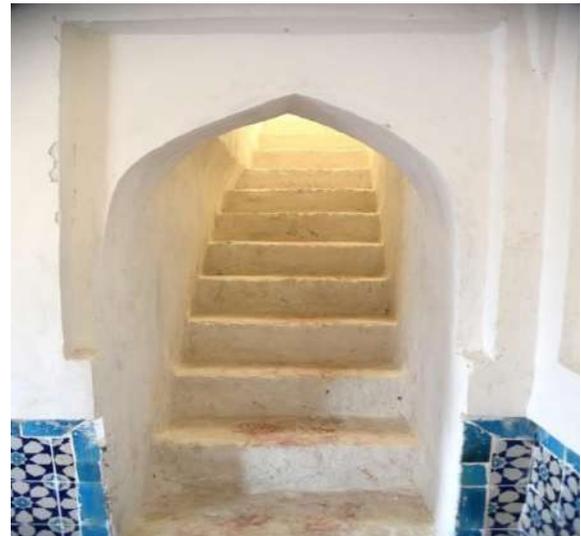
The Mae Jaman Mosque is a rectangular structure featuring three domes, two of which have entirely collapsed. Only the octagonal drum of the massive central dome remains, but on the verge of collapse, with unstable and irregular squinches.

When restoring the mosque, the squinches were initially reinforced by incorporating steel bars. A lintel was subsequently installed on the octagonal drum of the central dome. After the drum was rebuilt, the center dome was redesigned utilizing computer assistance. Thus, the two smaller domes were designed. Thus the structure was reconstructed to the original form of the three collapsed domes, brick by brick.

Finally, the domes were plastered with one coat of chiroli and two coats of lime. To protect them from rain and moisture, lime was applied which was followed by soapstone for waterproofing. In the final stage, the lotuses were crafted, and kashi finials were erected atop the three domes.

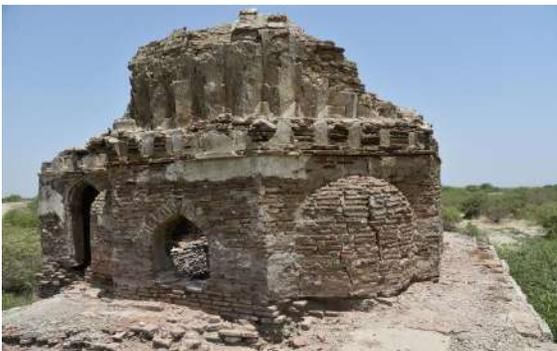
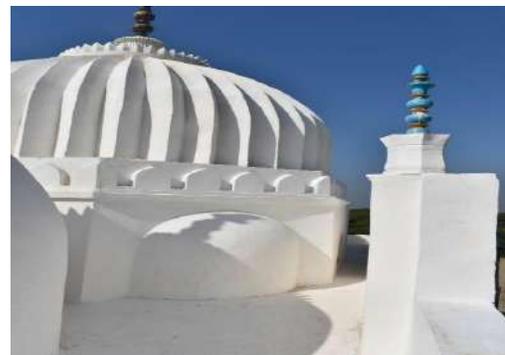
**Octagonal Drum Before**

**Octagonal Drum After**

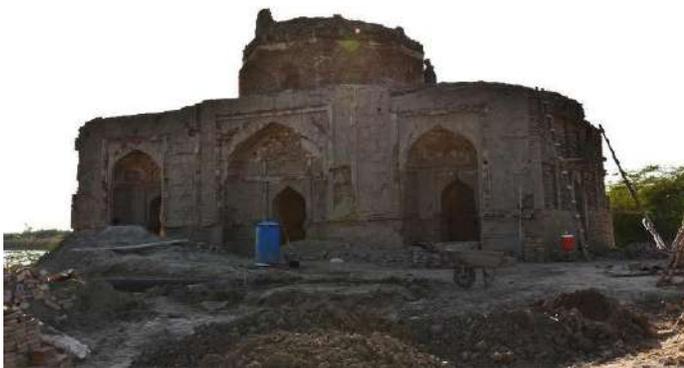
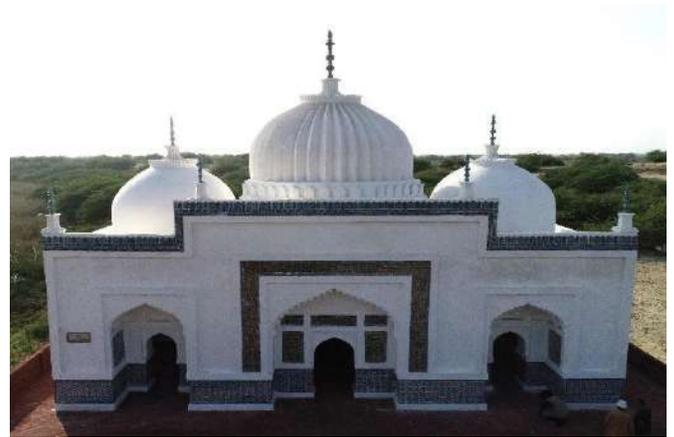
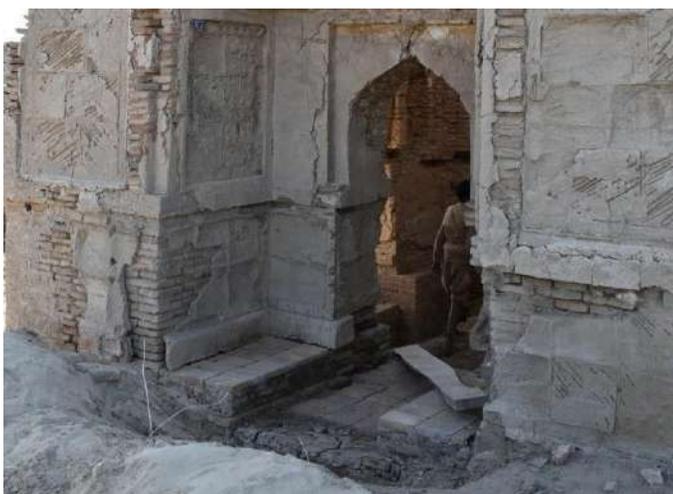
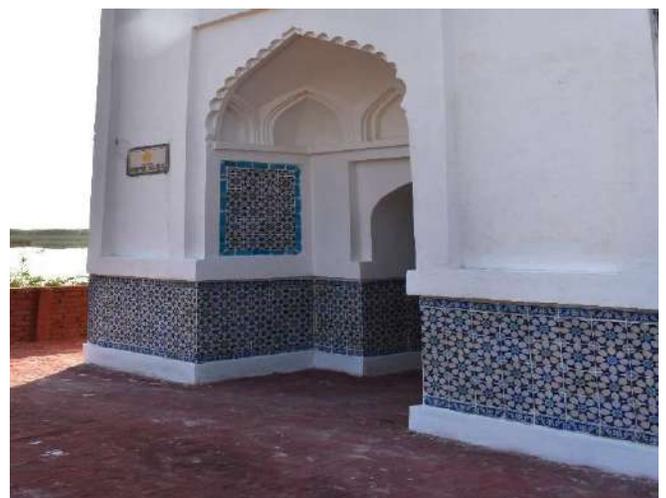
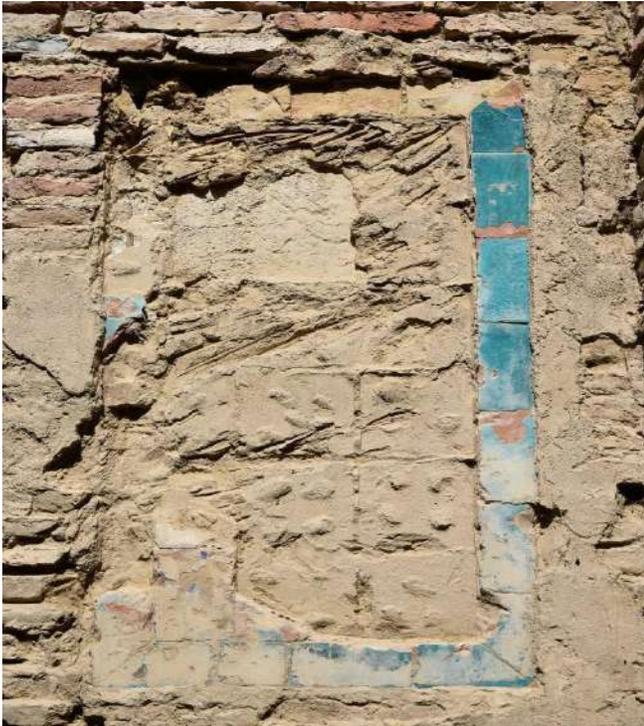
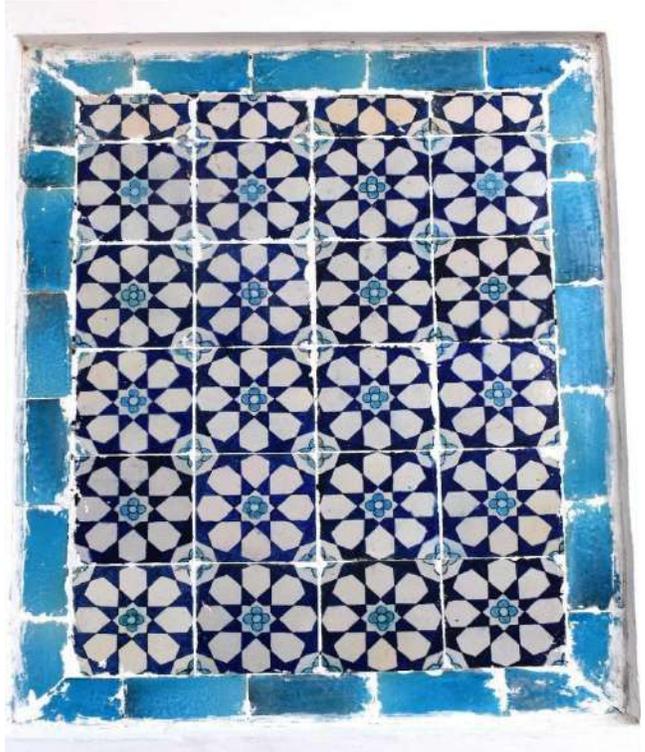
The tiles for the Mae Jaman Mosque were crafted in Halla by renowned Kashigars. The façade, dado, parapet wall, and side strips were restored using Kashi tiles of the same size and design. The Kashi tiles in the interior of the mosque were also missing, with only a few traces and broken tiles faintly visible. Mr. Kazim Alvi, a Kashigar from Halla, repeatedly visited the site to recreate the tiles with the same pattern, size, and colors.

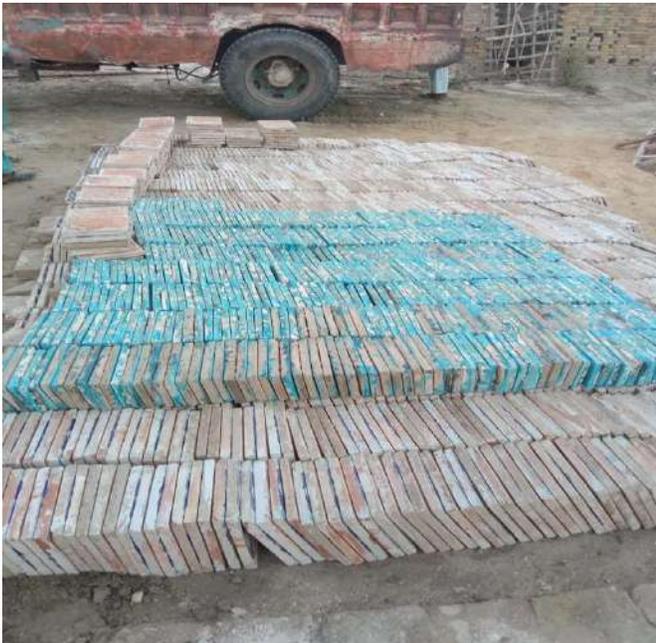
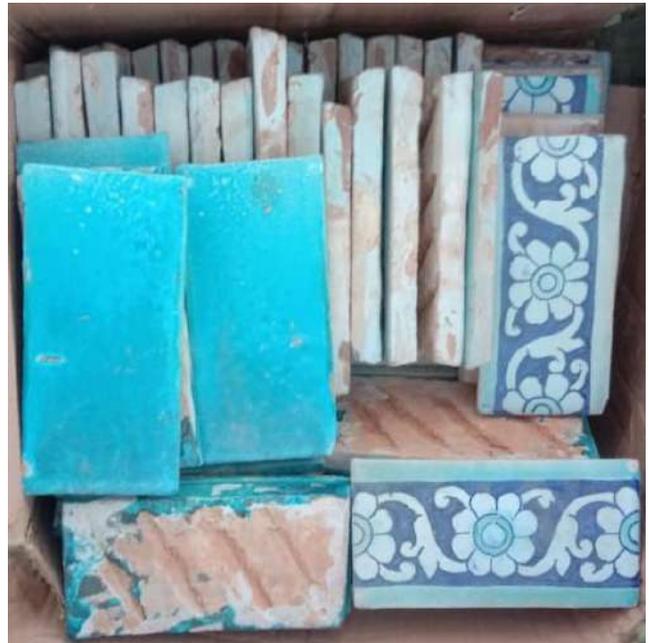
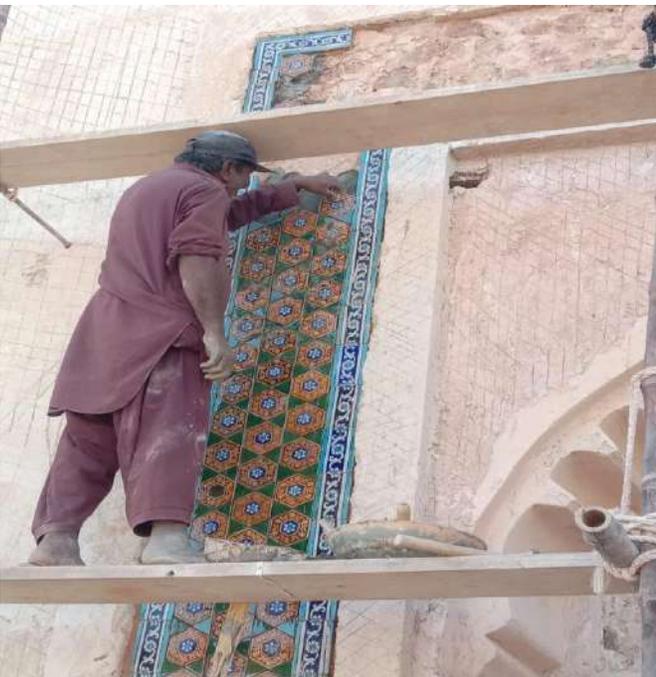
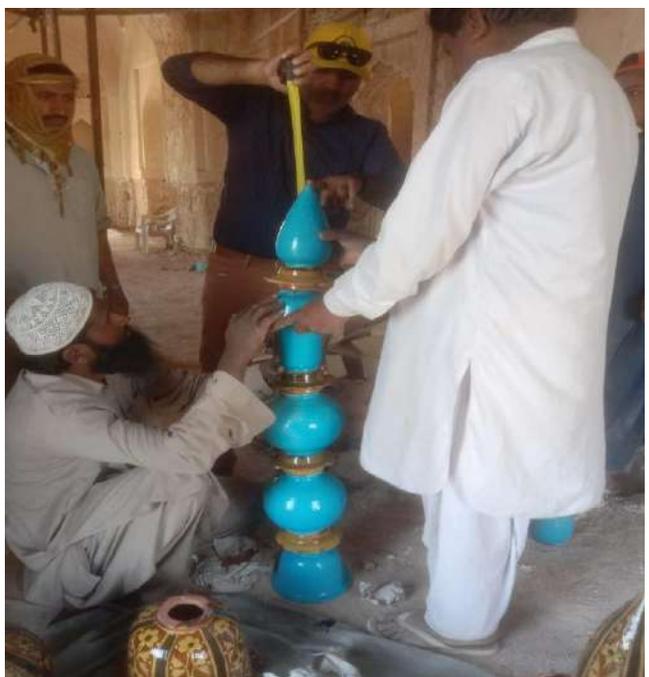
**The Kashigars from hala repeatedly visited the site to restore the tiles and finials adhering to the original pattern, size and colors.**

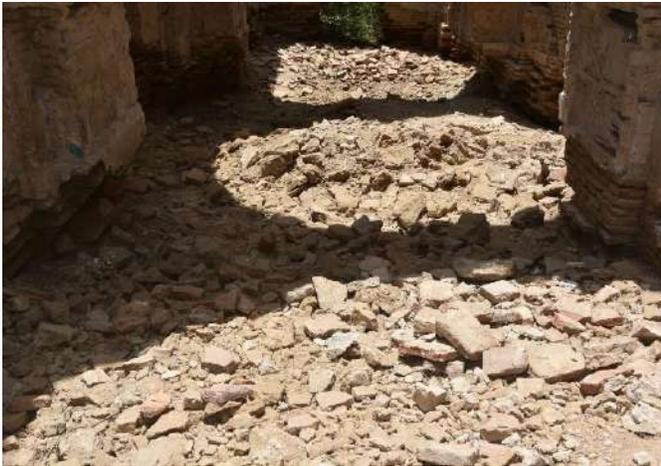
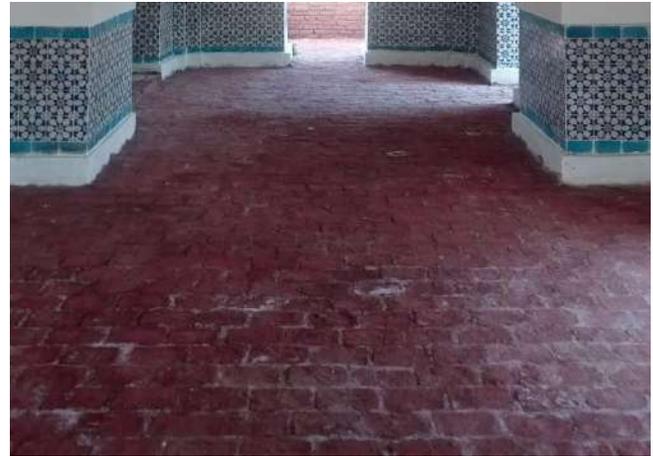
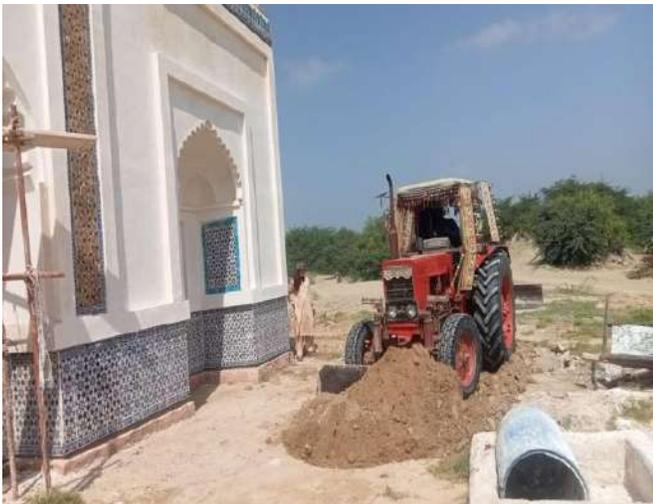
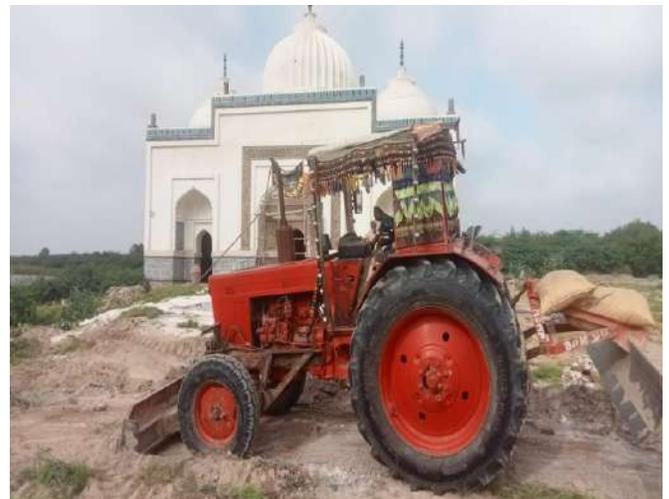
There were no traces of flooring, either inside or outside the mosque, to indicate whether tiles or mosaic were originally used. Therefore, flooring bricks were used, both in the interior and exterior of the mosque.

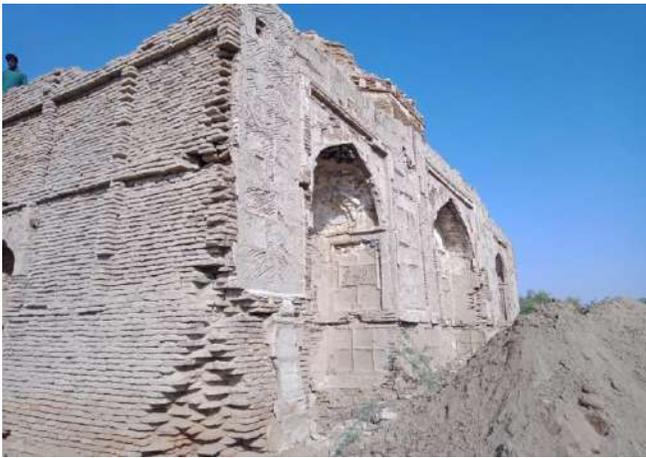
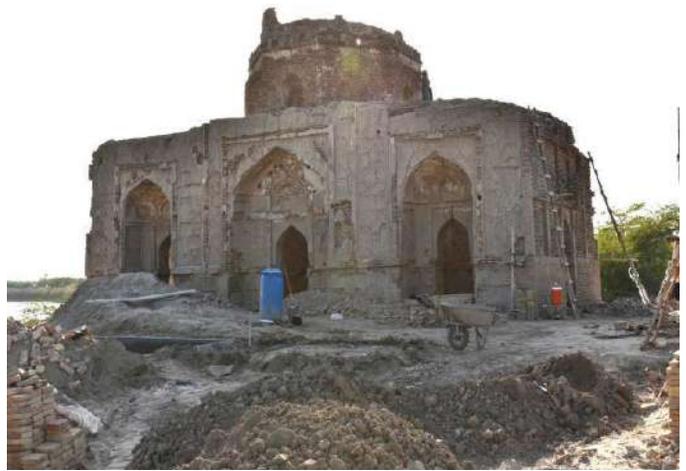
Subsequently, attempts were made to locate the old boundary wall of the Mae Jaman Mosque. To achieve this, several trenches were excavated to uncover the foundation of the Kalhora-period wall, an endeavor which proved fruitful. Using these footings, it was possible to reconstruct the brick wall around the mosque.
