COMPLETION REPORT

THE HINDU TEMPLE (SHIVA MARHI) AT MOOSA
KHATIAN

ENDOWMENT FUND TRUST
For Preservation of the Heritage of Sindh

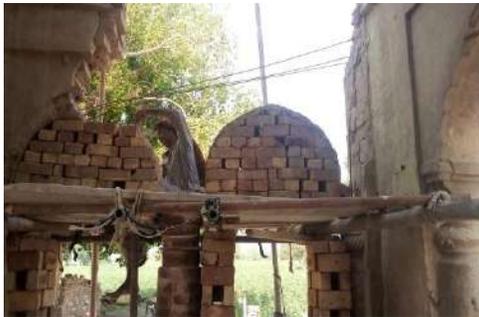
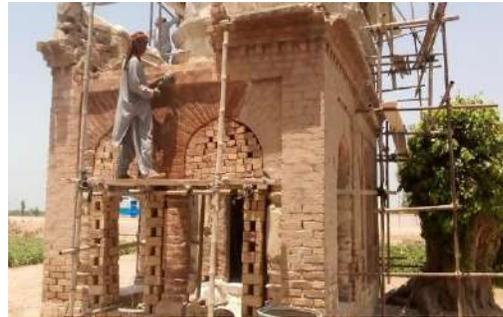
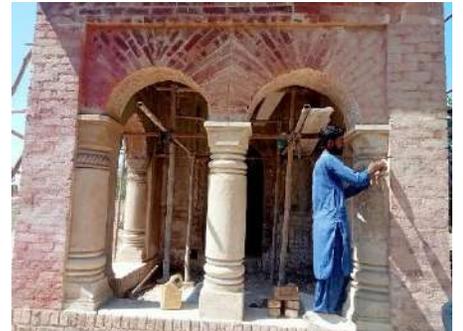
MAIN ARCH PHOTOGRAPHS:

The front arch openings were one of the most complex activities of the project. The engineers and masons on site managed to meticulously execute its reconstruction.

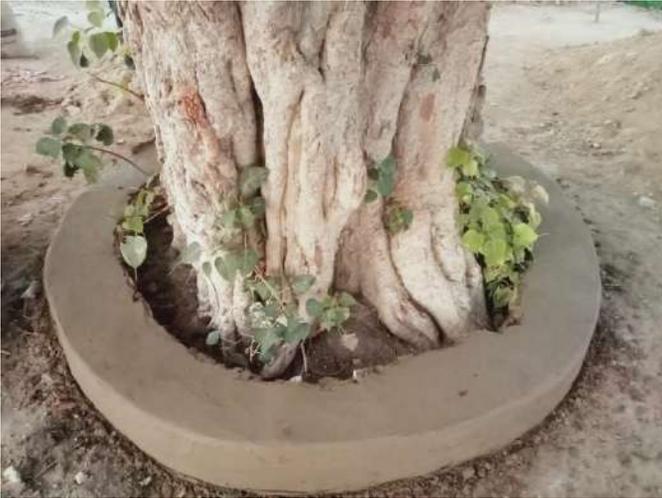
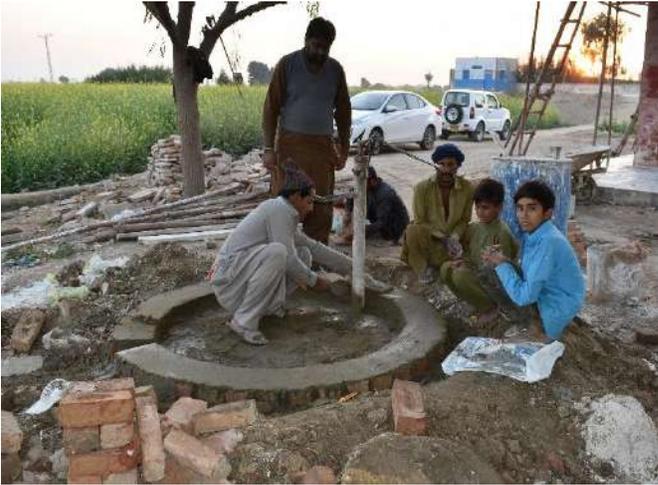
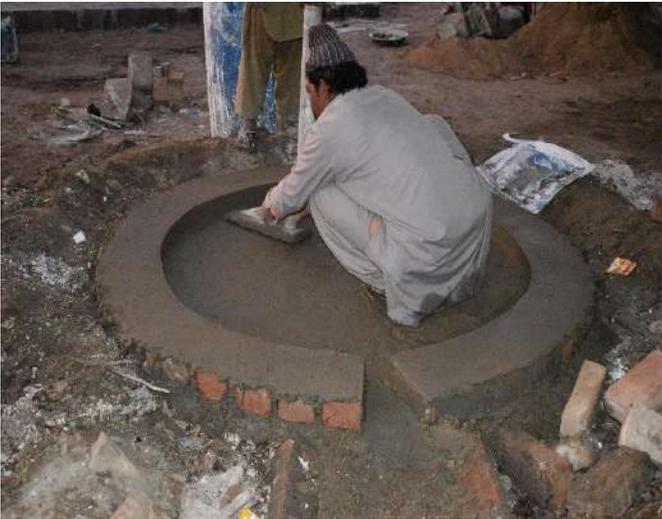
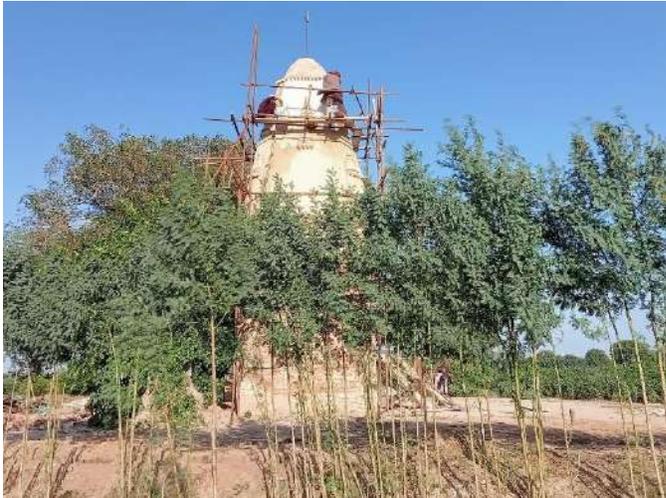
HARDSCAPING PHOTOGRAPHS:

The area around the temple was landscaped for beautification purposes.
