# GOBINDH RAM DARBAR

## Project Completion Report

**Center for Documentation and Conservation  
of the Heritage of Sindh**

**Endowment Fund Trust for Preservation  
of the Heritage of Sindh**

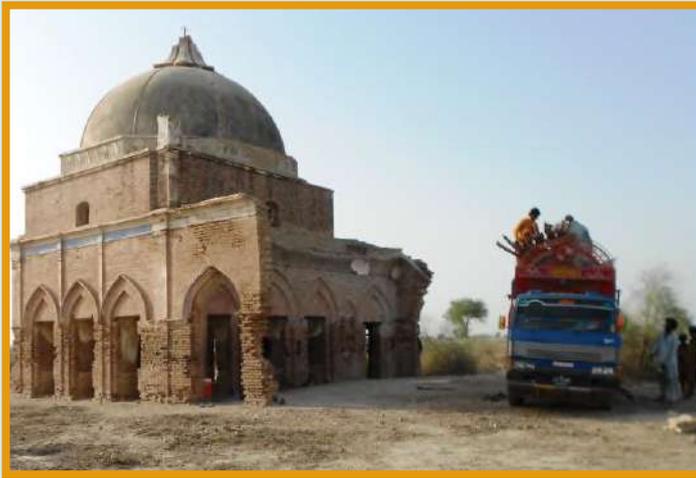
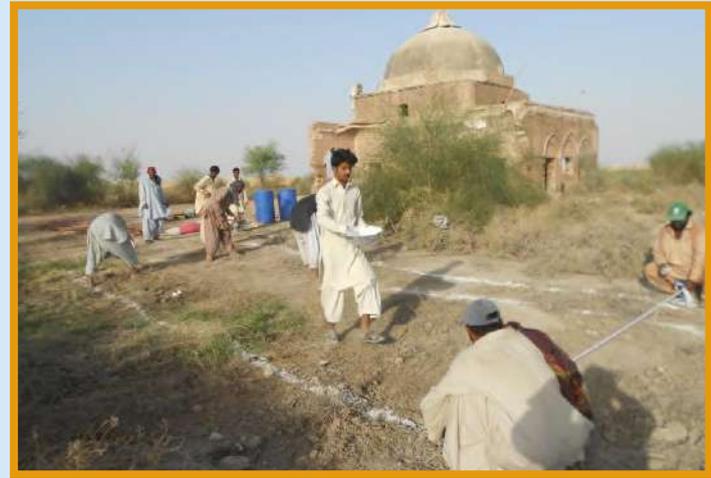
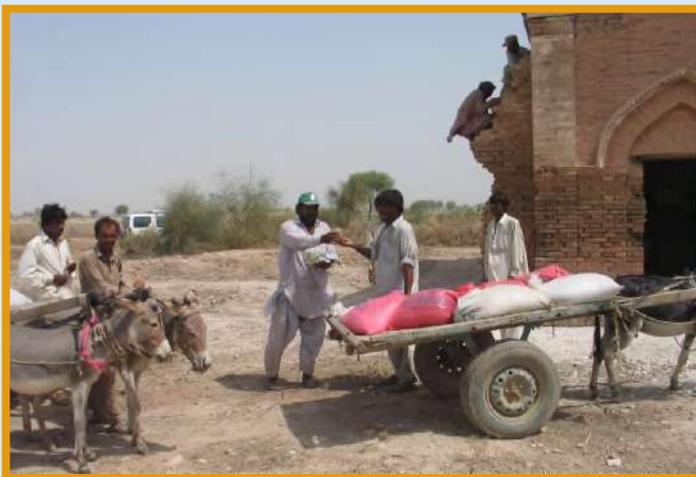
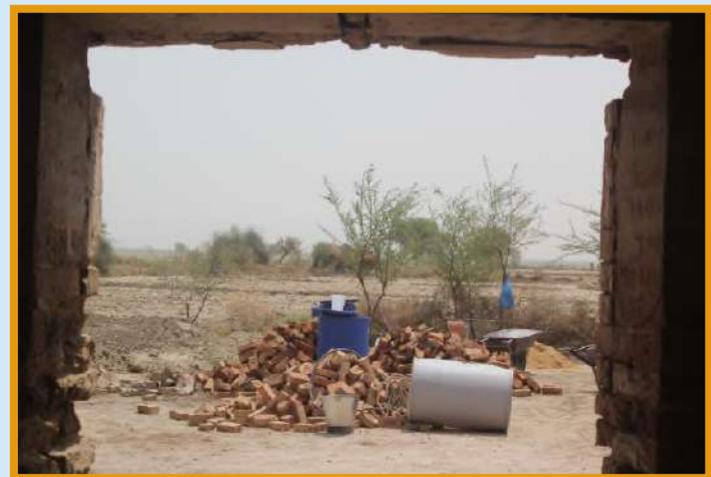
**EFT team reached at site to start the work**

- ◆ The EFT team started the restoration work at Gobindh Ram Darbar in the last week of August 2014.
- ◆ Construction Material and other tools are purchased.
- ◆ Temporary Office is Established.
- ◆ Supervisor and Labors from Hyderabad are shifted at site.
- ◆ One tank for lime mixing is constructed.
- ◆ Construction of water tank is under process.

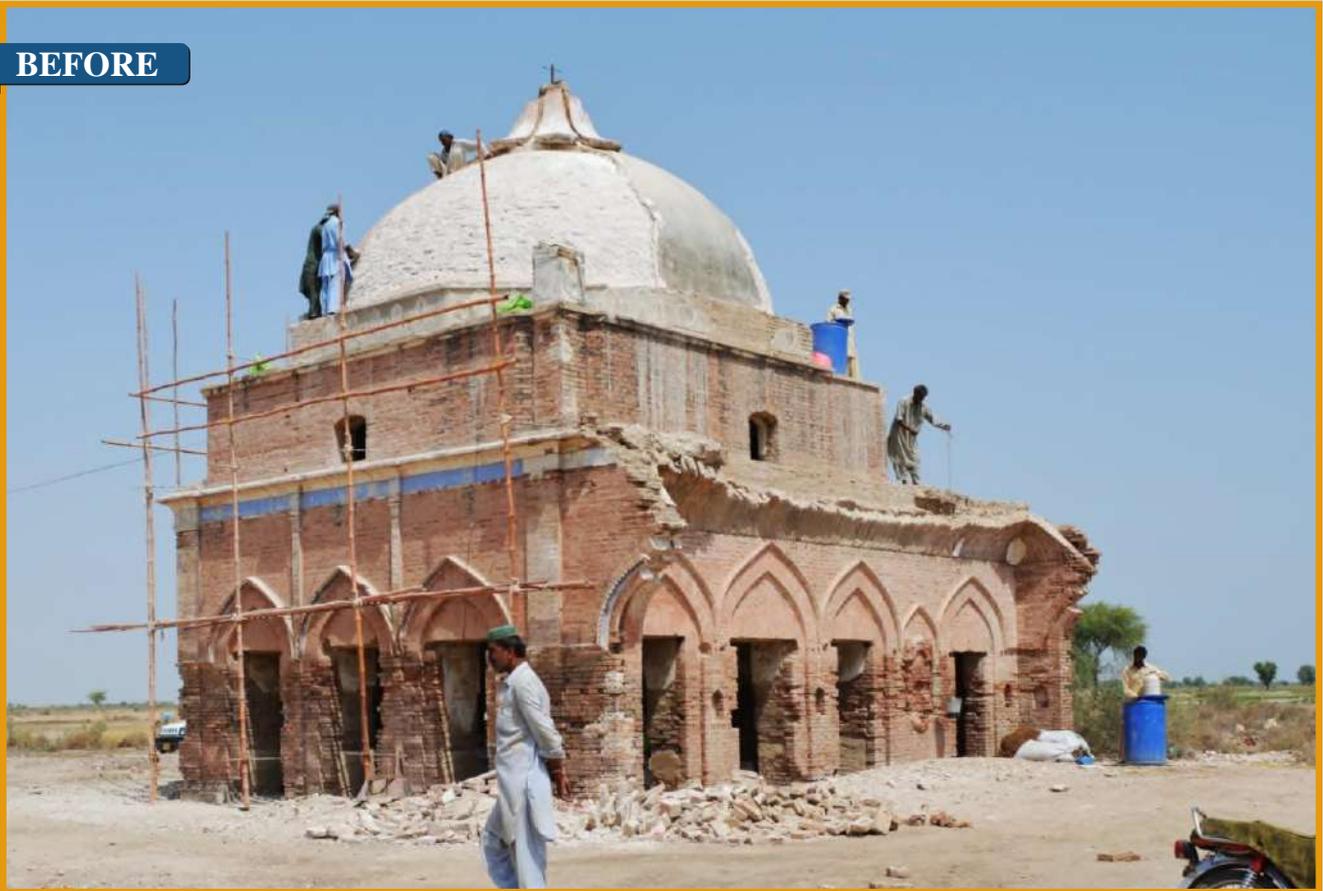
**BEFORE**

- ◆ There were rooms and verandas connected to central portion but they are completely destroyed except one hall in the north side and a portion of veranda in east having the signs of through roof but were destroyed and have two arches in either side.
- ◆ Due to Flood water and negligence, the building has developed cracks and fissures in the structures.
- ◆ Finial on the dome is completely destroyed.
- ◆ Minor cracks are appearing on the dome and plaster needs repair.
- ◆ Design on octagonal drum & Floral Pattern are completely destroyed.
- ◆ Cracks found in the circular arch of hall at northern side.
- ◆ Small niches with ogee arch constructed with carved bricks are damaged.
- ◆ Interior walls decorated with fresco work needs treatment.
- ◆ Floor tiles completely destroyed.
