# SAHIB MAHAL

Project Completion Report | 2018

Center for Documentation and Conservation of the Heritage of Sindh  
Endowment Fund Trust for Preservation of the Heritage of Sindh

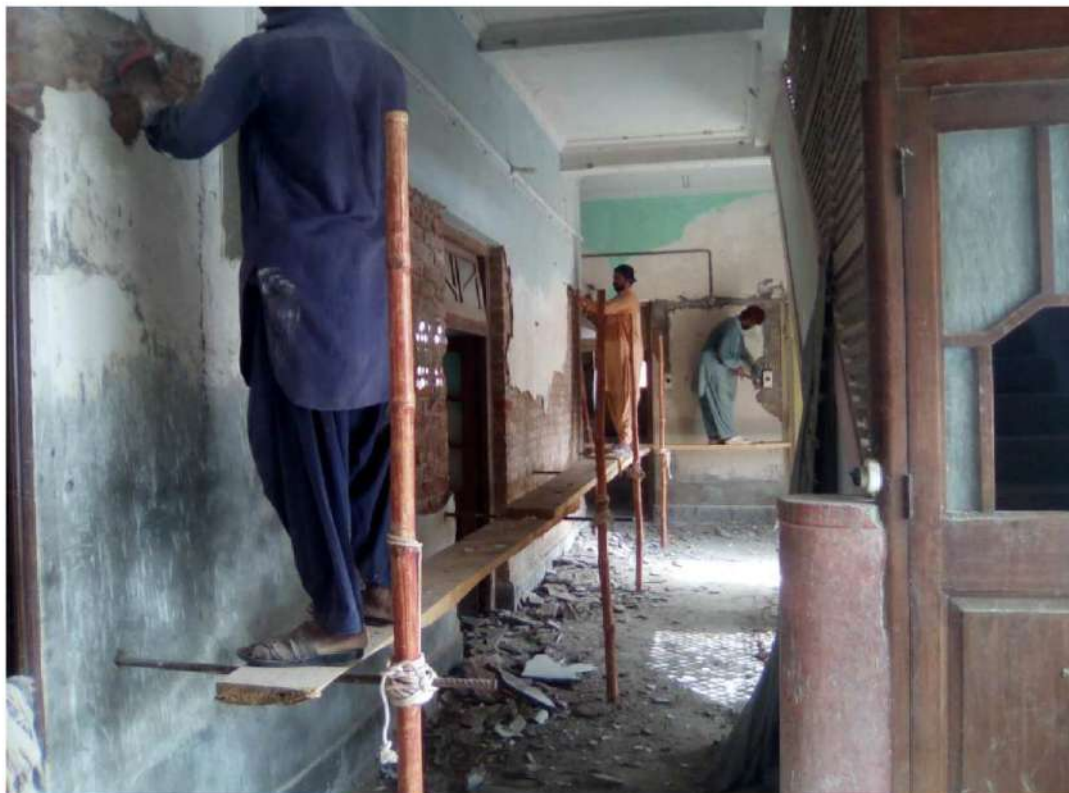
**labours are working to remove the salt effected portions of walls**

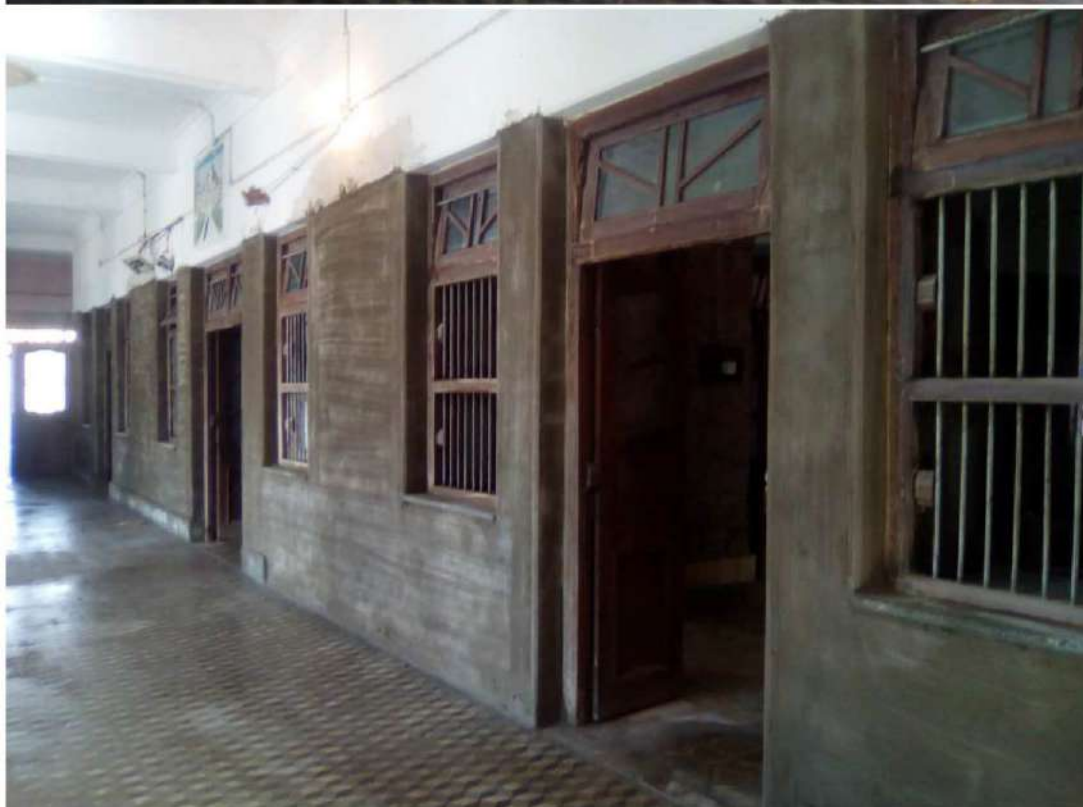
1st Coating of Cement

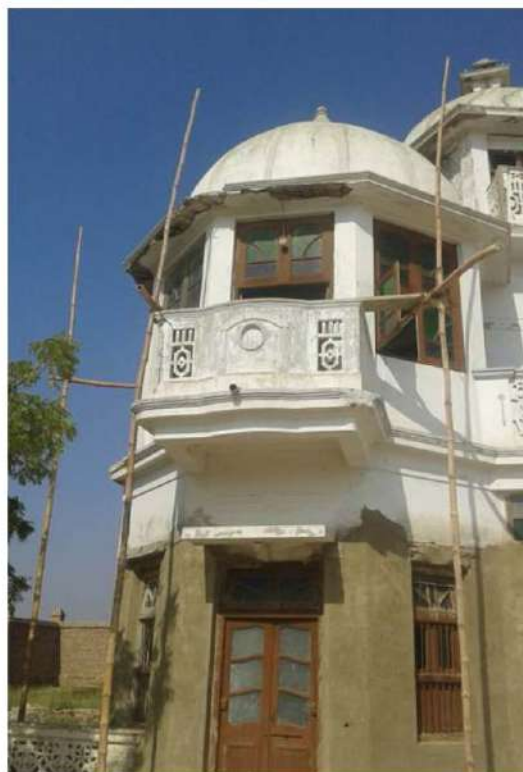
**Plastering of right side of facade are in progress**

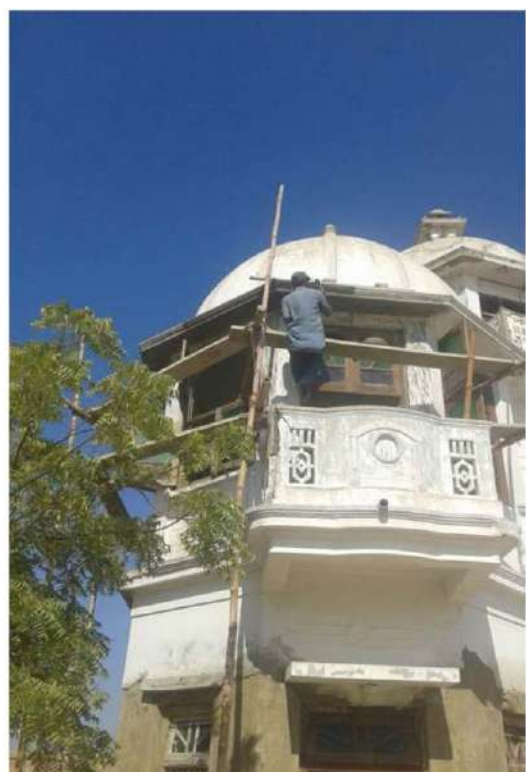
**Mason working on Chhaja on the top floor**

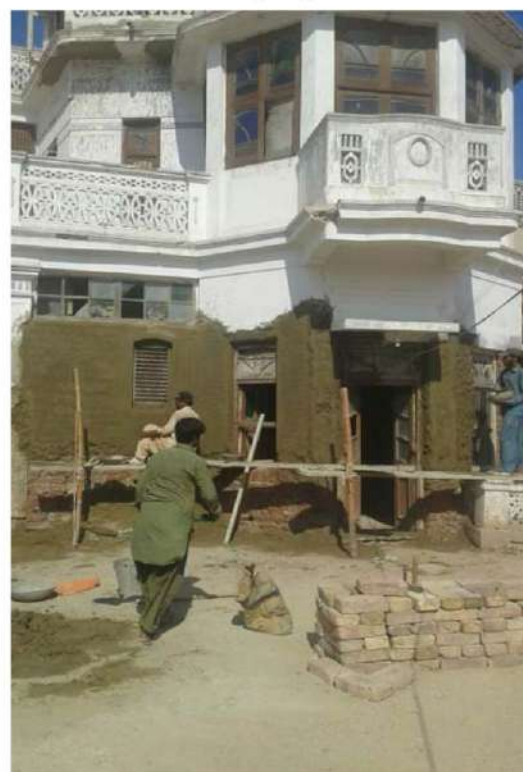
**Labours are busy plastering upto lintel on the left side of facade**

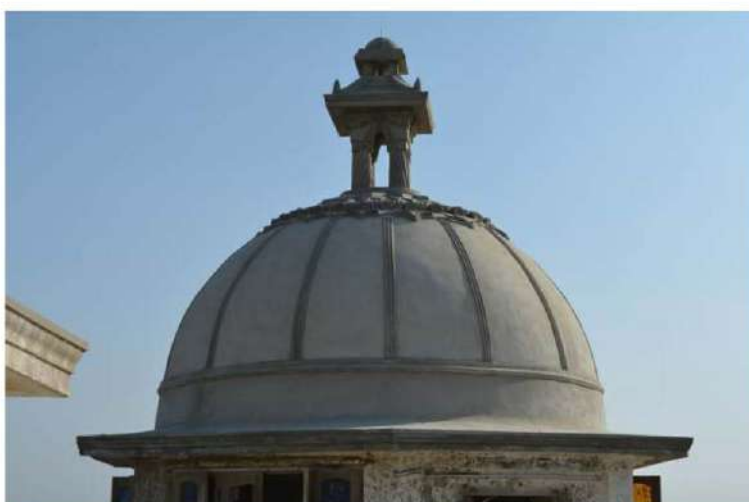
**Northern (Backside) Dome Progress upto December 2016**

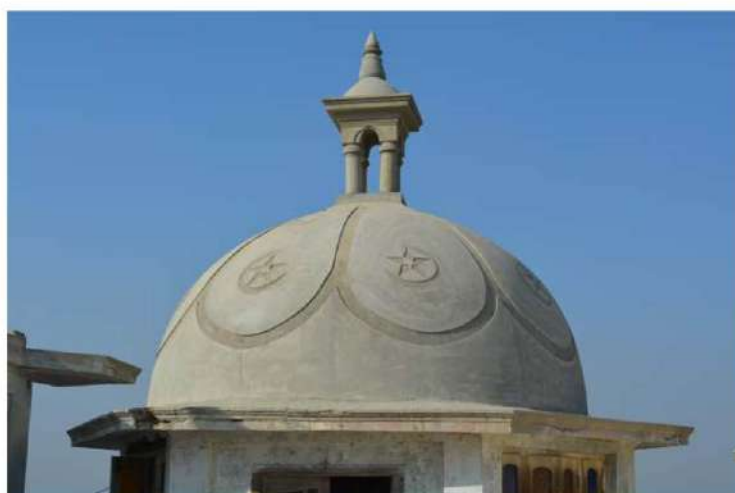
**Northern (Backside) Dome Progress upto December 2016**
