# SAHIB MAHAL

Project Completion Report | 2018

Center for Documentation and Conservation of the Heritage of Sindh  
Endowment Fund Trust for Preservation of the Heritage of Sindh

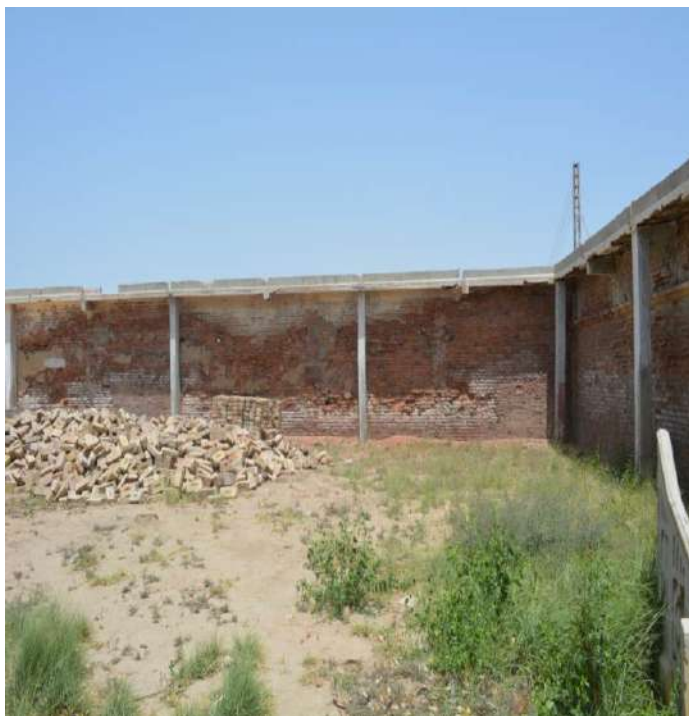
**BOUNDARY WALL**

Boundary wall is made with Brunt brick and cement mortar. Boundary wall is in very worst condition, major cracks has been appeared & missing parts of masonry. It needs immediate attention to start restoration work to preserve the Compound Wall by doing underpinning, re-masonry work in missing portion of the wall, throughout pointing & plaster with same material & technique used in previous with minimum intervention. Some portions of Boundary wall are recently constructed with Cement Brick Masonry, (Constructed by Owner/Custodian).

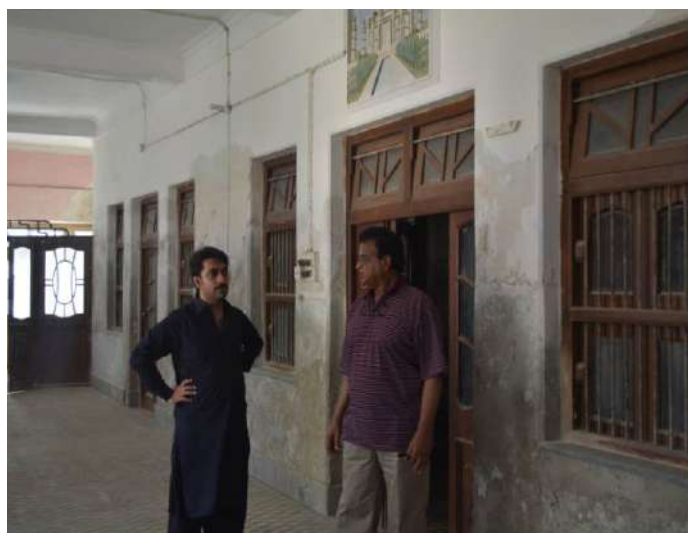
**SECOND VERANDA**

- Interior walls of 2nd Verandah are decorated with mural (fall sealing etc).
- Floor is made with Cemented tiles (Color); almost Tiles are deteriorated and needs removing replacing.

- Doors are made with wood and glass fixed in the doors for sun lightning, painted with wood Polish and all doors need repairing, replacing of glasses & polishing.

- Doors are made with Wood (Sag wan).
- Roof of 2nd verandah is made R.C.C & plastered with cement, painted with distemper and fall sealing work is also done on it, found in fine condition.

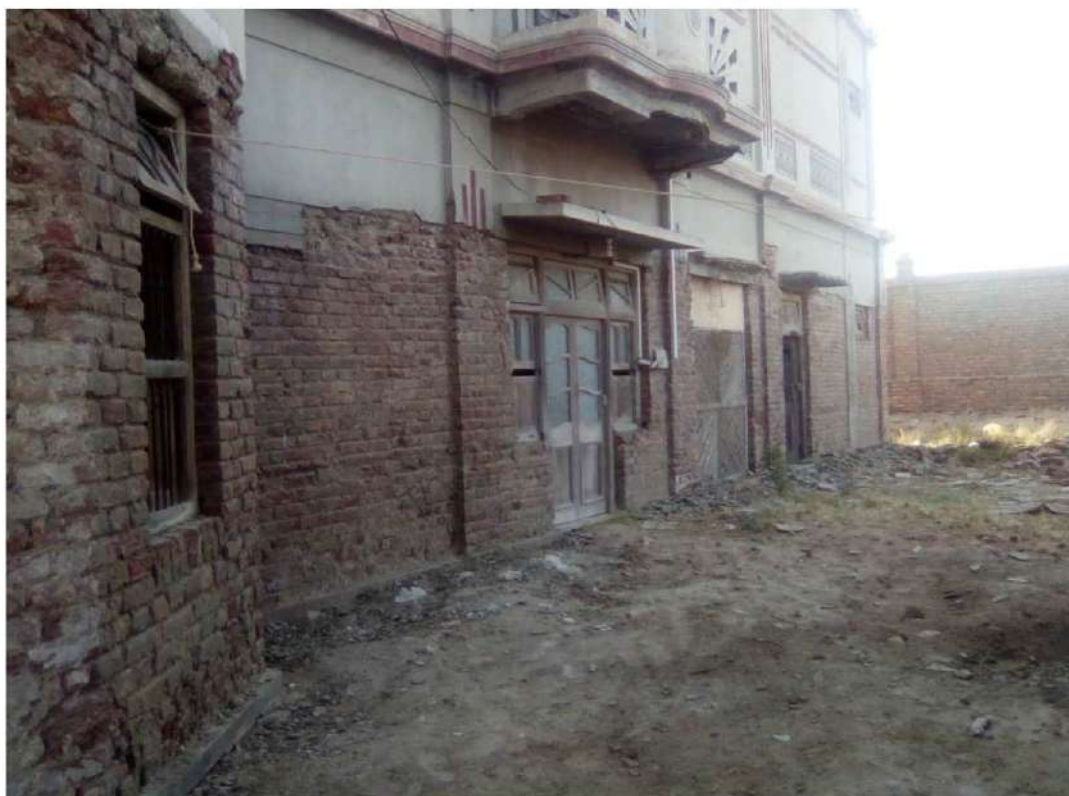
**Scraped portion of Sahib Mahal**

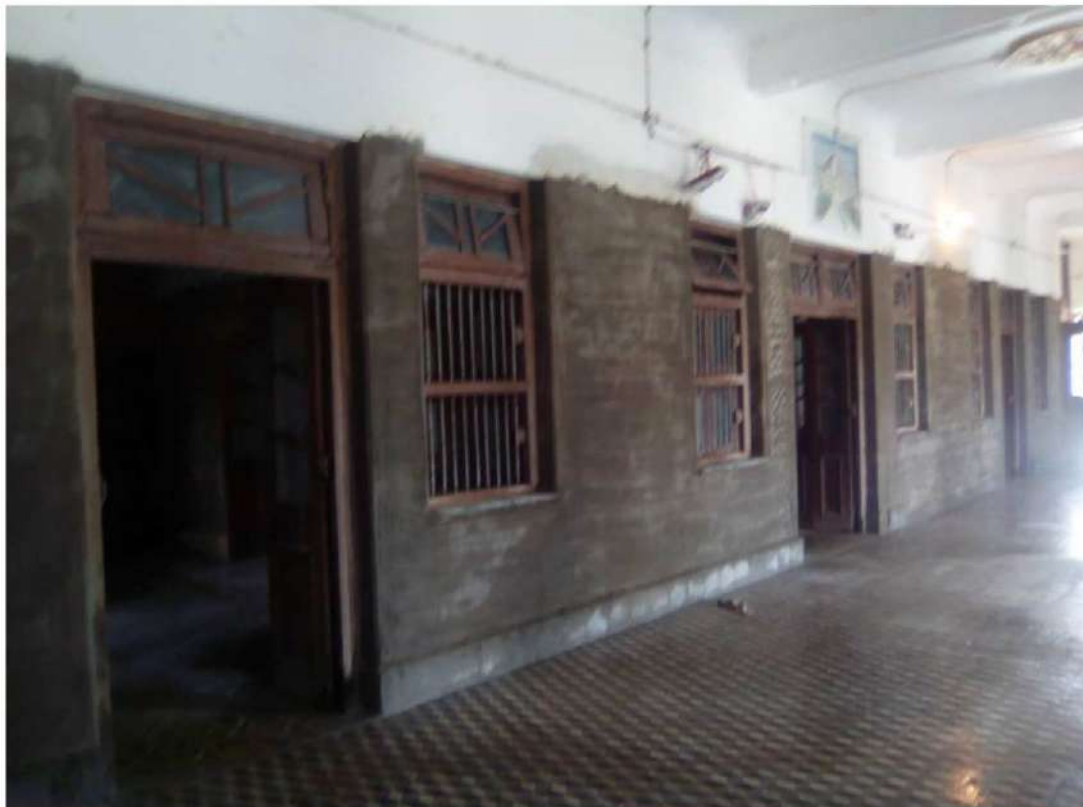
1st Coating of Cement

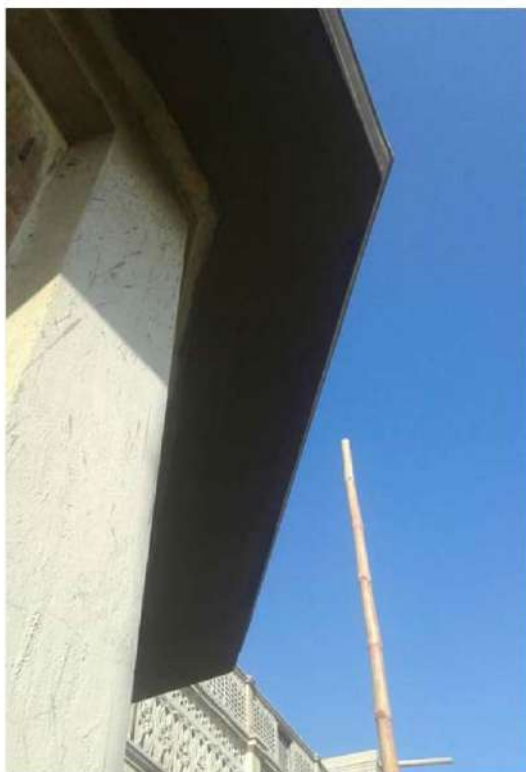
**Restored chhaja of Sahib Mahal**

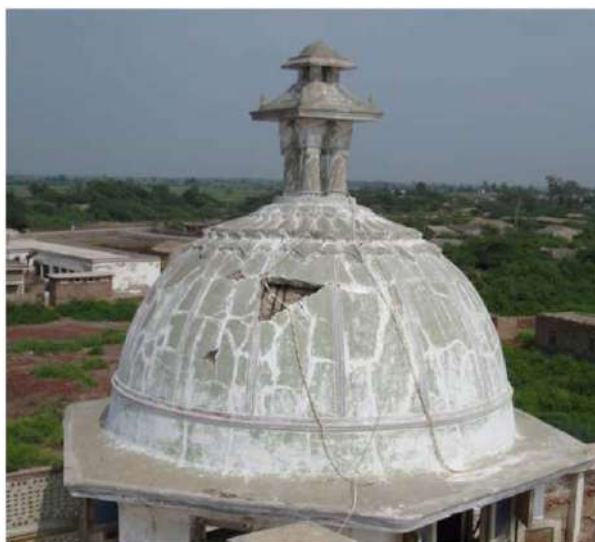
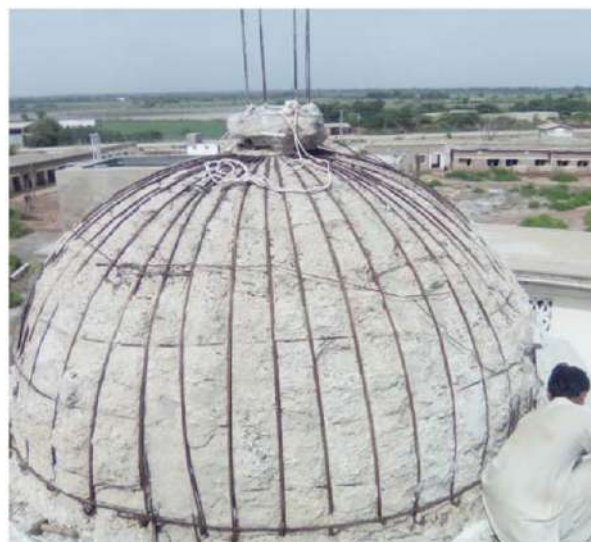
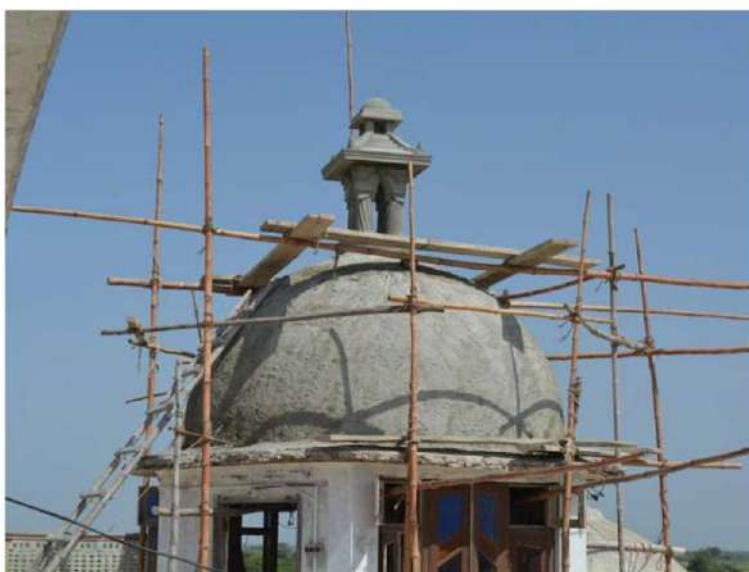
**Northern (Backside) Dome Progress upto December 2016**

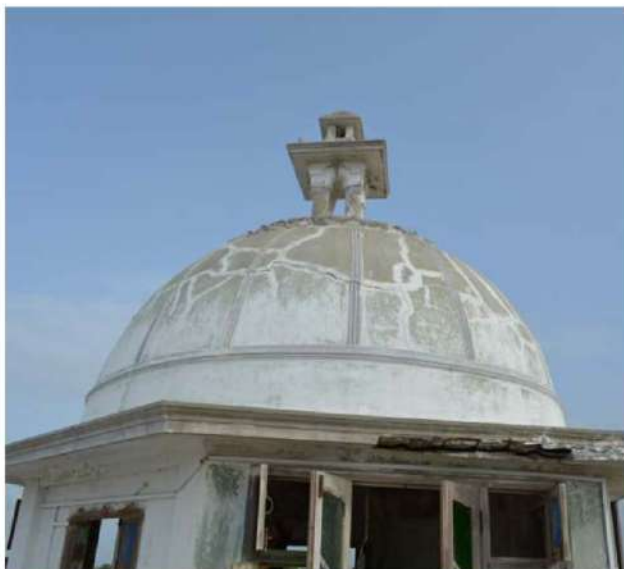
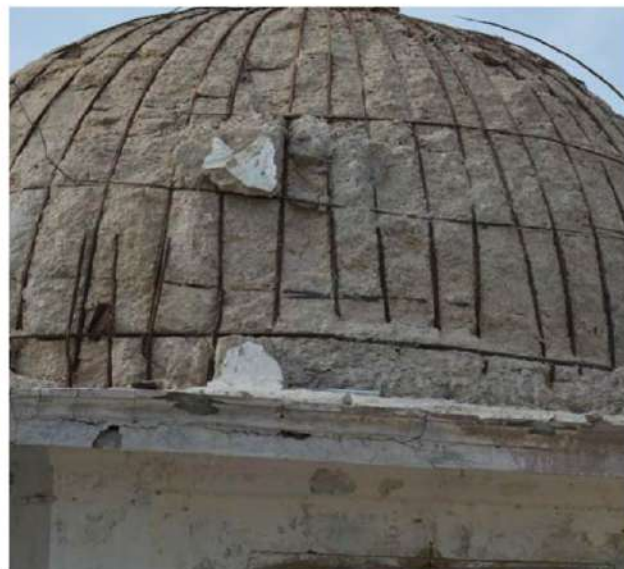
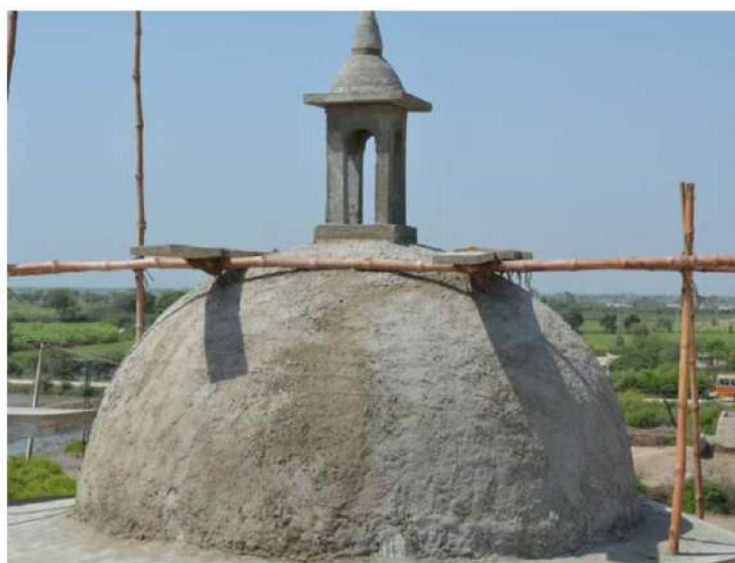
**Northern (Backside) Dome Progress upto December 2016**
